SAN JUAN ISLAND LIBRARY

BUILDING CONDITION ASSESSMENT & FEASIBILITY STUDY

May 2018

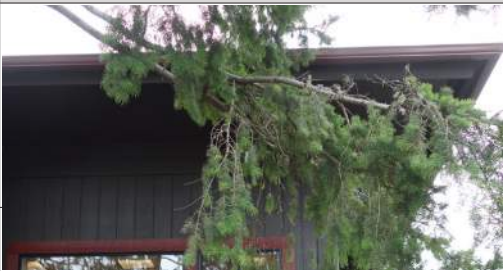
<p>Trees & plantings</p>	<p>Description: site plantings; trees, bushes, soil</p> <p>Condition: Good</p>	<p>Priority level: periodic pruning, cutting back areas where limbs are close to structure</p> <p>Estimated annual pruning cost: \$2,000/year Estimated tree removal and replacement costs: \$10,000</p>

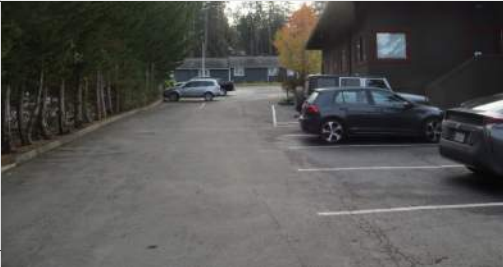
<p>Paving</p>	<p>Description: Flat and sloped paving at parking areas and walkways</p> <p>Condition: Varies- Poor to good, with areas of cracking and potholes, and low areas collecting water</p>	<p>Priority level: cyclical replacement in future based on service life.</p> <p>Estimated cost for asphalt patch and repair: \$4.50/sf</p>

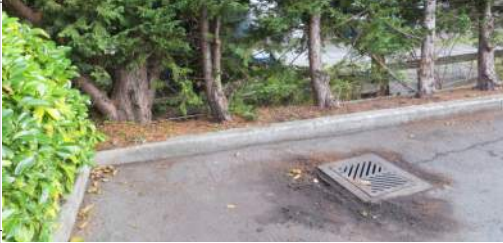
<p>Drainage</p>	<p>Description: Catch basin, typ 4 total storm drain (1 on west side, 3 on east side).</p> <p>Condition: Fair Further investigation recommended.</p>	<p>Priority level: cyclical replacement in future based on service life.</p> <p>Estimated cost for catch basin replacement / adjustment: \$14,000</p>

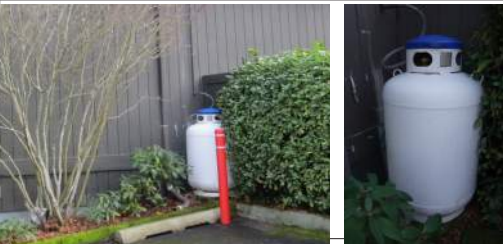
<p>Site equipment, misc</p>	<p>Description: Propane Tank</p> <p>Condition: Good</p>	<p>Priority level: cyclical replacement in future based on service life.</p>

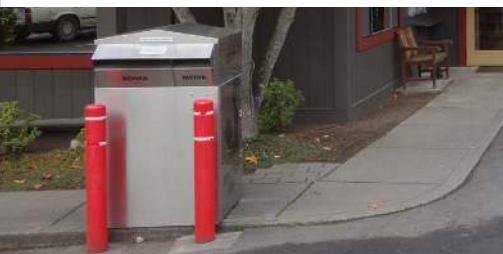
<p>Site equipment, misc</p>	<p>Description: Book drop and bollards</p> <p>Condition: Good</p>	<p>Priority level: cyclical replacement in future based on service life.</p>

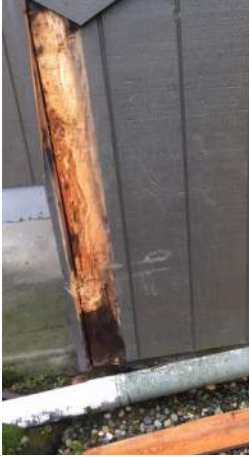
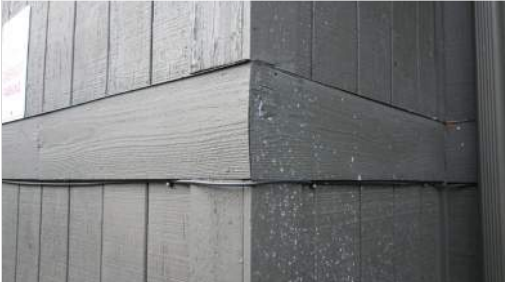
<p>Exterior Envelope: Siding</p>	<p>Description: Painted T-11 siding with painted 1x6 clear cedar trim at windows and doors (see below)</p> <p>Condition: Generally good, with exceptions at areas of white bloom (reference photo taken at east side, May 2016) or at exterior stair. Planted areas where dirt in direct contact with structure</p>	<p>Priority level: cyclical replacement in future based on service life. Repaint at recommended intervals based on lifespan (3-5 years), depending on maintenance and exposure. Inspect existing paint surfaces to determine extent of surface preparation necessary avoiding damage or removal of wood substrate.</p> <p>Estimated cost for miscellaneous wood repair/replacement: \$5,000</p>

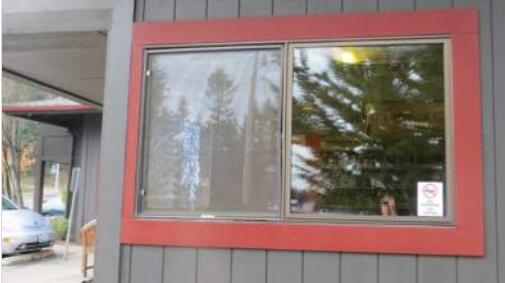
<p>Exterior Envelope: Windows</p>	<p>Description: Pre-finished aluminum sliding windows</p> <p>Condition: Varies- Poor to fair</p>	<p>Priority level: cyclical replacement in future based on service life. Windows appear to be in generally fair condition though there is evidence of possible water intrusion at some windows. Additional investigation recommended.</p>

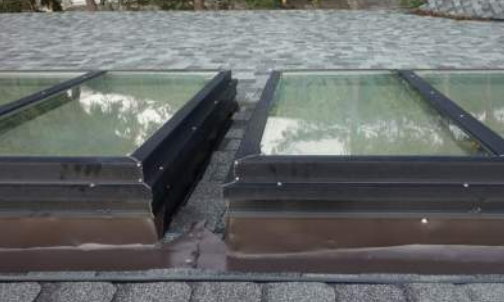
<p>Exterior Envelope: Skylights</p>	<p>Description: Curb-mounted skylight</p> <p>Condition: Fair</p>	<p>Priority level: cyclical replacement in future based on service life.</p>

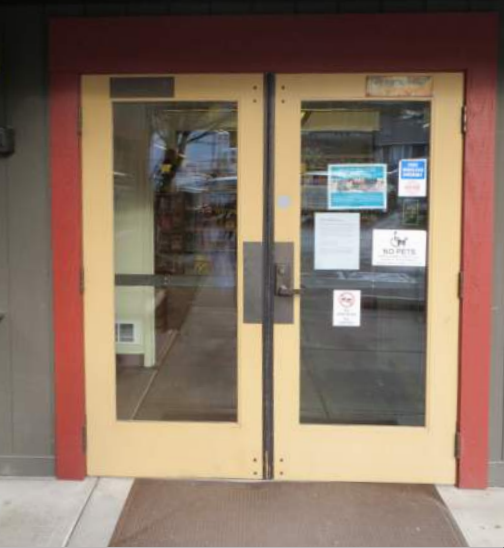
<p>Exterior Envelope: Doors</p>	<p>Description: Painted metal doors</p> <p>Condition: Good</p>	<p>Priority level: cyclical replacement in future based on service life. Repaint at recommended intervals based on lifespan (3-5 years), depending on maintenance and exposure.</p>

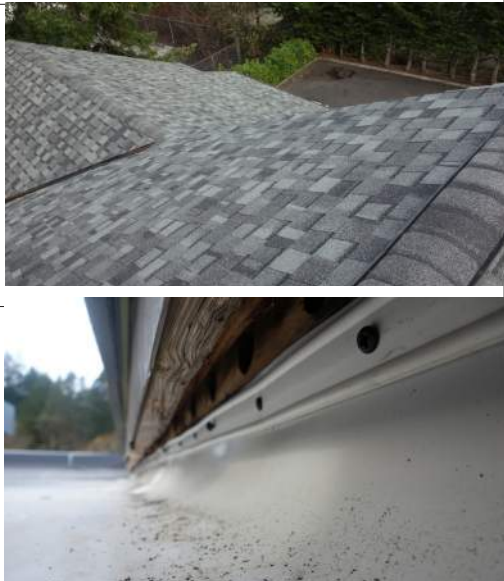
<p>Exterior Envelope: Roofing</p>	<p>Description: 2x6 rafters at 24" O.C. w/ comp roofing over #15 MW building paper over 1/2" CDX sheathing. 2017 Replacement w/ Durolast PVC membrane</p> <p>Condition: Generally good</p>	<p>Priority level: cyclical replacement in future based on service life.</p> <p>Estimated cost for re-roof: Re-roof: \$16/sf low slope roofs Re-roof: \$5.50/sf asphalt composition roofs</p> <p>Estimated cost for gutter replacement: \$4,180 total (\$11.00/lf)</p>

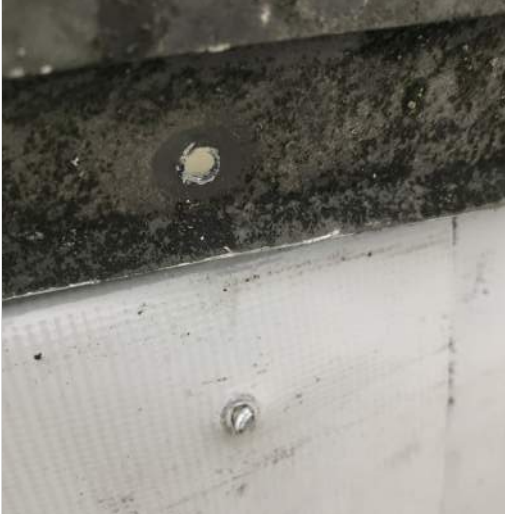
<p>Exterior systems: Skylight frame</p>	<p>Description: Metal skylight frame</p> <p>Condition: Poor</p>	<p>Priority level: cyclical replacement in future based on service life.</p>

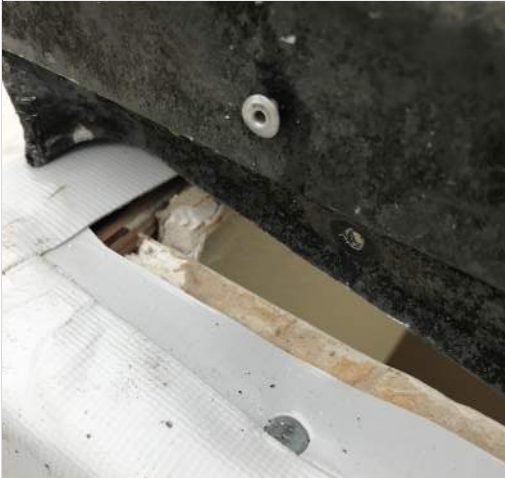
<p>Exterior systems: Skylight frame</p>	<p>Description: Metal skylight frame</p> <p>Condition: Poor</p>	<p>Priority level: cyclical replacement in future based on service life.</p>

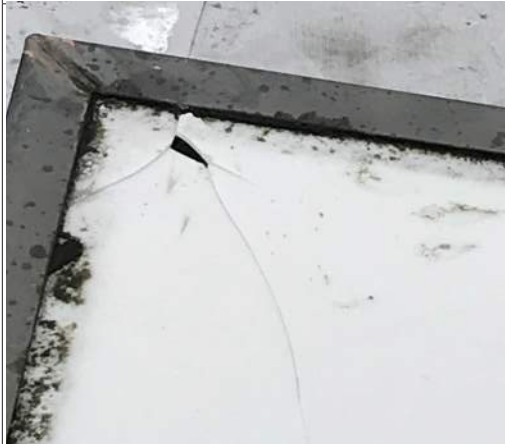
<p>Exterior systems: Skylight</p>	<p>Description: Skylight</p> <p>Condition: Poor</p>	<p>Priority level: cyclical replacement in future based on service life.</p>

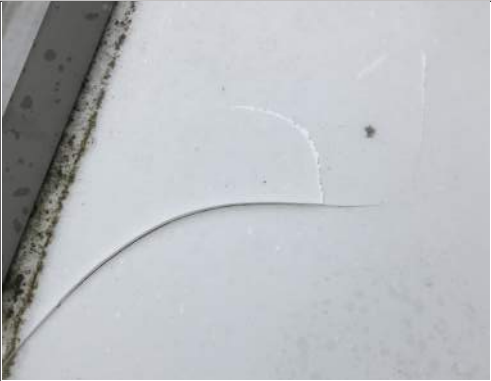
<p>Exterior systems: Skylight</p>	<p>Description: Skylight</p> <p>Condition: Poor</p>	<p>Priority level: cyclical replacement in future based on service life.</p>

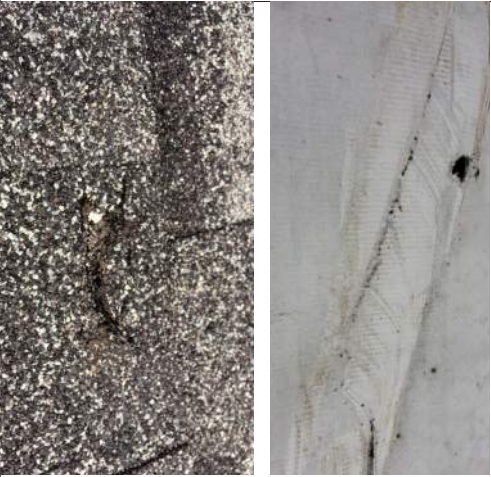
<p>Exterior systems: roofing</p>	<p>Description: Roofing shingles, membrane</p> <p>Condition: Poor</p>	<p>Priority level: cyclical replacement in future based on service life.</p> <p>See estimated costs for re-roof.</p>

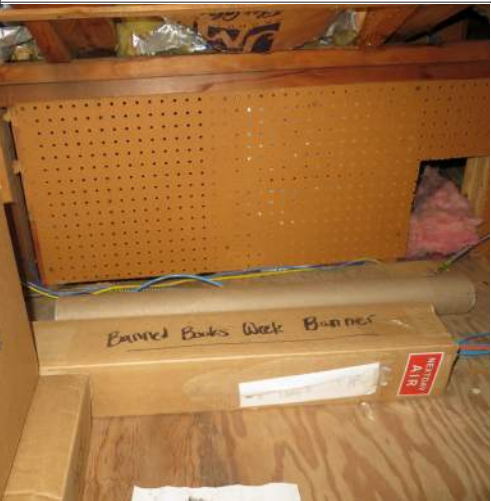
<p>Insulation</p>	<p>Description: Missing insulation at exterior walls, subsequent heat loss</p> <p>Condition: Poor</p>	<p>Priority level: high priority</p> <p>Estimated cost for replacement of missing insulation: \$5,000</p>

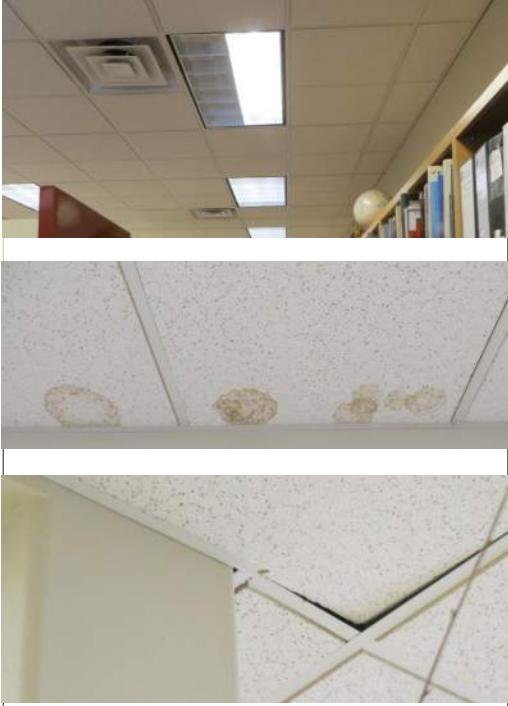
<p data-bbox="170 961 524 993">Interior finishes/systems: Ceilings</p>	<p data-bbox="673 289 971 415">Description: Suspended ceiling system; 24"x24" Acoustical ceiling tile with square edge</p> <p data-bbox="673 447 870 478">Condition: Varies</p>	<p data-bbox="1063 289 1458 352">Priority level: cyclical replacement in future based on service life.</p> <p data-bbox="1063 384 1469 478">30 percent of tiles should be replaced due to staining, torque, or signs of wear.</p> <p data-bbox="1063 510 1469 636">Estimated cost for ACT replacement: \$6.50/sf (replacement of individual tiles will be readily apparent)</p>

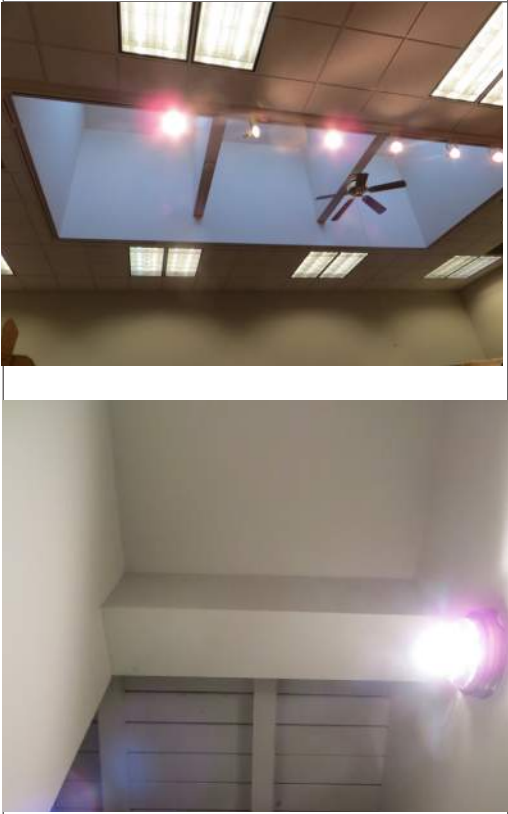
<p data-bbox="170 1854 524 1885">Interior finishes/systems: Ceilings</p>	<p data-bbox="673 1050 977 1144">Description: Painted GWB ceiling/soffit at skylight, Staff workroom</p> <p data-bbox="673 1176 862 1207">Condition: Good</p>	<p data-bbox="1063 1050 1464 1113">Priority level: cyclical replacement in future based on service life.</p> <p data-bbox="1063 1113 1464 1333">Repaint at recommended intervals based on lifespan (3-5 years), depending on maintenance and exposure. Inspect existing paint surfaces to determine extent of surface preparation necessary avoiding damage of substrate.</p> <p data-bbox="1063 1365 1437 1459">Estimated cost to replace ceiling lights with LED bulbs: \$40,00</p> <p data-bbox="1063 1491 1437 1585">Estimated cost for lighting upgrades throughout building: (\$8.00/sf) (8 x 9200 = \$73,600)</p>

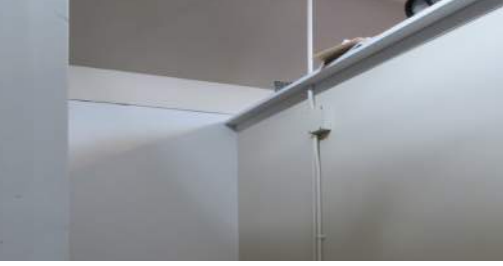
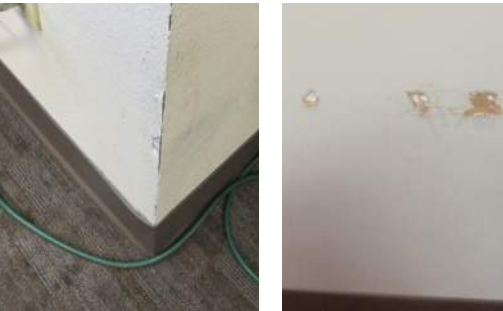
<p>Interior finishes/systems: Walls</p>	<p>Description: Painted GWB wall surfaces</p> <p>Condition: Varies</p>	<p>Priority level: cyclical replacement in future based on service life. Repaint at recommended intervals based on lifespan (3-5 years), depending on maintenance and exposure. Inspect existing paint surfaces to determine extent of surface preparation necessary avoiding damage of substrate.</p> <p>Estimated cost to repaint interior: \$40,000</p>

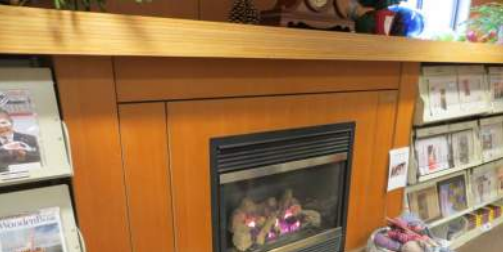
<p>Interior finishes/systems: Walls</p>	<p>Description: Wood paneling at fire place</p> <p>Condition: Good</p>	<p>Priority level: cyclical replacement in future based on service life.</p>

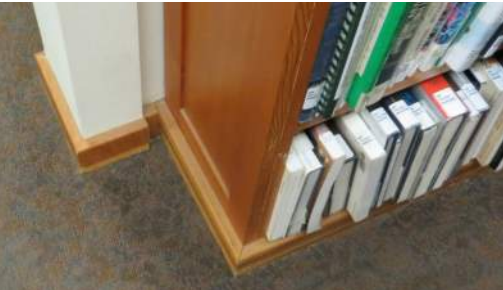
<p>Interior finishes/systems: Wall base</p>	<p>Description: Wood base at periodicals/fireplace</p> <p>Condition: Good</p>	<p>Priority level: cyclical replacement in future based on service life.</p>

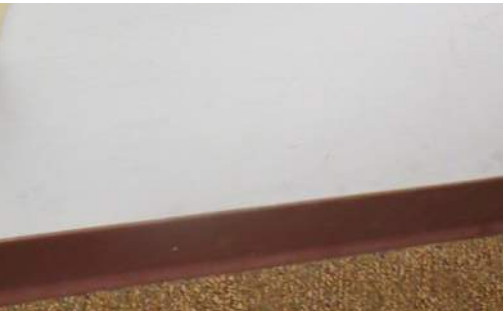
<p>Interior finishes/systems: Wall base</p>	<p>Description: Resilient base</p> <p>Condition: Good</p>	<p>Priority level: cyclical replacement in future based on service life.</p>

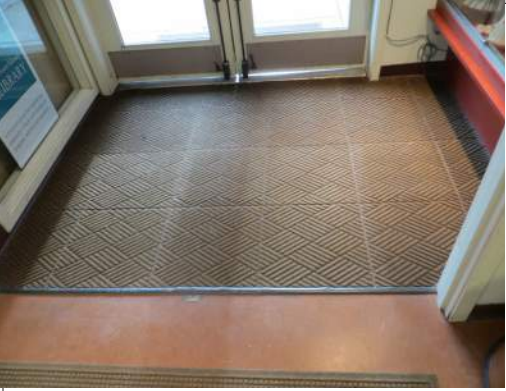
<p data-bbox="175 657 529 684">Interior finishes/systems: Flooring</p>	<p data-bbox="678 289 1003 352">Description: Walk-off mat at entry</p> <p data-bbox="678 384 865 411">Condition: Good</p>	<p data-bbox="1068 289 1474 352">Priority level: cyclical replacement in future based on service life.</p>

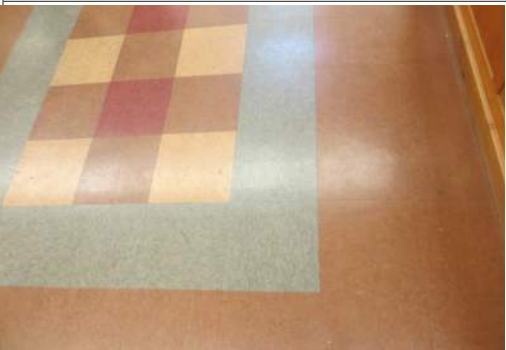
<p data-bbox="175 1073 529 1100">Interior finishes/systems: Flooring</p>	<p data-bbox="678 737 922 800">Description: Resilient flooring</p> <p data-bbox="678 831 865 858">Condition: Good</p>	<p data-bbox="1068 737 1474 800">Priority level: cyclical replacement in future based on service life.</p>

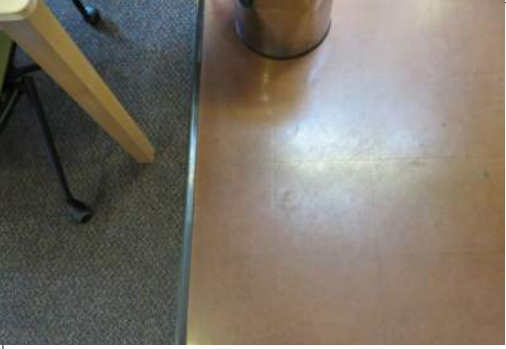
<p data-bbox="175 1493 529 1520">Interior finishes/systems: Flooring</p>	<p data-bbox="678 1150 1011 1245">Description: Carpet/Resilient flooring transitions</p> <p data-bbox="678 1213 865 1241">Condition: Good</p>	<p data-bbox="1068 1150 1474 1213">Priority level: cyclical replacement in future based on service life.</p>

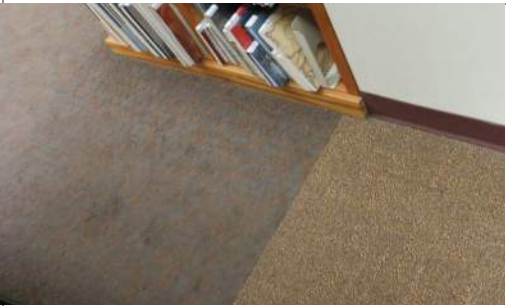
<p data-bbox="175 1860 529 1887">Interior finishes/systems: Flooring</p>	<p data-bbox="678 1566 902 1593">Description: Carpet</p> <p data-bbox="678 1625 930 1652">Condition: Varies- Fair</p>	<p data-bbox="1068 1566 1474 1629">Priority level: cyclical replacement in future based on service life.</p>

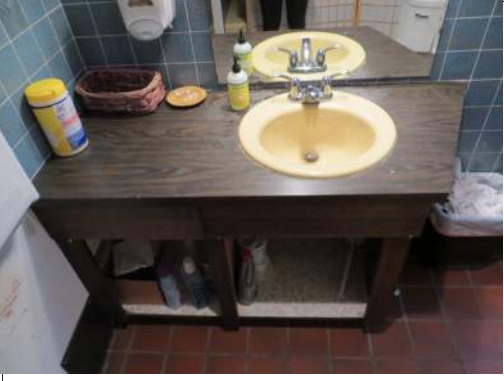
<p data-bbox="151 657 370 682">Misc: Staff Bathroom</p>	<p data-bbox="654 289 950 352">Description: Existing staff bathroom</p> <p data-bbox="654 384 833 409">Condition: Poor</p>	<p data-bbox="1044 289 1385 447">Replace bathroom door. Cyclical replacement in future based on service life: update fixtures and finishes, provide ADA-accessibility.</p> <p data-bbox="1044 478 1369 541">Estimated cost for bathroom upgrade: \$4,000</p>

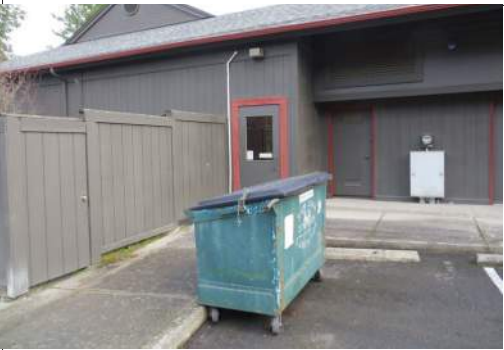
<p data-bbox="151 1071 410 1096">Misc: Garbage enclosure</p>	<p data-bbox="654 730 898 793">Description: Garbage enclosure</p> <p data-bbox="654 825 824 850">Condition: N/A</p>	<p data-bbox="1044 730 1409 793">Estimated cost for building new garbage enclosure: \$3,000.</p>

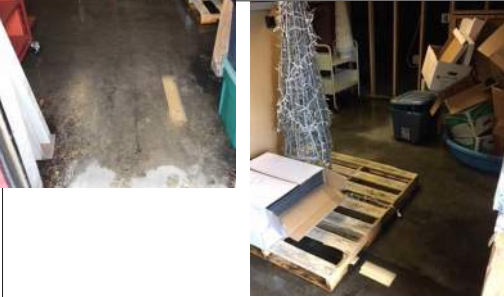
<p data-bbox="151 1501 540 1526">Misc: Stormwater systems/Basement</p>	<p data-bbox="654 1150 954 1213">Description: Ongoing Basement flooding issues</p> <p data-bbox="654 1245 833 1270">Condition: Poor</p>	<p data-bbox="1044 1150 1433 1308">Priority level: high priority Excavate building foundation perimeter, remove and replace portions of parking lot, install new pipe and drains.</p> <p data-bbox="1044 1339 1401 1402">Estimated cost for stormwater system replacement: \$150,000</p> <p data-bbox="1044 1434 1442 1654">Note: Mold at Basement ongoing problem, with patron and staff complaints regarding health. Additional investigation recommended prior to abatement. Estimated abatement cost: \$50,000</p>

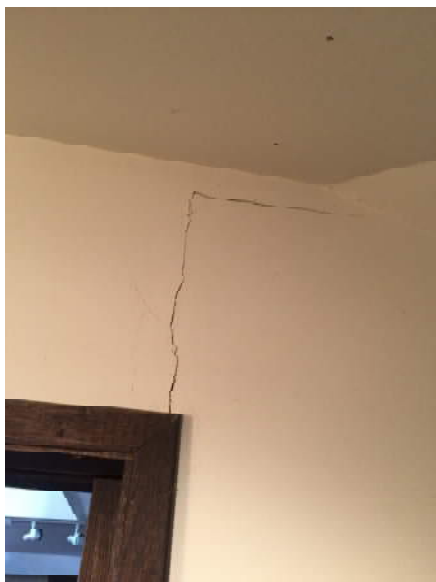
However, at one location, at the interface between the new and existing roof, we identified an area of distress along the corner of the doorway leading to the attic bathroom. At this location, a crack has developed in the interior finish on each side of the wall over the western corner of the door (See attached photos)

Distress over attic door (north side)

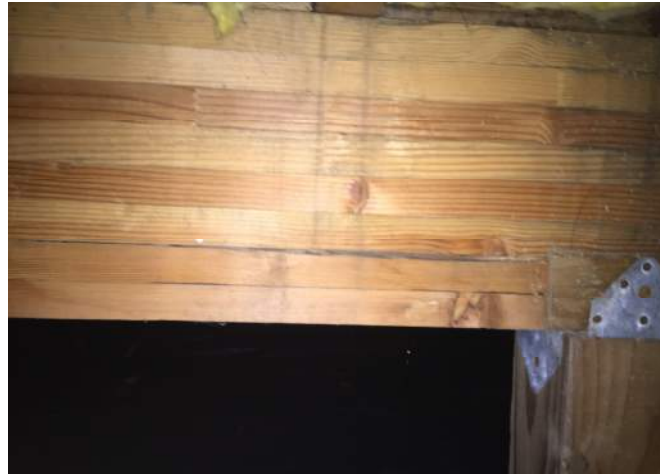
At one location, we identified that one of the glue-laminated beams was experiencing some delamination at the bottom two laminations.

Delamination at the bottom of one glue-laminated beam

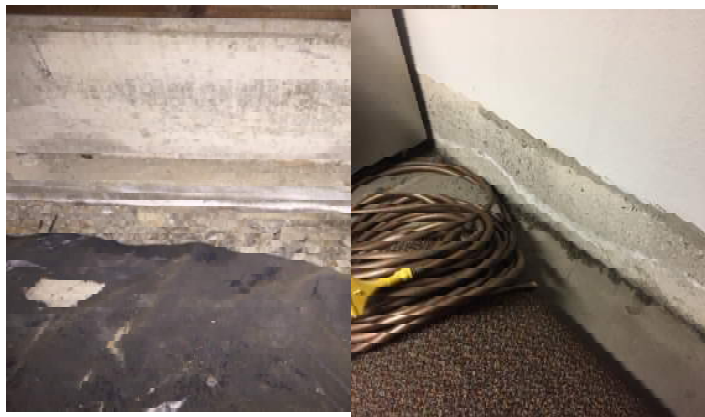
Efflorescence on interior face of exterior concrete construction.

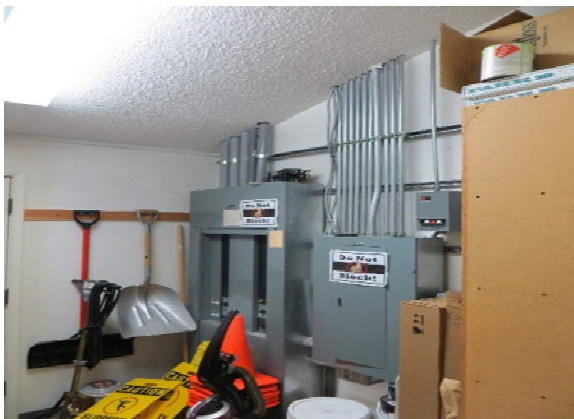
The main panel is a Square D, I-Line style panelboard. It is a modern type panelboard that contains circuit breakers (not fuses). It appears that it was new in 1994 when an addition was built onto the Library. It appears to be in good condition and is a similar type that would still be installed in a new building today. It has five main circuit breakers. 3 of the five circuit breakers are rated 200 amp, 3 phase and supply sub-panels in the building. The fourth circuit breaker supplies a 3 phase mechanical unit HC-1. The fifth breaker supplies a 1 phase mechanical unit AHU-1. Six main breakers is the maximum limit allowed by code, however, there is physical space to add another breaker, leaving capacity for future growth.

Picture 4 – Main Switchboard Located in Elec. Rm.

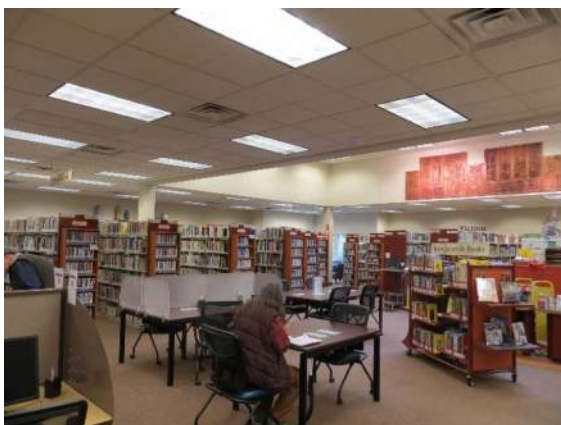
The existing interior lighting in the 1994 building addition is primarily made up of commercial recessed 2x4 fluorescent fixtures with T8 lamps. There are some incandescent track lighting and incandescent can lights. T8 fluorescent lighting is still a fairly efficient means of lighting. The existing fluorescent lighting appears to be in good condition.

Picture 6 – Existing T8 Fluorescent Lighting

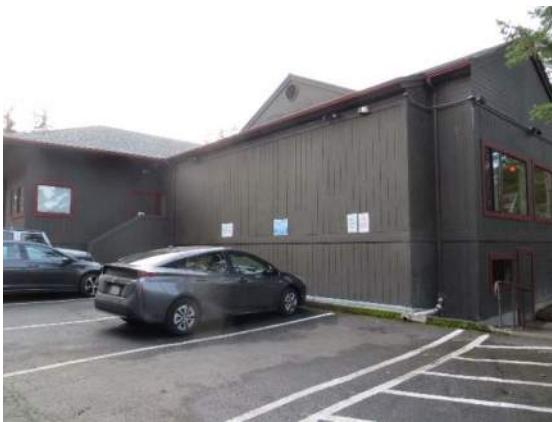
The existing exterior lighting is primarily made up of building mounted lights with no pole mounted lights for the parking lot. The site visit was performed during the day time, however, the existing lighting does not appear that it provides very much light at night. The exterior lights are primarily high pressure sodium (HPS) wall packs, building mounted. The north and east sides of the building appear to be underlit. At some point in time, incandescent flood lights have been added with surface conduit routing from light to light around the perimeter to provide more light. LED lighting is currently a more efficient lighting method. Eventually, the exterior lighting should be replaced/upgraded with LED type.

Picture 8 – East HPS and Incand. Lighting
