SAN JUAN ISLAND LIBRARY

BUILDING CONDITION ASSESSMENT & FEASIBILITY STUDY

May 2018

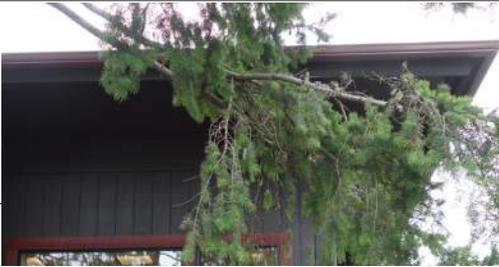
<p>Trees & plantings</p>	<p>Description: site plantings; trees, bushes, soil</p> <p>Condition: Good</p>	<p>Priority level: periodic pruning, cutting back areas where limbs are close to structure</p> <p>Estimated annual pruning cost: \$2,000/year</p> <p>Estimated tree removal and replacement costs: \$10,000</p>

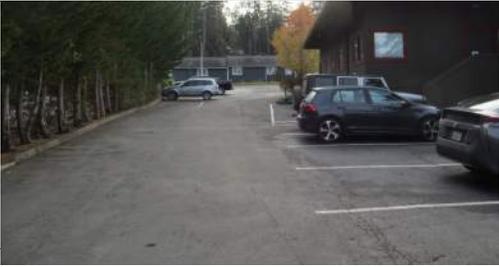
<p>Paving</p>	<p>Description: Flat and sloped paving at parking areas and walkways</p> <p>Condition: Varies- Poor to good, with areas of cracking and potholes, and low areas collecting water</p>	<p>Priority level: cyclical replacement in future based on service life.</p> <p>Estimated cost for asphalt patch and repair: \$4.50/sf</p>

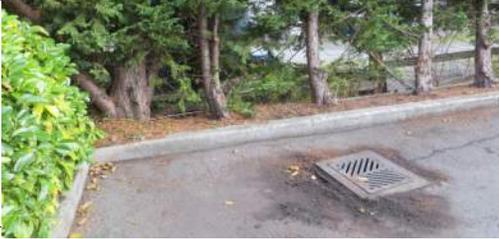
<p>Drainage</p>	<p>Description: Catch basin, typ 4 total storm drain (1 on west side, 3 on east side).</p> <p>Condition: Fair Further investigation recommended.</p>	<p>Priority level: cyclical replacement in future based on service life.</p> <p>Estimated cost for catch basin replacement / adjustment: \$14,000</p>

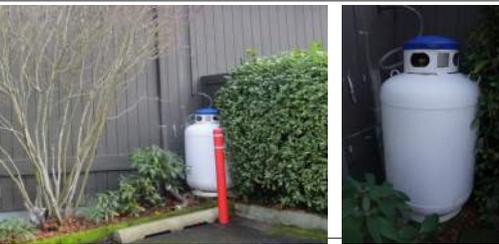
<p>Site equipment, misc</p>	<p>Description: Propane Tank</p> <p>Condition: Good</p>	<p>Priority level: cyclical replacement in future based on service life.</p>

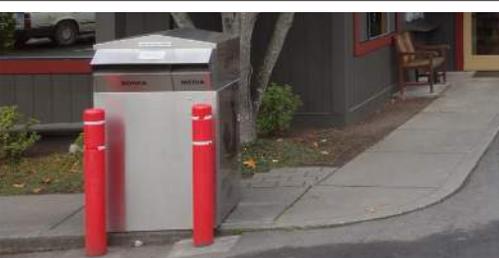
<p>Site equipment, misc</p>	<p>Description: Book drop and bollards</p> <p>Condition: Good</p>	<p>Priority level: cyclical replacement in future based on service life.</p>

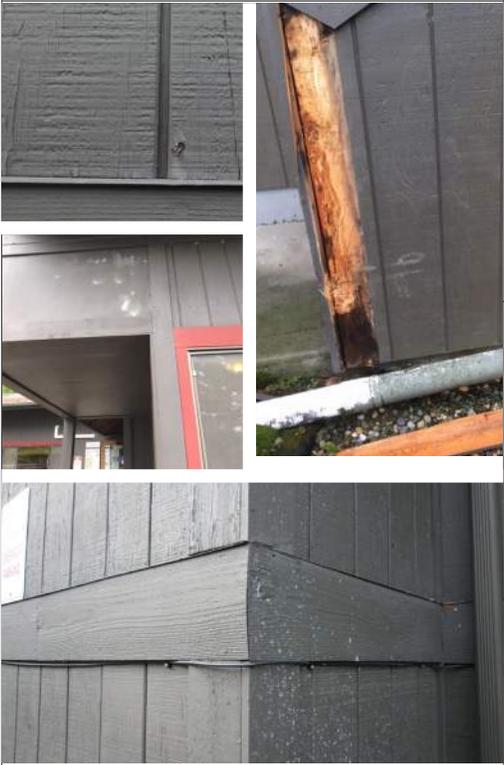
<p data-bbox="168 1520 435 1545">Exterior Envelope: Siding</p>	<p data-bbox="672 772 1006 1150">Description: Painted T-11 siding with painted 1x6 clear cedar trim at windows and doors (see below) Condition: Generally good, with exceptions at areas of white bloom (reference photo taken at east side, May 2016) or at exterior stair. Planted areas where dirt in direct contact with structure</p>	<p data-bbox="1058 772 1461 1087">Priority level: cyclical replacement in future based on service life. Repaint at recommended intervals based on lifespan (3-5 years), depending on maintenance and exposure. Inspect existing paint surfaces to determine extent of surface preparation necessary avoiding damage or removal of wood substrate.</p> <p data-bbox="1058 1155 1455 1218">Estimated cost for miscellaneous wood repair/replacement: \$5,000</p>

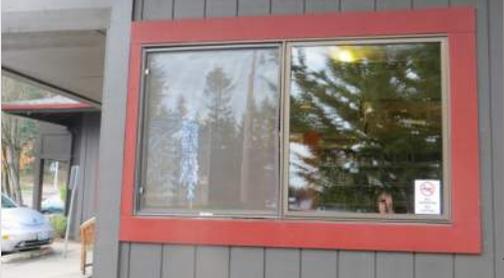
<p data-bbox="168 1856 467 1881">Exterior Envelope: Windows</p>	<p data-bbox="672 1596 980 1747">Description: Pre-finished aluminum sliding windows Condition: Varies- Poor to fair</p>	<p data-bbox="1058 1596 1455 1843">Priority level: cyclical replacement in future based on service life. Windows appear to be in generally fair condition though there is evidence of possible water intrusion at some windows. Additional investigation recommended.</p>

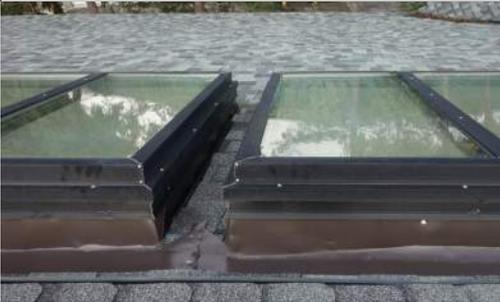
<p data-bbox="147 583 444 611">Exterior Envelope: Skylights</p>	<p data-bbox="651 289 971 348">Description: Curb-mounted skylight</p> <p data-bbox="651 384 821 411">Condition: Fair</p>	<p data-bbox="1040 289 1438 348">Priority level: cyclical replacement in future based on service life.</p>

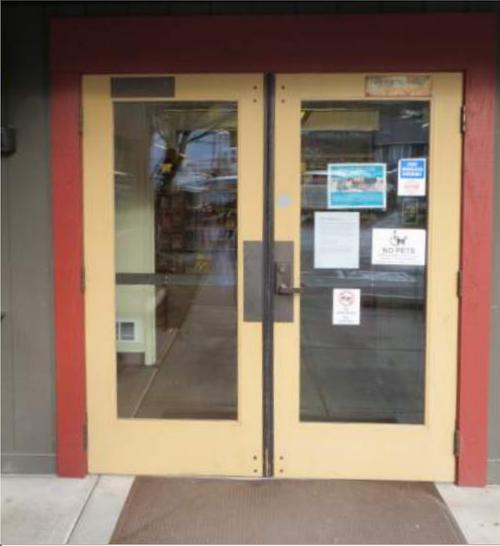
<p data-bbox="147 1203 412 1230">Exterior Envelope: Doors</p>	<p data-bbox="651 665 959 724">Description: Painted metal doors</p> <p data-bbox="651 760 841 787">Condition: Good</p>	<p data-bbox="1040 665 1438 850">Priority level: cyclical replacement in future based on service life. Repaint at recommended intervals based on lifespan (3-5 years), depending on maintenance and exposure.</p>

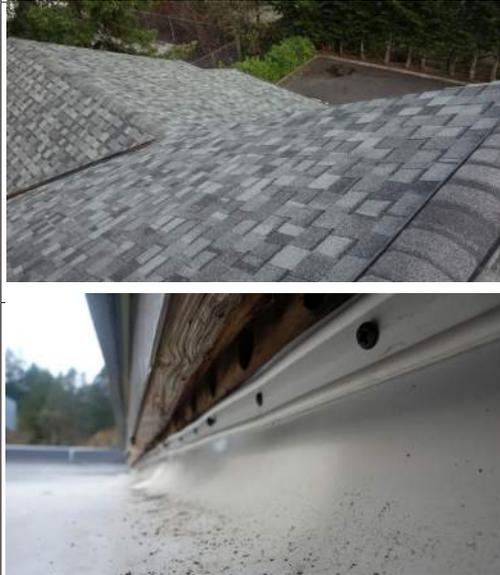
<p data-bbox="147 1864 428 1892">Exterior Envelope: Roofing</p>	<p data-bbox="651 1291 984 1509">Description: 2x6 rafters at 24" O.C. w/ comp roofing over #15 MW building paper over 1/2" CDX sheathing. 2017 Replacement w/ Durolast PVC membrane</p> <p data-bbox="651 1482 954 1509">Condition: Generally good</p>	<p data-bbox="1040 1291 1438 1350">Priority level: cyclical replacement in future based on service life.</p> <p data-bbox="1040 1386 1406 1509">Estimated cost for re-roof: Re-roof: \$16/sf low slope roofs Re-roof: \$5.50/sf asphalt composition roofs</p> <p data-bbox="1040 1545 1341 1635">Estimated cost for gutter replacement: \$4,180 total (\$11.00/lf)</p>

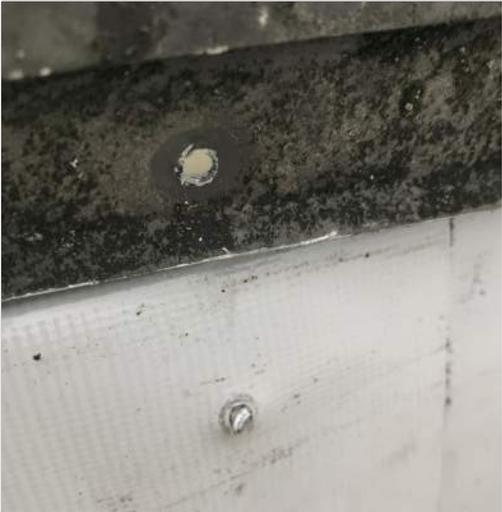
<p>Description: Metal skylight frame</p> <p>Condition: Poor</p>	<p>Priority level: cyclical replacement in future based on service life.</p>
<p>Exterior systems: Skylight frame</p>

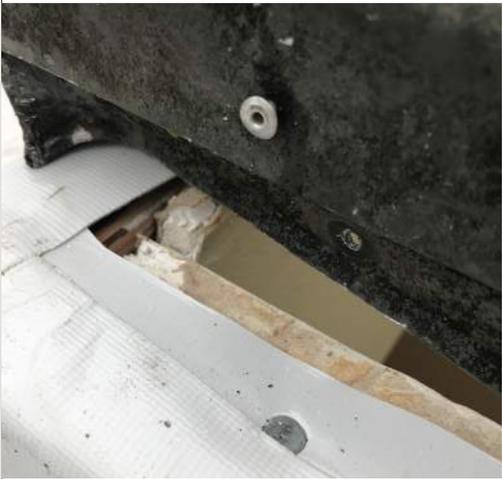
<p>Description: Metal skylight frame</p> <p>Condition: Poor</p>	<p>Priority level: cyclical replacement in future based on service life.</p>
<p>Exterior systems: Skylight frame</p>

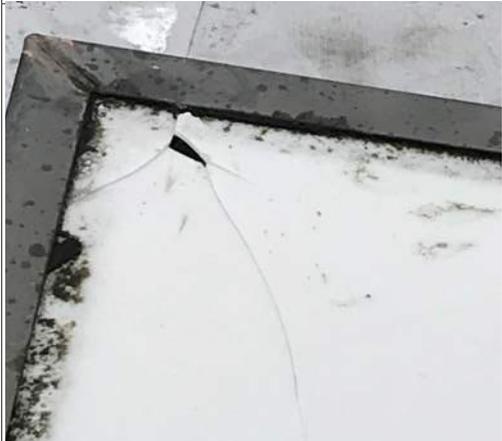
<p>Description: Skylight</p> <p>Condition: Poor</p>	<p>Priority level: cyclical replacement in future based on service life.</p>
<p>Exterior systems: Skylight</p>

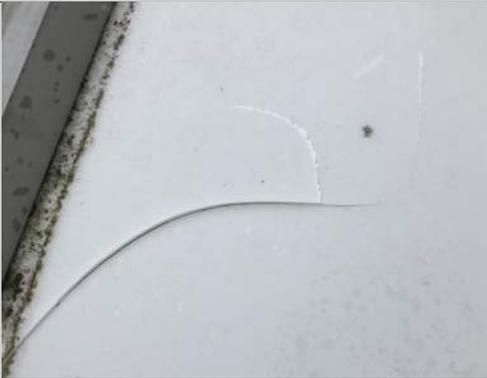
<p data-bbox="151 667 427 695">Exterior systems: Skylight</p>	<p data-bbox="643 289 883 317">Description: Skylight</p> <p data-bbox="643 384 824 411">Condition: Poor</p>	<p data-bbox="1097 289 1425 380">Priority level: cyclical replacement in future based on service life.</p>

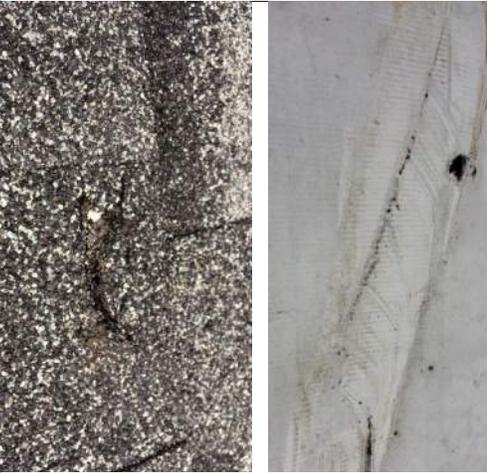
<p data-bbox="151 1213 415 1241">Exterior systems: roofing</p>	<p data-bbox="643 751 992 810">Description: Roofing shingles, membrane</p> <p data-bbox="643 819 824 846">Condition: Poor</p>	<p data-bbox="1097 751 1425 842">Priority level: cyclical replacement in future based on service life.</p> <p data-bbox="1097 882 1414 940">See estimated costs for re-roof.</p>

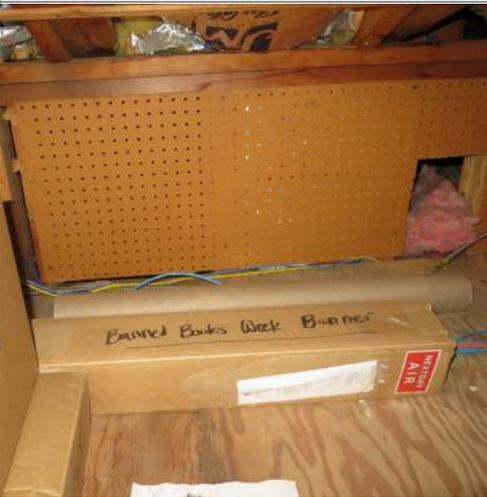
<p data-bbox="151 1864 256 1892">Insulation</p>	<p data-bbox="643 1312 1029 1402">Description: Missing insulation at exterior walls, subsequent heat loss</p> <p data-bbox="643 1438 824 1465">Condition: Poor</p>	<p data-bbox="1097 1312 1393 1339">Priority level: high priority</p> <p data-bbox="1097 1375 1370 1465">Estimated cost for replacement of missing insulation: \$5,000</p>

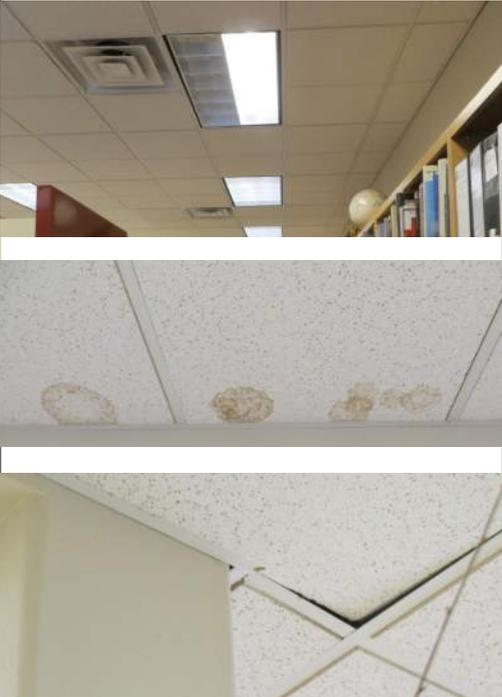
<p data-bbox="170 961 526 989">Interior finishes/systems: Ceilings</p>	<p data-bbox="672 289 976 415">Description: Suspended ceiling system; 24"x24" Acoustical ceiling tile with square edge</p> <p data-bbox="672 447 870 474">Condition: Varies</p>	<p data-bbox="1062 289 1458 348">Priority level: cyclical replacement in future based on service life.</p> <p data-bbox="1062 384 1468 478">30 percent of tiles should be replaced due to staining, torque, or signs of wear.</p> <p data-bbox="1062 510 1468 636">Estimated cost for ACT replacement: \$6.50/sf (replacement of individual tiles will be readily apparent)</p>

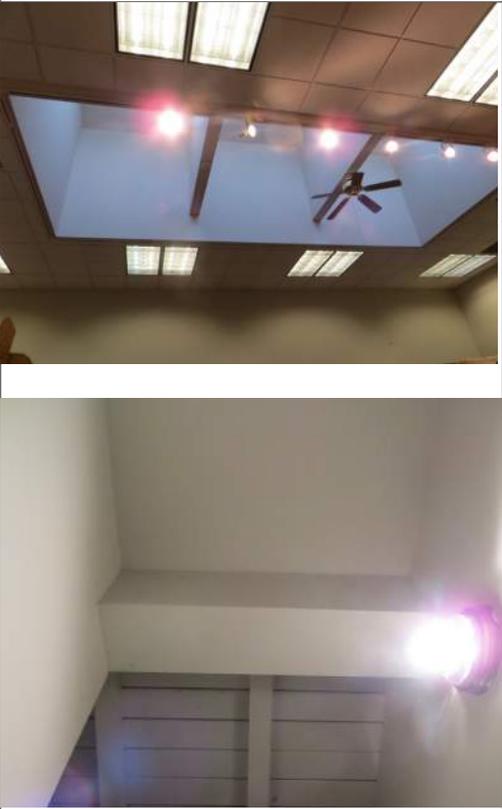
<p data-bbox="170 1854 526 1881">Interior finishes/systems: Ceilings</p>	<p data-bbox="672 1050 976 1144">Description: Painted GWB ceiling/soffit at skylight, Staff workroom</p> <p data-bbox="672 1176 862 1203">Condition: Good</p>	<p data-bbox="1062 1050 1463 1108">Priority level: cyclical replacement in future based on service life.</p> <p data-bbox="1062 1115 1463 1335">Repaint at recommended intervals based on lifespan (3-5 years), depending on maintenance and exposure. Inspect existing paint surfaces to determine extent of surface preparation necessary avoiding damage of substrate.</p> <p data-bbox="1062 1367 1438 1461">Estimated cost to replace ceiling lights with LED bulbs: \$40,00</p> <p data-bbox="1062 1493 1430 1587">Estimated cost for lighting upgrades throughout building: (\$8.00/sf) (8 x 9200 = \$73,600)</p>

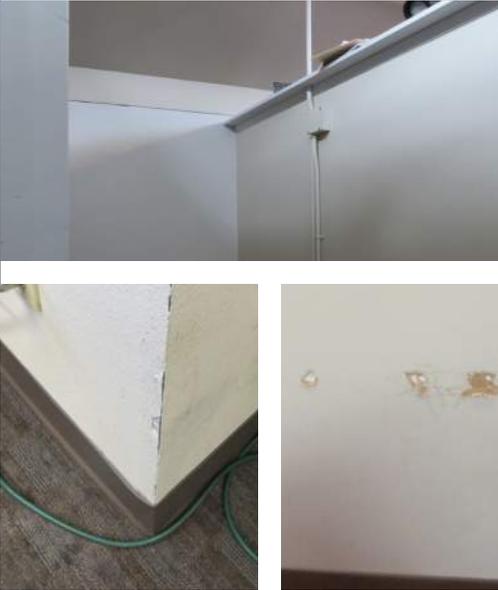
<p data-bbox="120 850 618 909">Interior finishes/systems: Walls</p>	<p data-bbox="618 260 1013 346">Description: Painted GWB wall surfaces</p> <p data-bbox="618 346 1013 420">Condition: Varies</p>	<p data-bbox="1013 260 1476 598">Priority level: cyclical replacement in future based on service life. Repaint at recommended intervals based on lifespan (3-5 years), depending on maintenance and exposure. Inspect existing paint surfaces to determine extent of surface preparation necessary avoiding damage of substrate.</p> <p data-bbox="1013 598 1476 672">Estimated cost to repaint interior: \$40,000</p>

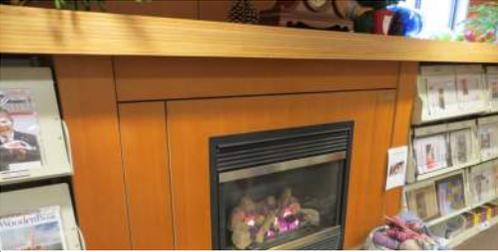
<p data-bbox="120 1161 618 1220">Interior finishes/systems: Walls</p>	<p data-bbox="618 909 1013 997">Description: Wood paneling at fire place</p> <p data-bbox="618 997 1013 1071">Condition: Good</p>	<p data-bbox="1013 909 1476 997">Priority level: cyclical replacement in future based on service life.</p>

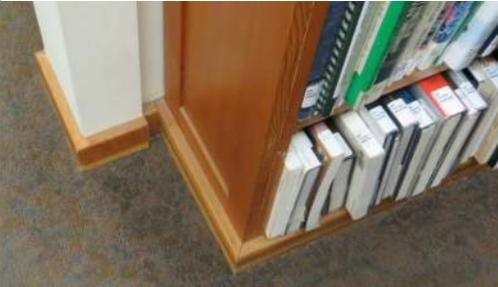
<p data-bbox="120 1507 618 1556">Interior finishes/systems: Wall base</p>	<p data-bbox="618 1220 1013 1312">Description: Wood base at periodicals/fireplace</p> <p data-bbox="618 1312 1013 1386">Condition: Good</p>	<p data-bbox="1013 1220 1476 1312">Priority level: cyclical replacement in future based on service life.</p>

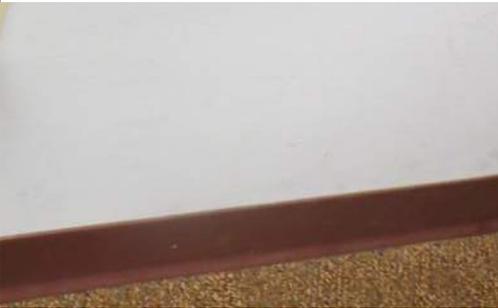
<p data-bbox="120 1864 618 1927">Interior finishes/systems: Wall base</p>	<p data-bbox="618 1556 1013 1627">Description: Resilient base</p> <p data-bbox="618 1627 1013 1701">Condition: Good</p>	<p data-bbox="1013 1556 1476 1648">Priority level: cyclical replacement in future based on service life.</p>

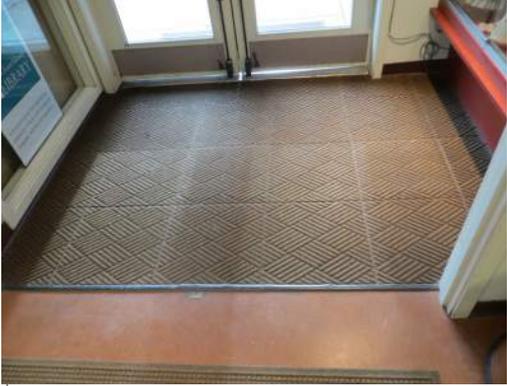
<p data-bbox="172 657 529 684">Interior finishes/systems: Flooring</p>	<p data-bbox="675 289 1006 352">Description: Walk-off mat at entry</p> <p data-bbox="675 384 867 411">Condition: Good</p>	<p data-bbox="1065 289 1468 352">Priority level: cyclical replacement in future based on service life.</p>

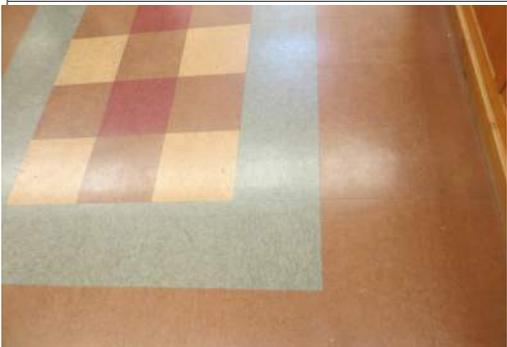
<p data-bbox="172 1073 529 1100">Interior finishes/systems: Flooring</p>	<p data-bbox="675 735 922 798">Description: Resilient flooring</p> <p data-bbox="675 829 867 856">Condition: Good</p>	<p data-bbox="1065 735 1468 798">Priority level: cyclical replacement in future based on service life.</p>

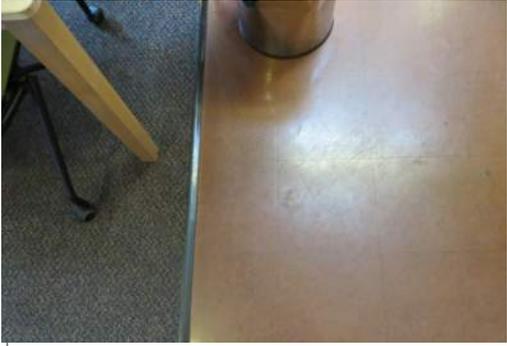
<p data-bbox="172 1488 529 1516">Interior finishes/systems: Flooring</p>	<p data-bbox="675 1148 1013 1245">Description: Carpet/Resilient flooring transitions</p> <p data-bbox="675 1213 867 1241">Condition: Good</p>	<p data-bbox="1065 1148 1468 1211">Priority level: cyclical replacement in future based on service life.</p>

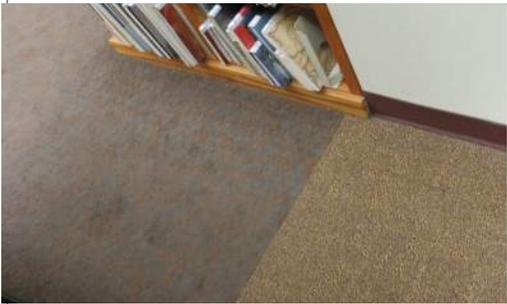
<p data-bbox="172 1856 529 1883">Interior finishes/systems: Flooring</p>	<p data-bbox="675 1564 902 1591">Description: Carpet</p> <p data-bbox="675 1623 932 1650">Condition: Varies- Fair</p>	<p data-bbox="1065 1564 1468 1627">Priority level: cyclical replacement in future based on service life.</p>

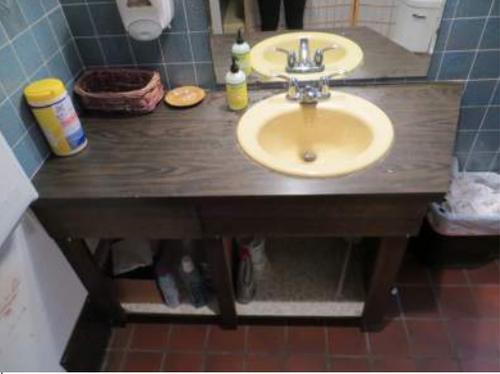
<p data-bbox="151 659 370 684">Misc: Staff Bathroom</p>	<p data-bbox="651 291 951 352">Description: Existing staff bathroom</p> <p data-bbox="651 386 833 411">Condition: Poor</p>	<p data-bbox="1040 291 1385 447">Replace bathroom door. Cyclical replacement in future based on service life: update fixtures and finishes, provide ADA-accessibility.</p> <p data-bbox="1040 480 1373 541">Estimated cost for bathroom upgrade: \$4,000</p>

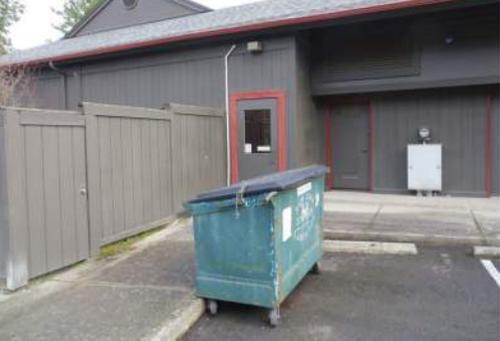
<p data-bbox="151 1075 407 1100">Misc: Garbage enclosure</p>	<p data-bbox="651 739 898 800">Description: Garbage enclosure</p> <p data-bbox="651 833 826 858">Condition: N/A</p>	<p data-bbox="1040 739 1409 800">Estimated cost for building new garbage enclosure: \$3,000.</p>

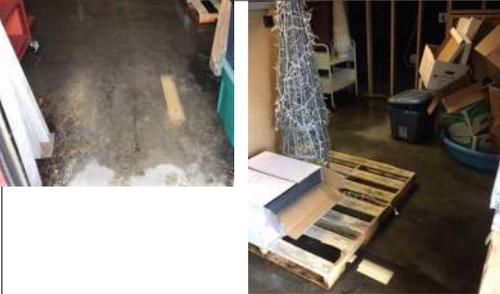
<p data-bbox="151 1505 537 1530">Misc: Stormwater systems/Basement</p>	<p data-bbox="651 1152 951 1213">Description: Ongoing Basement flooding issues</p> <p data-bbox="651 1247 833 1272">Condition: Poor</p>	<p data-bbox="1040 1152 1433 1308">Priority level: high priority Excavate building foundation perimeter, remove and replace portions of parking lot, install new pipe and drains.</p> <p data-bbox="1040 1341 1406 1402">Estimated cost for stormwater system replacement: \$150,000</p> <p data-bbox="1040 1436 1442 1654">Note: Mold at Basement ongoing problem, with patron and staff complaints regarding health. Additional investigation recommended prior to abatement. Estimated abatement cost: \$50,000</p>

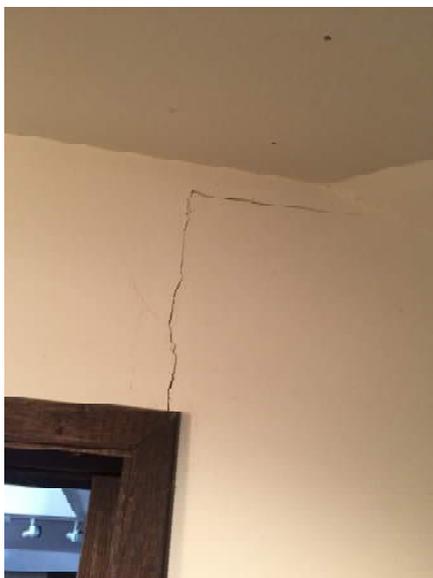
However, at one location, at the interface between the new and existing roof, we identified an area of distress along the corner of the doorway leading to the attic bathroom. At this location, a crack has developed in the interior finish on each side of the wall over the western corner of the door (See attached photos)

Distress over attic door (north side)

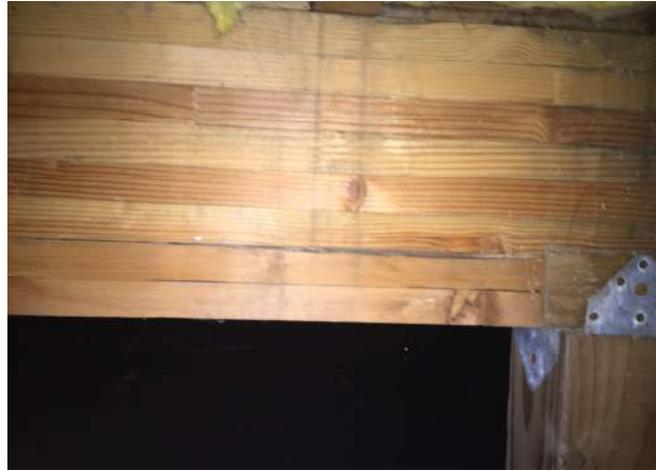
At one location, we identified that one of the glue-laminated beams was experiencing some delamination at the bottom two laminations.

Delamination at the bottom of one glue-laminated beam

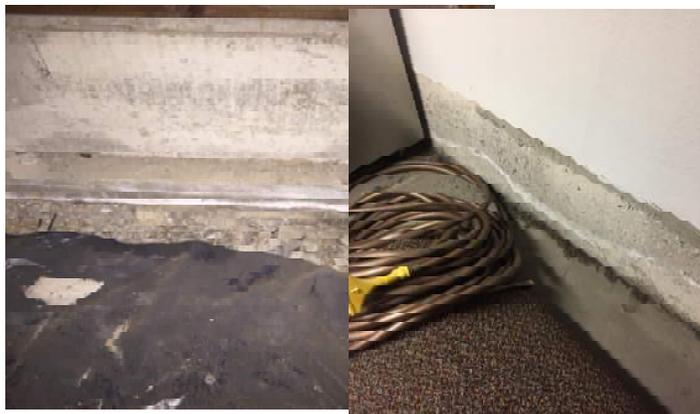
Efflorescence on interior face of exterior concrete construction.
