SAN JUAN ISLAND LIBRARY Building Condition Assessment & Feasibility Study

Community Meetings

May 20th and 21st, 2018

Building Status Report

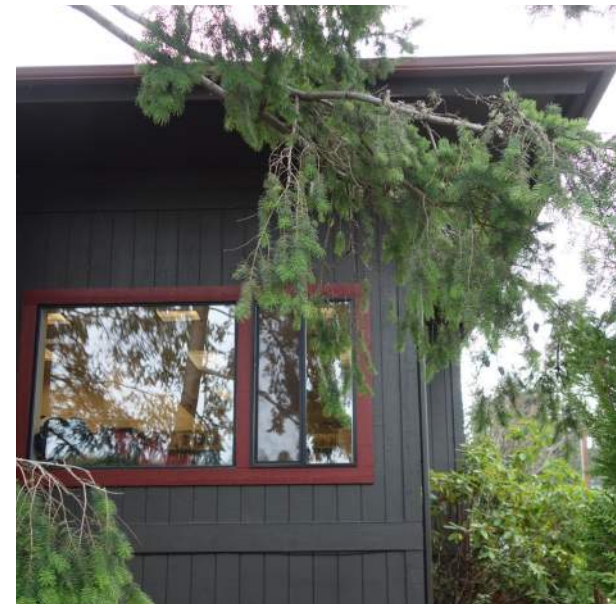
TREES & PLANTINGS

CONDITION:
Site plantings: trees, bushes, soil in good condition.

RECOMMENDATION:
Periodic pruning, cutting back areas where limbs are close to structure.

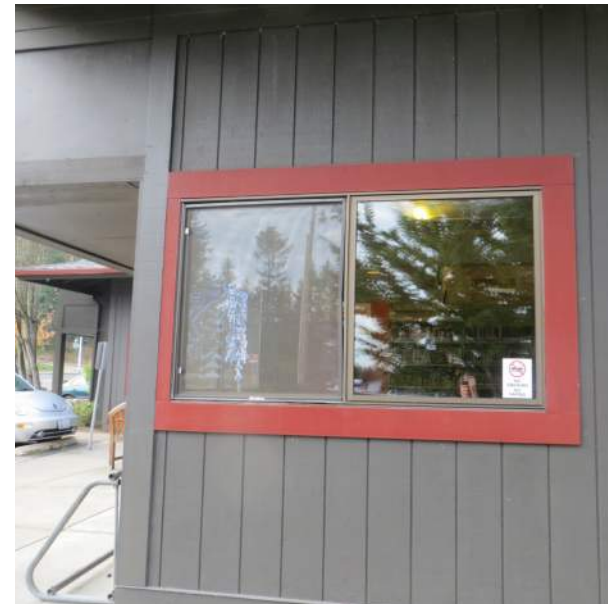
EXTERIOR ENVELOPE: WINDOWS

CONDITION:
Pre-finished aluminum sliding windows in varied condition.

RECOMMENDATION:
Windows appear to be in good condition without evidence of water intrusion. Recently a number of windows have been reported as "falling". Cyclical replacement in future based on service life.

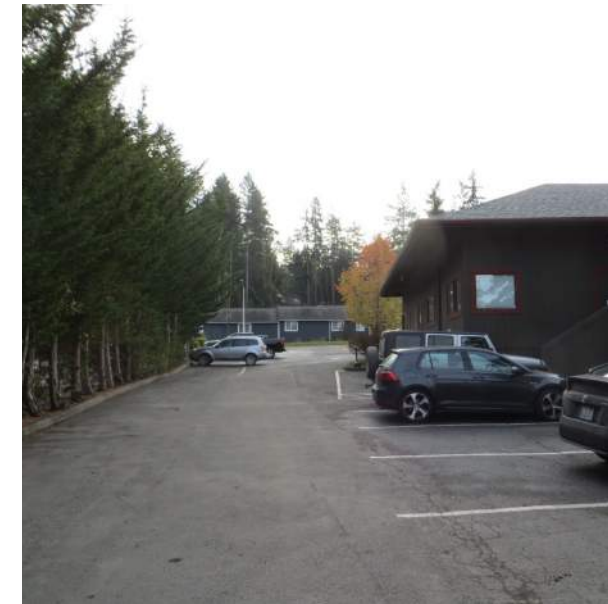
PAVING

CONDITION:
Flat and sloped paving at parking areas in varied condition - poor to good.

RECOMMENDATION:
Cyclical replacement in future based on service life.

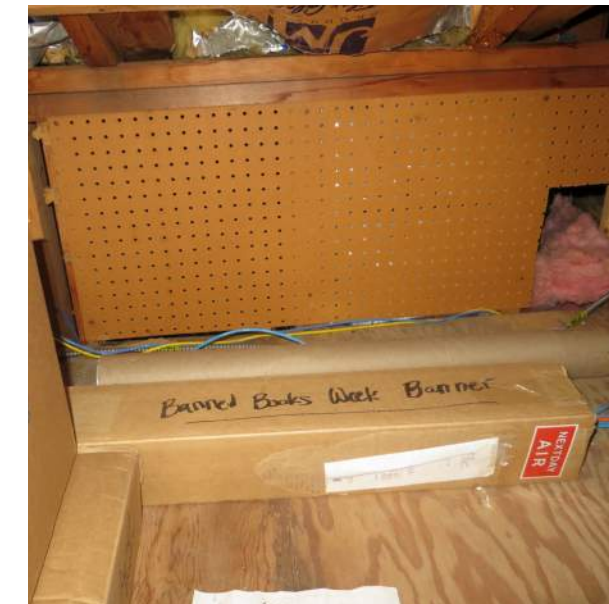
INSULATION

CONDITION:
Missing insulation at exterior walls, subsequent heat loss, in poor condition.

RECOMMENDATION:
High priority.

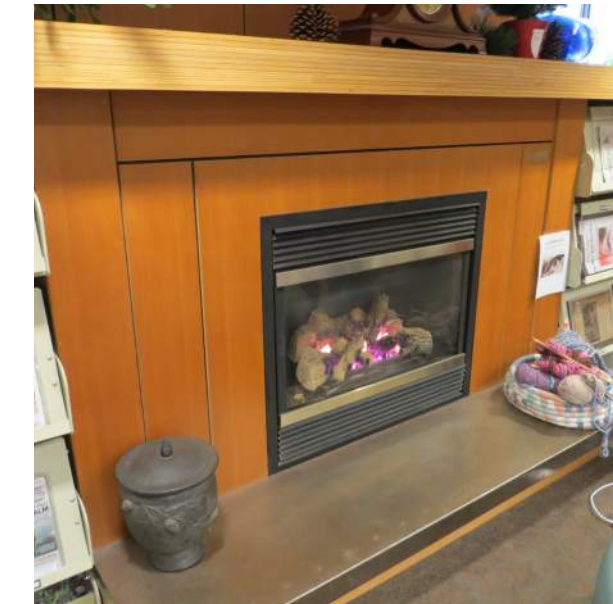
INTERIOR FINISHES/SYSTEMS: WALLS

CONDITION:
Wood paneling at fire place in good condition.

RECOMMENDATION:
Cyclical replacement in future based on service life.

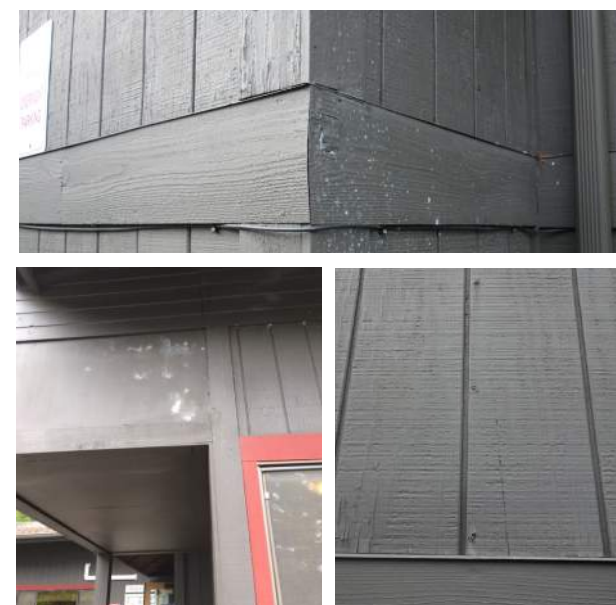
EXTERIOR ENVELOPE: SIDING

CONDITION:
Painted T-11 siding with painted 1x6 clear cedar trim at windows and doors in generally good condition. Exceptions at areas of white bloom (reference photo taken at east side, May 2016).

RECOMMENDATION:
Cyclical replacement in future based on service life. Repaint at recommended intervals based on lifespan (3-5 years), depending on maintenance and exposure. Inspect existing paint surfaces to determine extent of surface preparation necessary avoiding damage or removal of wood substrate.

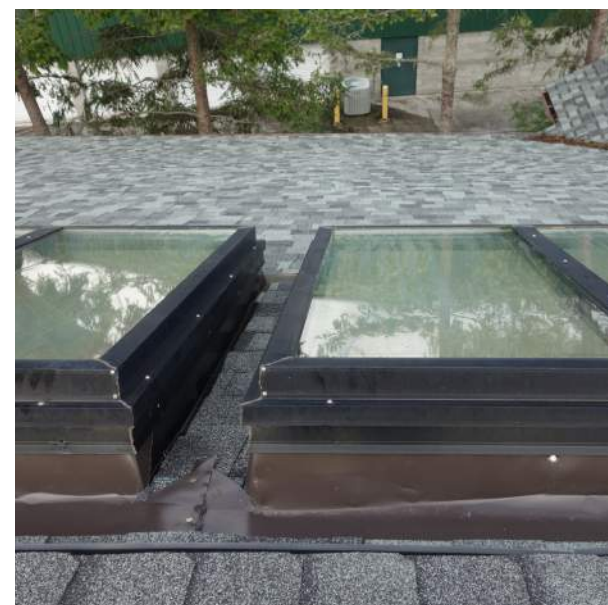
EXTERIOR ENVELOPE: SKYLIGHTS

CONDITION:
Curb-mounted skylight in fair condition.

RECOMMENDATION:
Cyclical replacement in future based on service life.

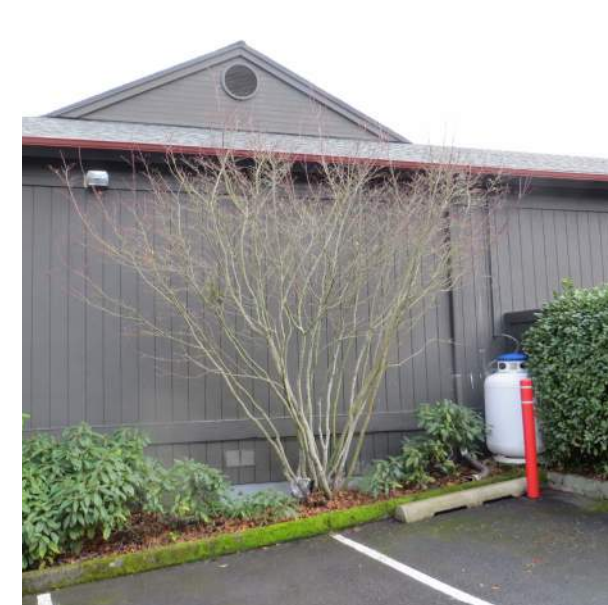
SITE EQUIPMENT, MISC

CONDITION:
Propane Tank in good condition.

RECOMMENDATION:
Cyclical replacement in future based on service life.

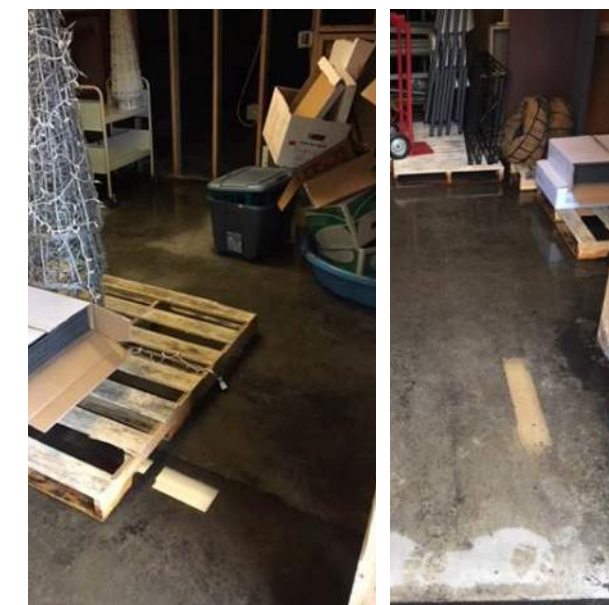
STORMWATER SYSTEMS/BASEMENT

CONDITION:
Ongoing Basement flooding issues in poor condition.

RECOMMENDATION:
High priority. Excavate building foundation perimeter, remove and replace portions of parking lot, install new pipe and drains.

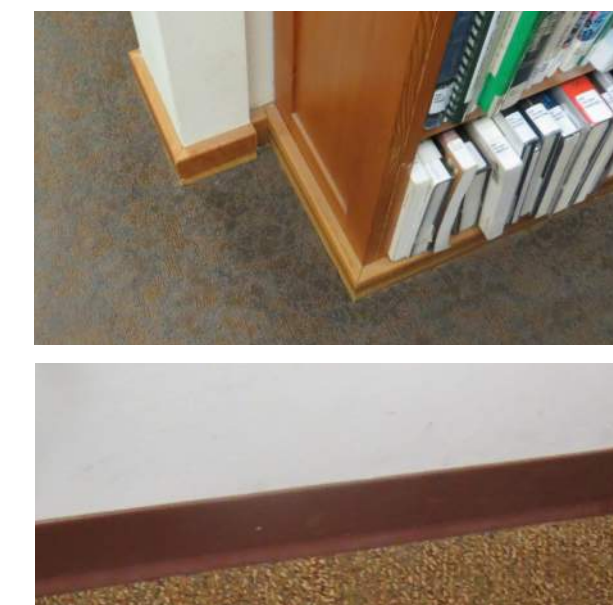
INTERIOR FINISHES/SYSTEMS: WALL BASE

CONDITION:
Wood base at periodicals/fireplace & Resilient base in good condition.

RECOMMENDATION:
Cyclical replacement in future based on service life.

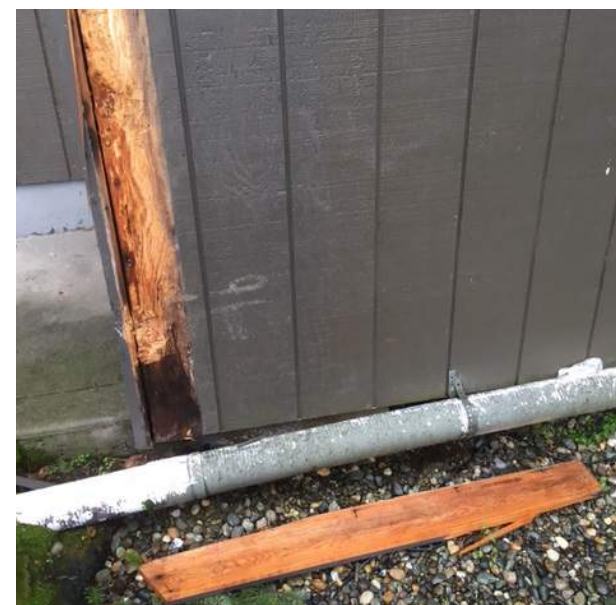
EXTERIOR SYSTEMS: SIDING

CONDITION:
Exterior siding at stair in poor condition.

RECOMMENDATION:
Cyclical replacement in future based on service life.

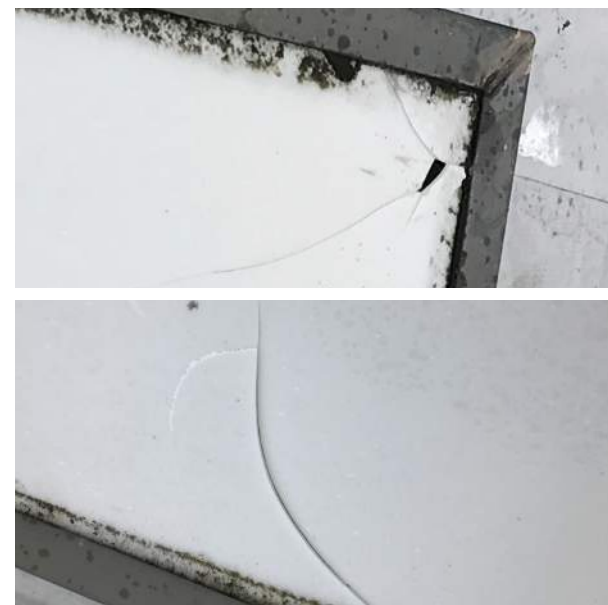
EXTERIOR ENVELOPE: SKYLIGHTS

CONDITION:
Skylight in poor condition.

RECOMMENDATION:
Cyclical replacement in future based on service life.

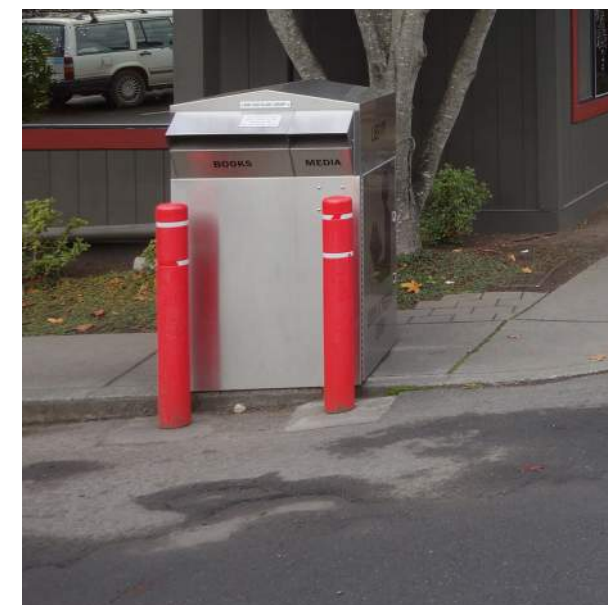
SITE EQUIPMENT, MISC

CONDITION:
Book drop and bollards in good condition.

RECOMMENDATION:
Cyclical replacement in future based on service life.

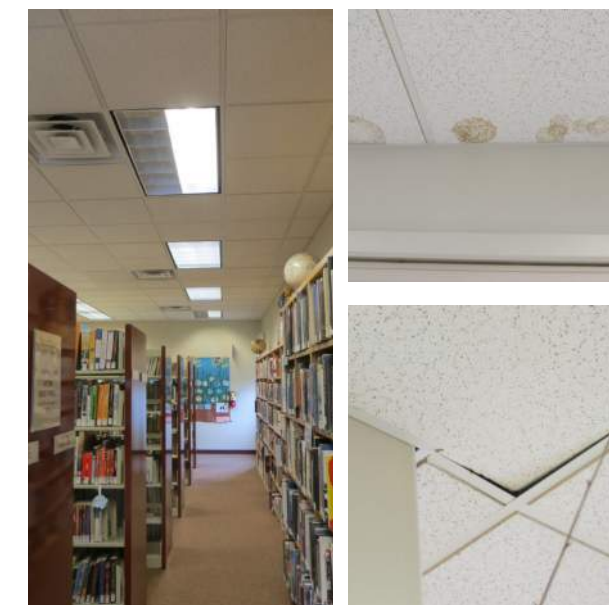
INTERIOR FINISHES/SYSTEMS: CEILINGS

CONDITION:
Suspended ceiling system; 24"x24" Acoustical ceiling tile with square edge in varied condition.

RECOMMENDATION:
Cyclical replacement in future based on service life. 30 percentage of tiles should be replaced due to staining, torque, or signs of wear.

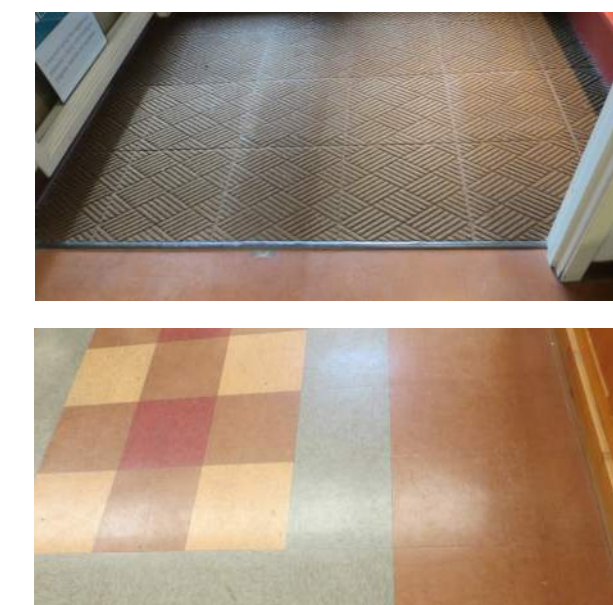
INTERIOR FINISHES/SYSTEMS: FLOORING

CONDITION:
Walk-off mat at entry & Resilient flooring in good condition.

RECOMMENDATION:
Cyclical replacement in future based on service life.

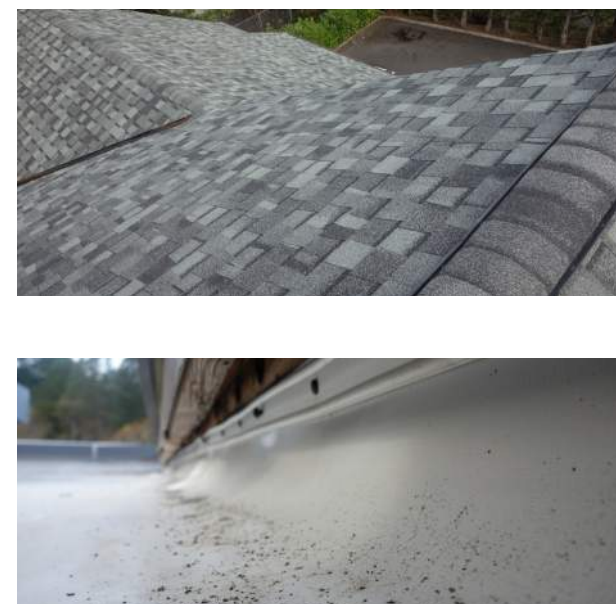
EXTERIOR ENVELOPE: ROOFING

CONDITION:
2x6 rafters at 24" O.C. w/ comp roofing over #15 CDX building paper over 1/2" CDX sheathing. 2017 Replacement w/ Durolast PVC membrane in generally good condition.

RECOMMENDATION:
Cyclical replacement in future based on service life.

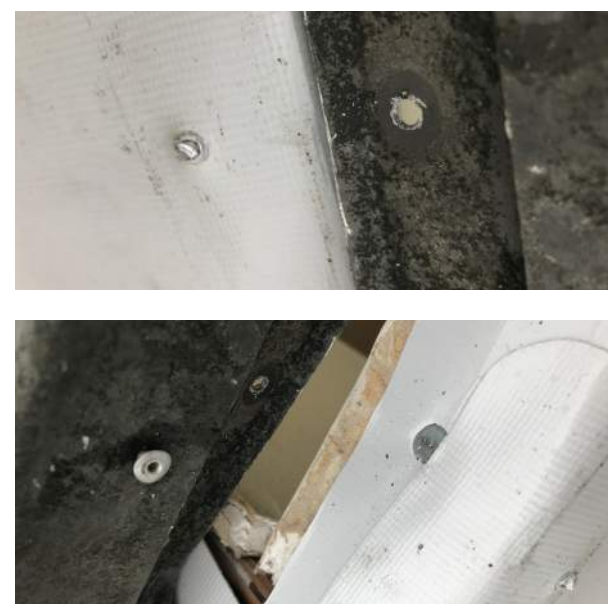
EXTERIOR SYSTEMS: SKYLIGHT FRAME

CONDITION:
Metal skylight frame in poor condition.

RECOMMENDATION:
Cyclical replacement in future based on service life.

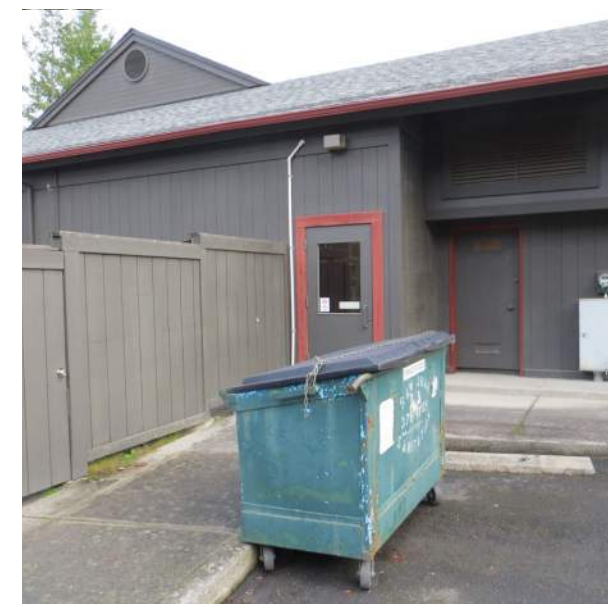
GARBAGE ENCLOSURE

CONDITION:
Garbage enclosure, N/A

RECOMMENDATION:
New garbage enclosure to be built.

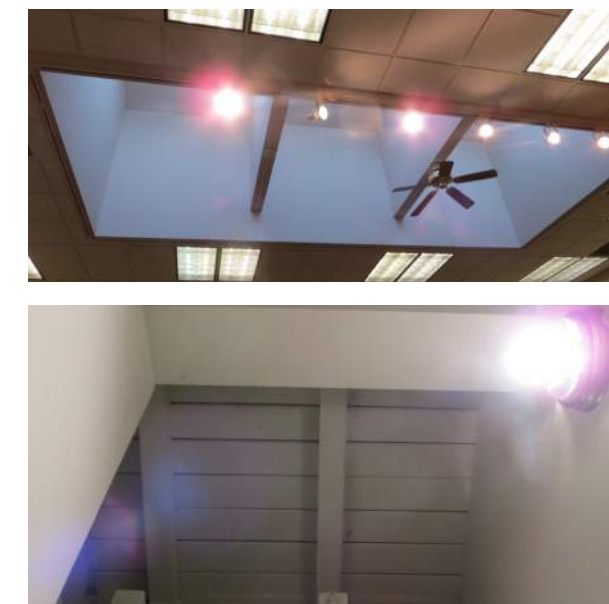
INTERIOR FINISHES/SYSTEMS: CEILINGS

CONDITION:
Painted GWB ceiling/soffit at skylight & Staff workroom in good condition.

RECOMMENDATION:
Cyclical replacement in future based on service life. Repaint at recommended intervals based on lifespan (3-5 years), depending on maintenance and exposure. Inspect existing paint surfaces to determine extent of surface preparation necessary avoiding damage of substrate.

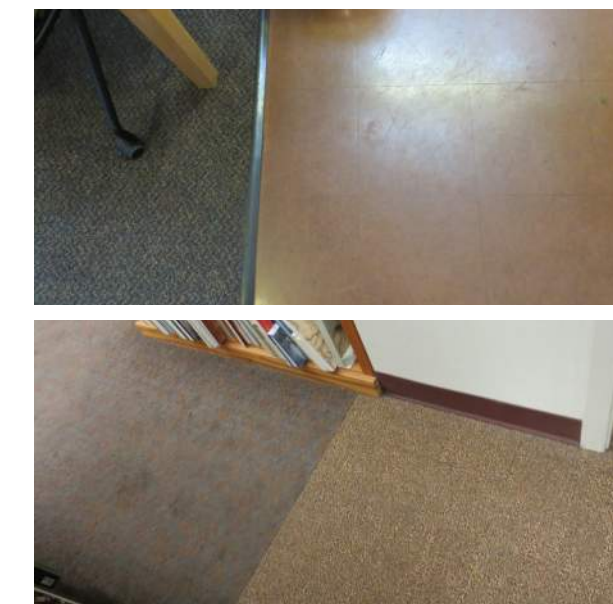
INTERIOR FINISHES/SYSTEMS: FLOORING

CONDITION:
Carpet/Resilient flooring transitions in varied to good condition.

RECOMMENDATION:
Cyclical replacement in future based on service life.

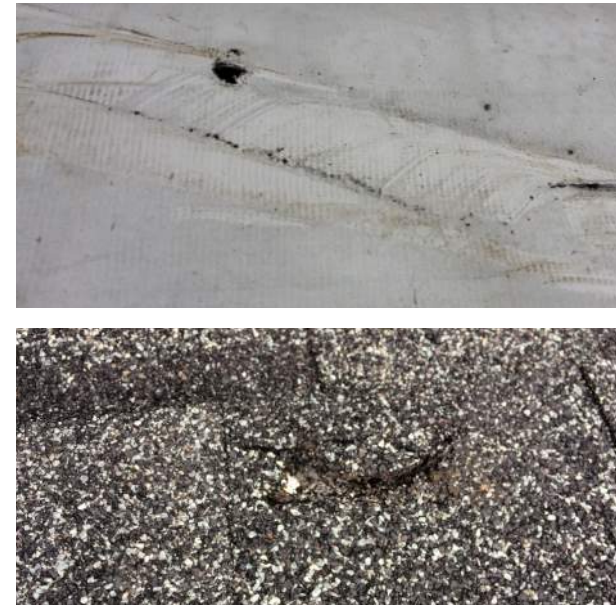
EXTERIOR SYSTEMS: ROOFING

CONDITION:
Roofing shingles, membrane in poor condition.

RECOMMENDATION:
Cyclical replacement in future based on service life.

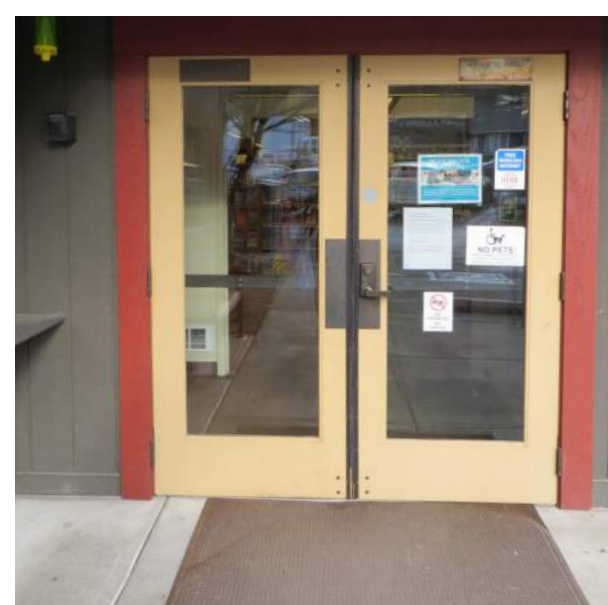
EXTERIOR ENVELOPE: DOORS

CONDITION:
Painted metal doors in good condition.

RECOMMENDATION:
Cyclical replacement in future based on service life. Repaint at recommended intervals based on lifespan (3-5 years), depending on maintenance and exposure.

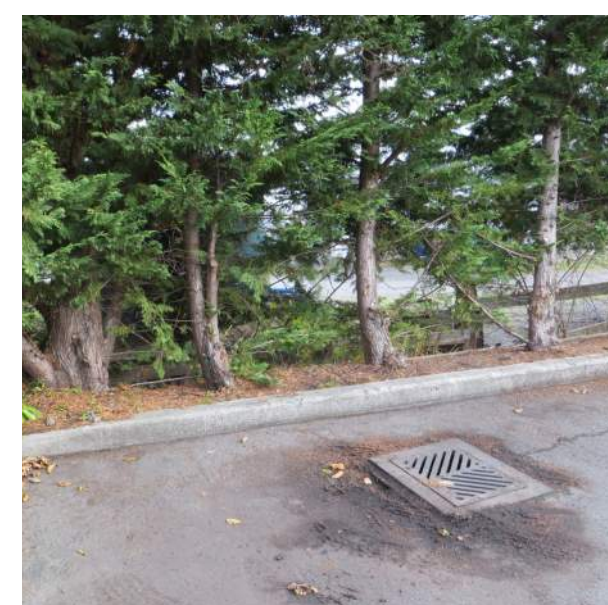
DRAINAGE

CONDITION:
Catch basin, typ, in fair condition. Further investigation recommended.

RECOMMENDATION:
Cyclical replacement in future based on service life.

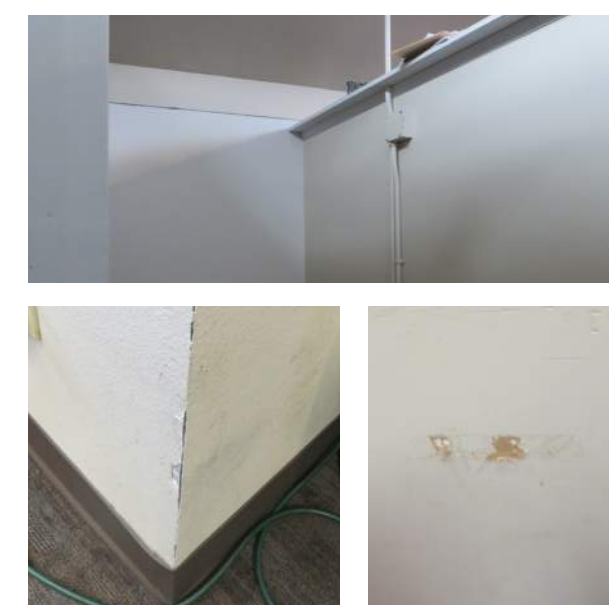
INTERIOR FINISHES/SYSTEMS: WALLS

CONDITION:
Painted GWB wall surfaces in good condition.

RECOMMENDATION:
Cyclical replacement in future based on service life. Repaint at recommended intervals based on lifespan (3-5 years), depending on maintenance and exposure. Inspect existing paint surfaces to determine extent of surface preparation necessary avoiding damage of substrate.

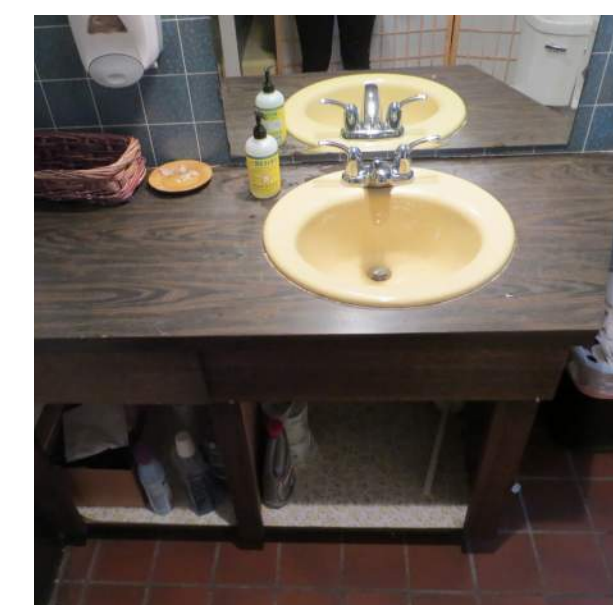
STAFF BATHROOM

CONDITION:
Existing staff bathroom in poor condition.

RECOMMENDATION:
Replace bathroom door. Cyclical replacement in future based on service life: update fixtures and finishes, provide ADA-accessibility.

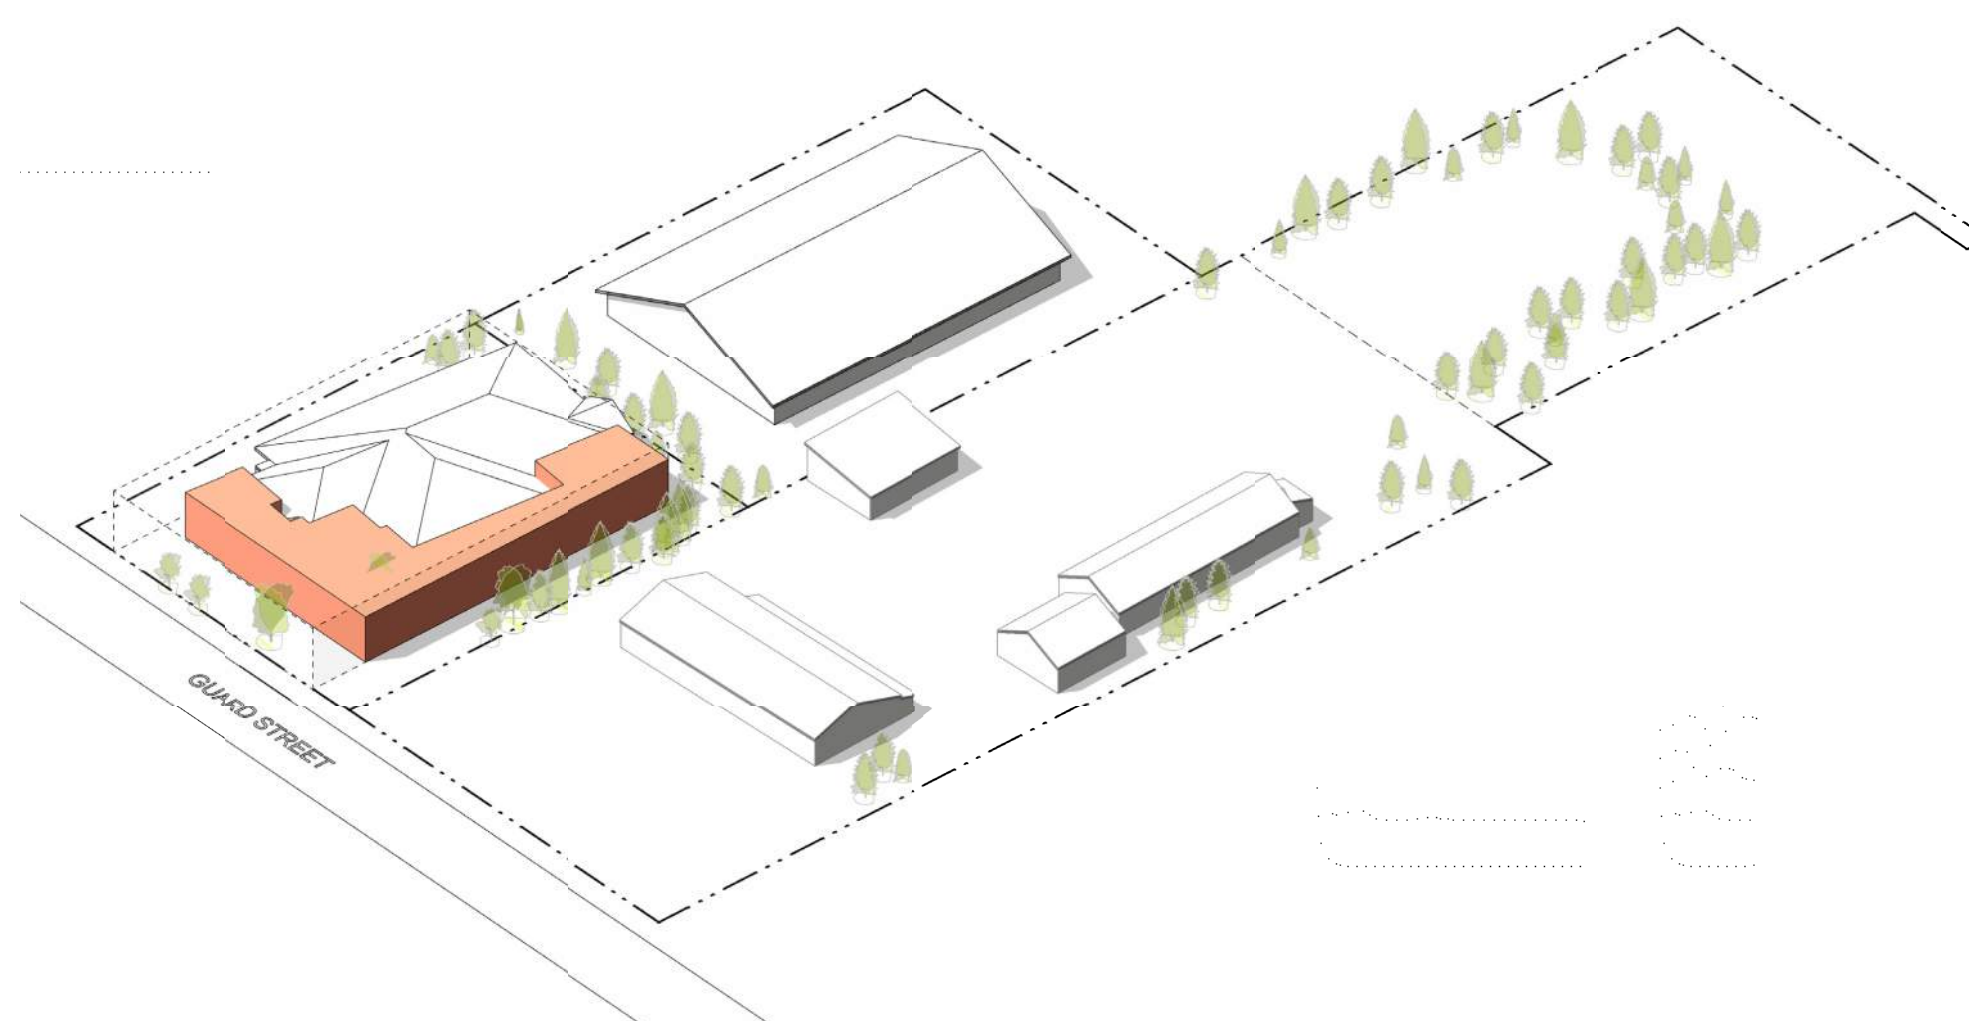
A: EXPAND OUT \$ 5.8 Million

CHALLENGES	OPPORTUNITIES
Building area expansion limitation	Improves building's relationship to street
Insufficient parking	
Access to daylight (wide building)	
Doesn't improve circulation flow	
Requires extensive systems upgrade; electrical, mechanical, fire protection	
Cost for acquiring parking easement

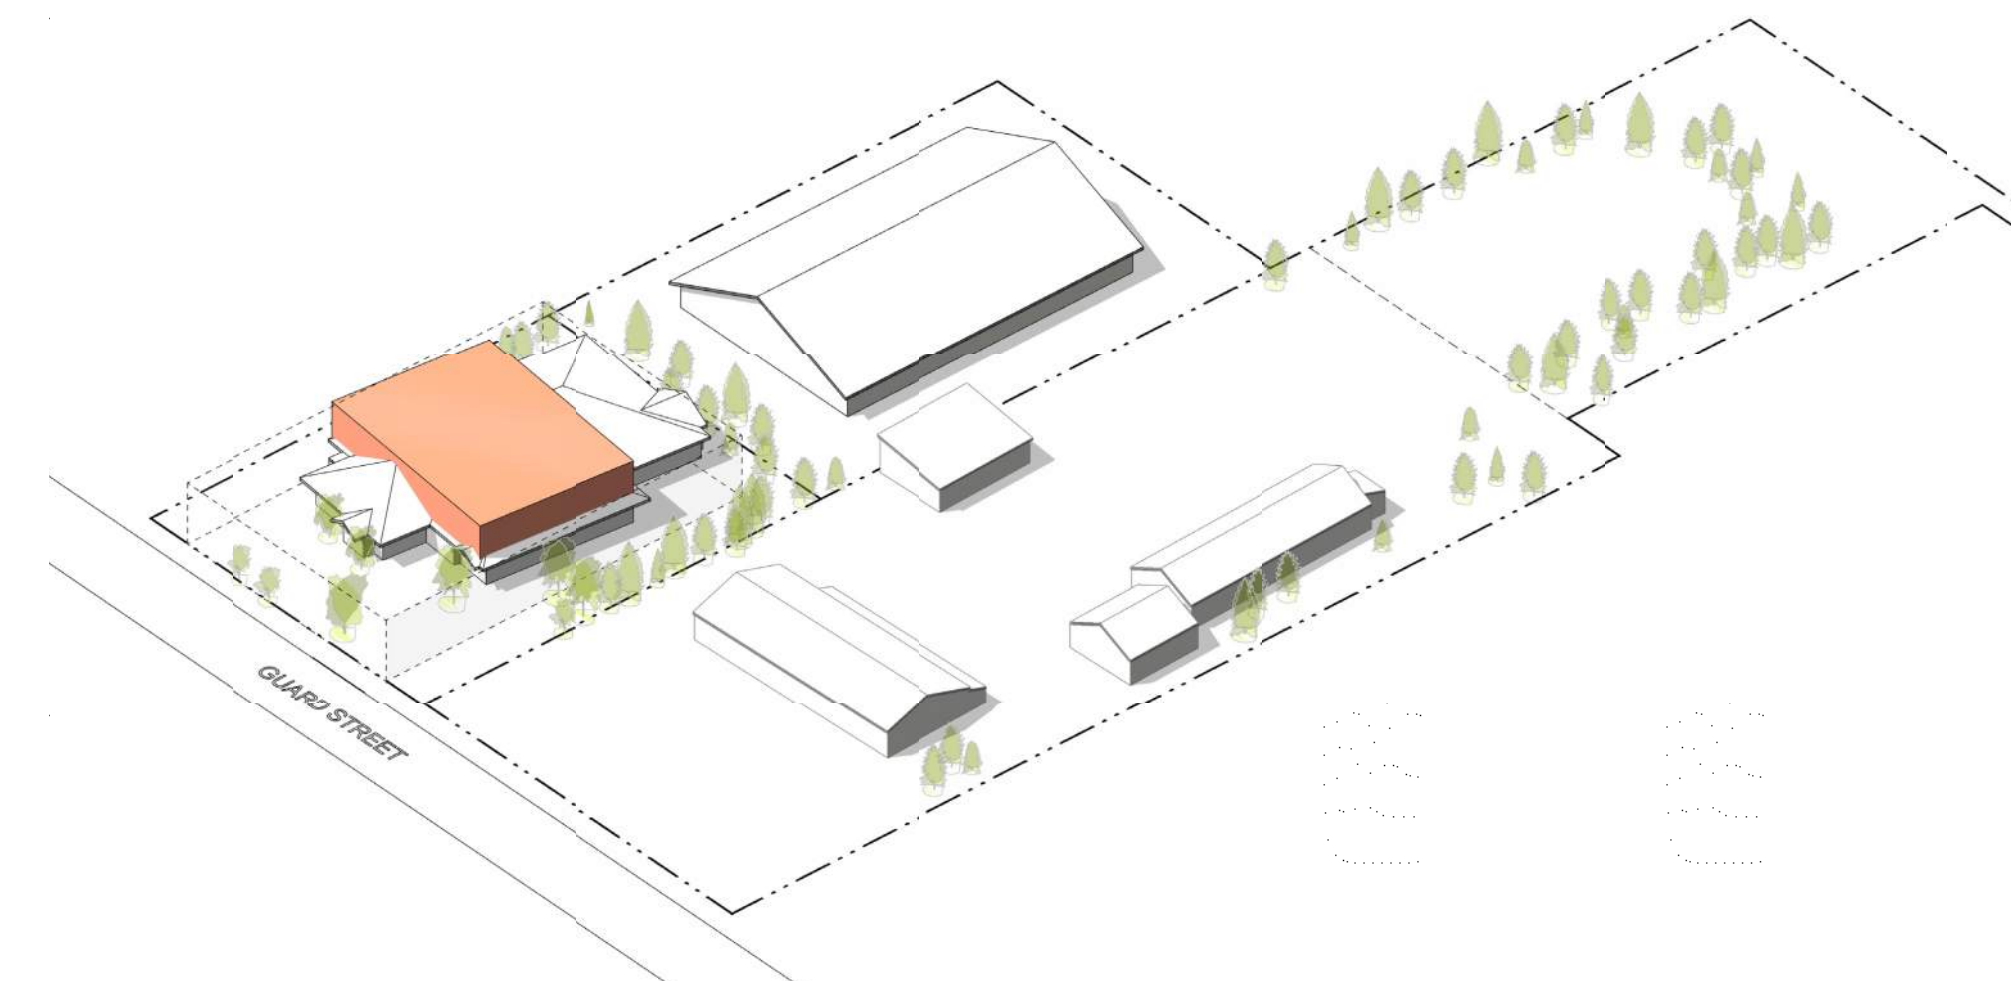
B: EXPAND UP \$ 6.7 Million

CHALLENGES	OPPORTUNITIES
Parking area expansion limitation	Access to daylight (top light)
Adding a second floor necessitates an elevator, with large cost impacts	
Increased operational costs	
Doesn't improve circulation flow	
Requires extensive systems upgrade; electrical, mechanical, fire protection	
Additional structural requirements for adding second floor

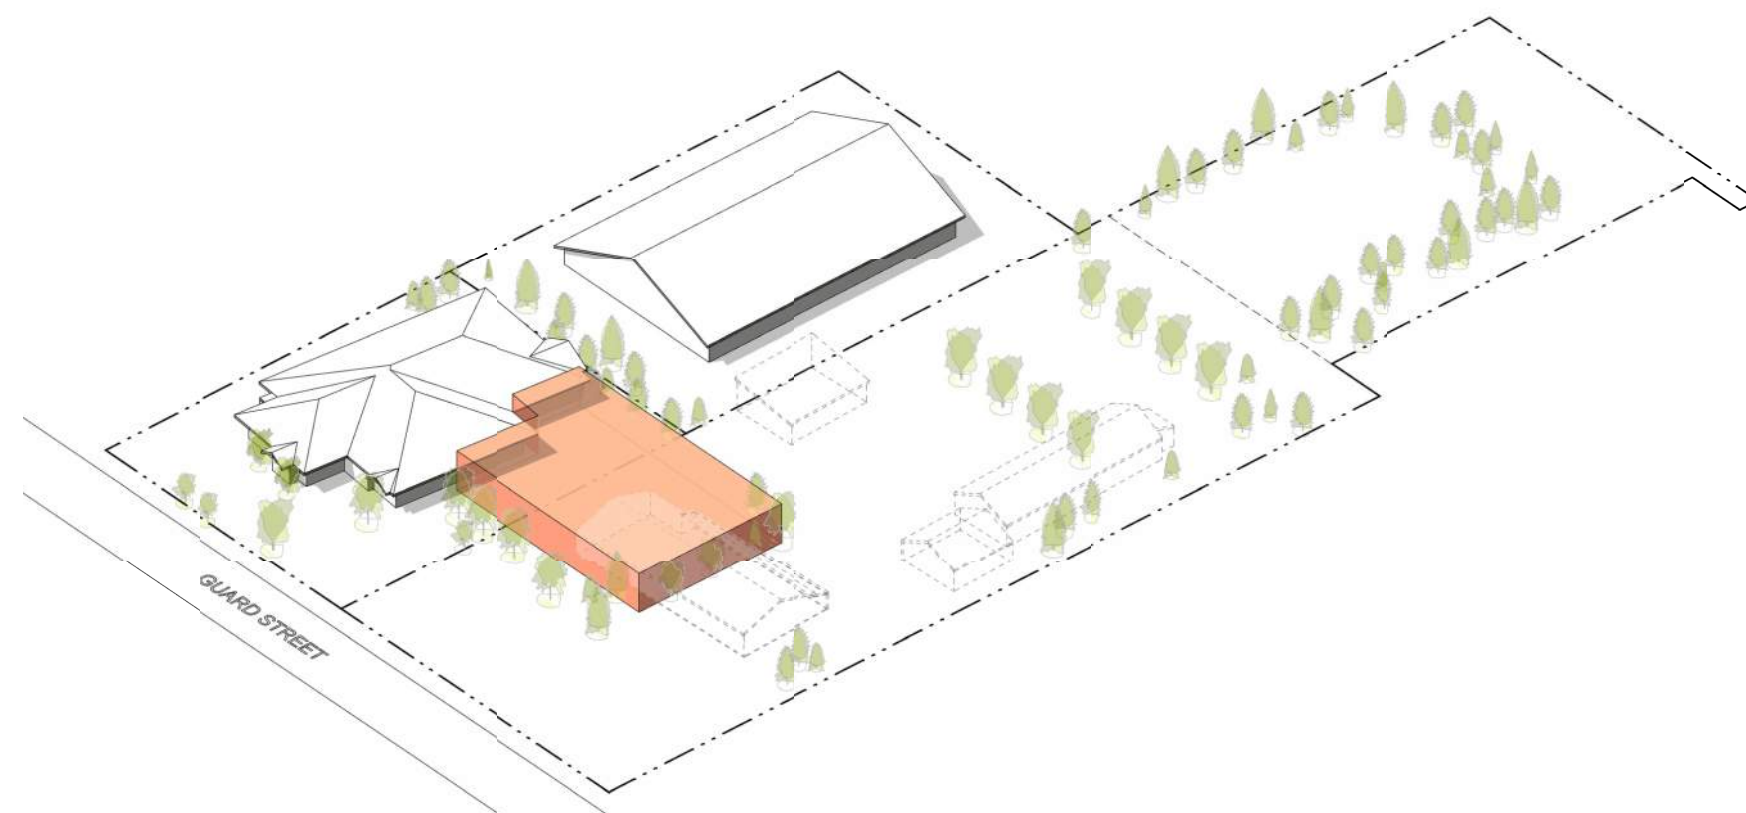
C: EXTEND LIBRARY ONTO NEXT-DOOR LOT

CHALLENGES	OPPORTUNITIES
Property sale/subdivision coordination and negotiation	Utilize existing building
Requires extensive systems upgrade; electrical, mechanical, fire protection	Phaseable- existing building could remain largely operational during construction with a reduction in services
Operations- sightlines	Parking expansion
	Access to daylight
	Exterior program area

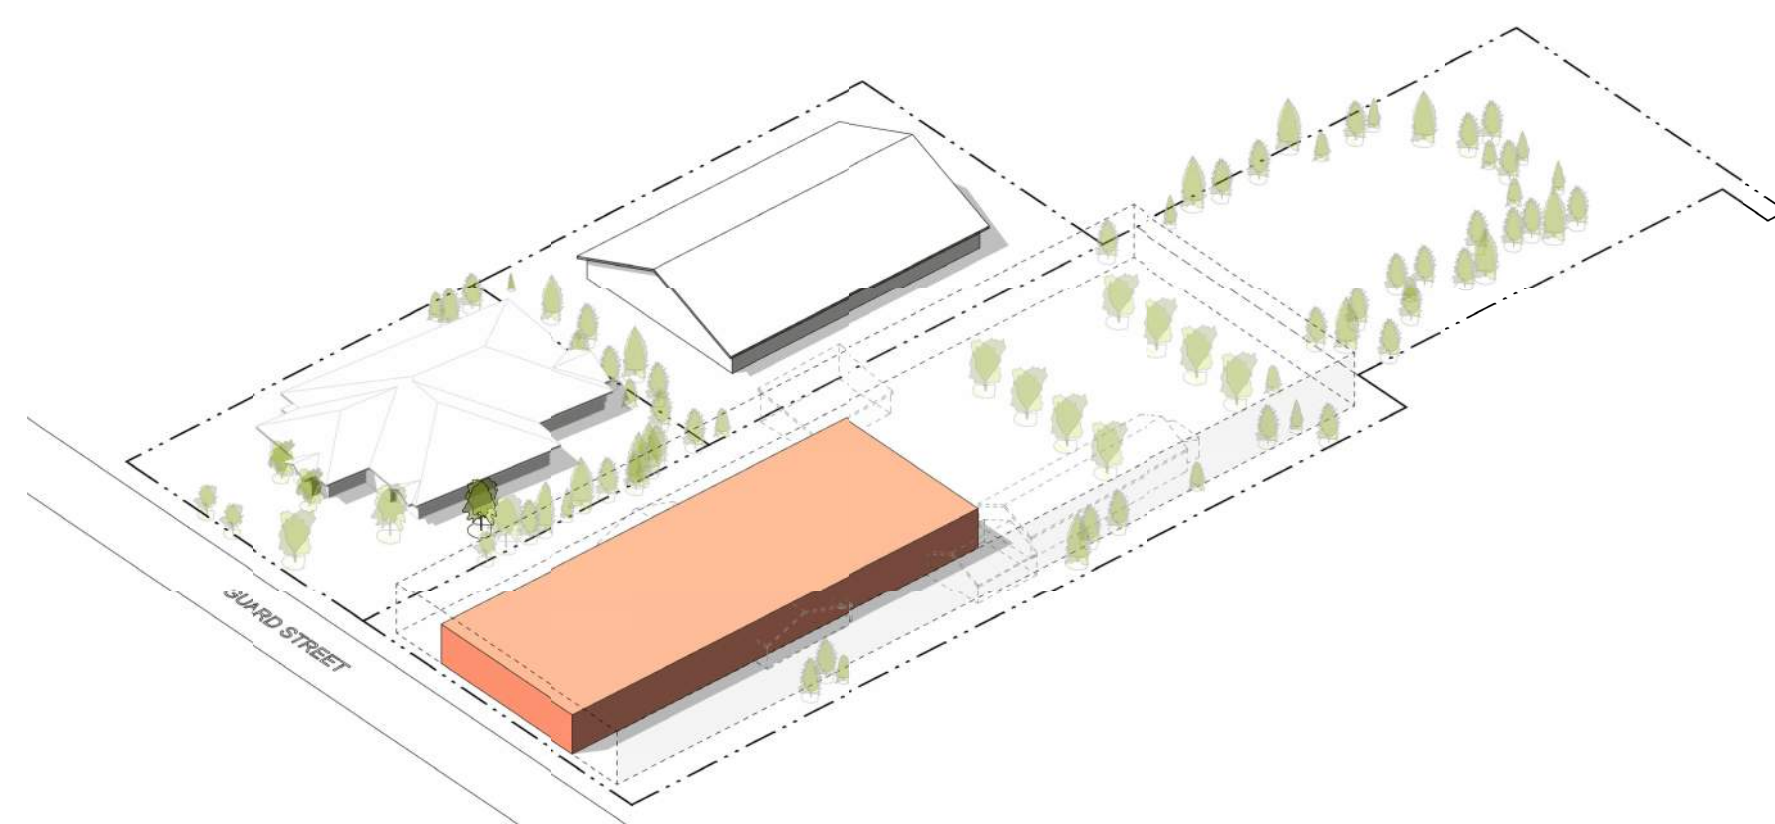
D: NEW LIBRARY ON NEW SITE

CHALLENGES	OPPORTUNITIES
Site acquisition costs	New building: light, air, flexibility, circulation flow
Unknowns: soil condition, hazardous materials	Parking options
	Relationship to street
	Phaseable- Library could remain operational on existing site during construction with minor disruption in services
	Building expansion area for long term growth
	Least operational costs

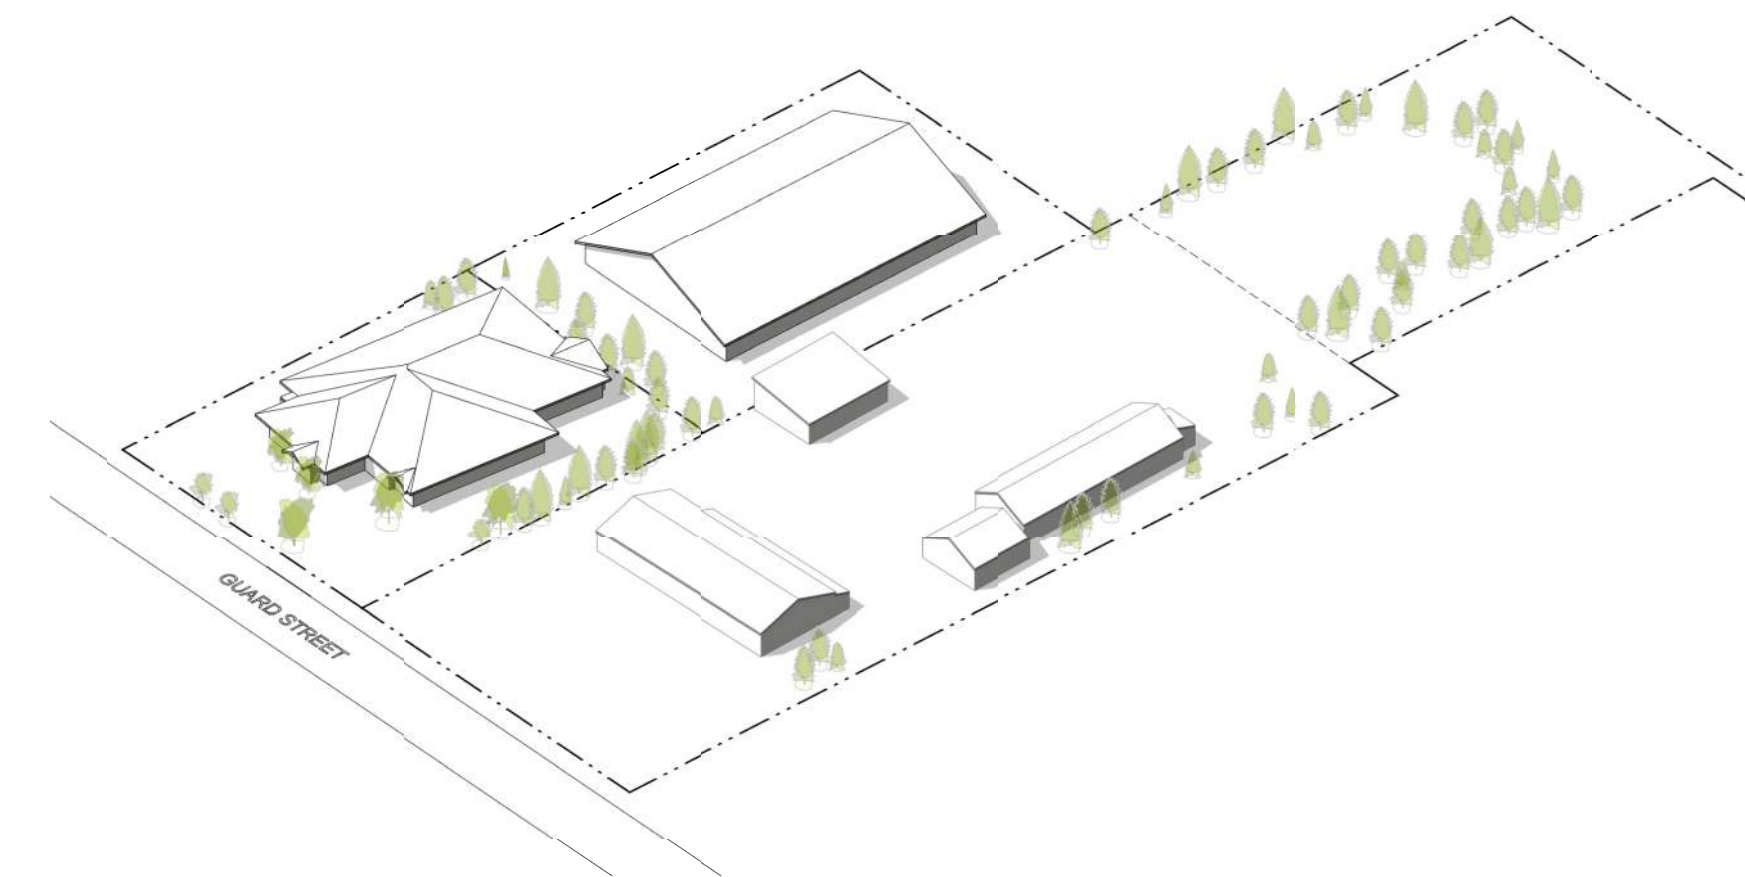
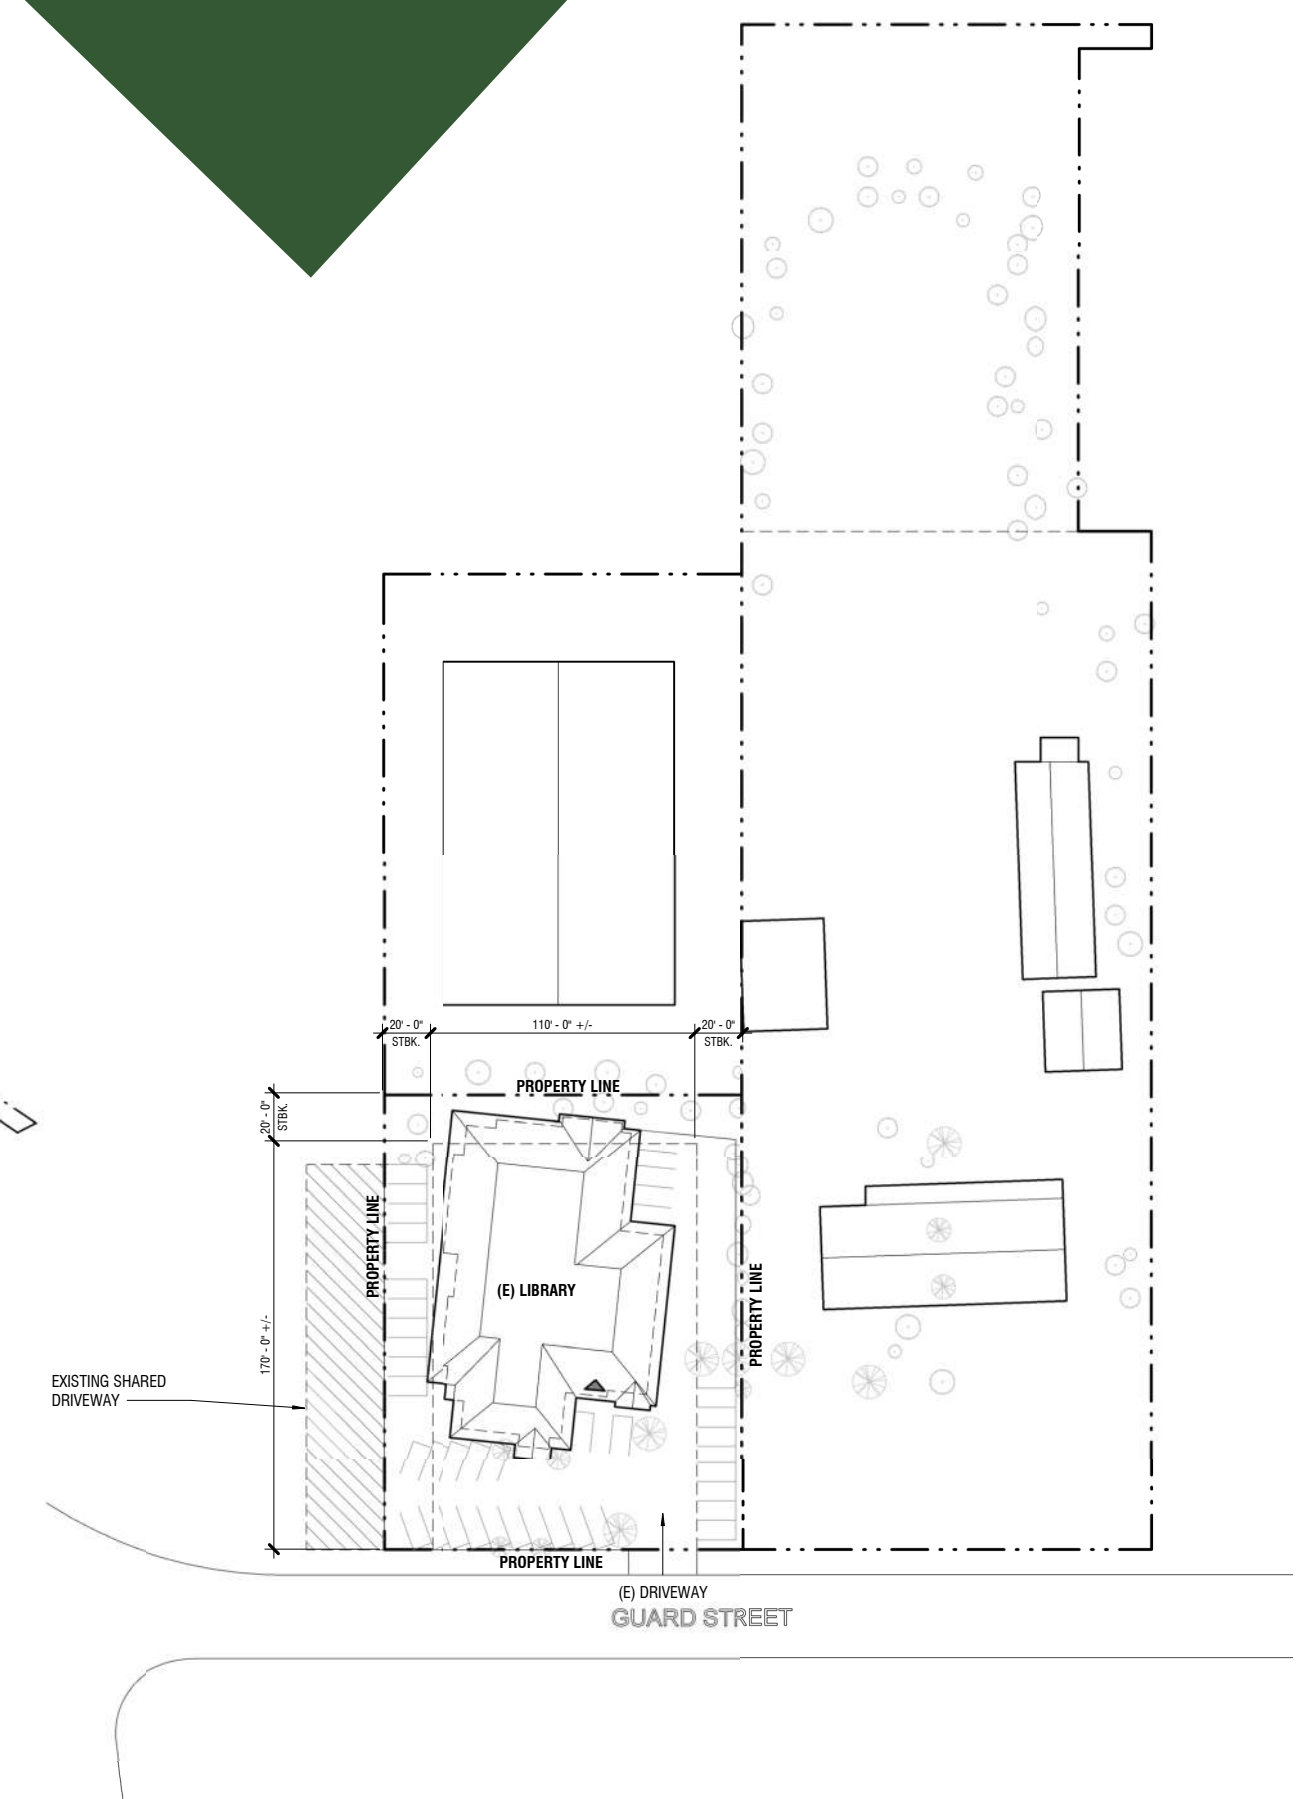
E: MAINTAIN EXISTING BUILDING

NO ADDITIONAL SPACE EXPANSION

Increasing costs for maintainance and upkeep
