SAN JUAN ISLAND LIBRARY

BUILDING CONDITION ASSESSMENT & FEASIBILITY STUDY

May 2018

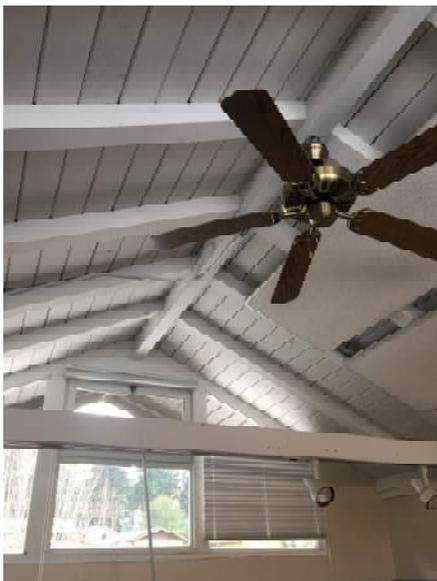
The existing roof structure consists of sawn lumber roof purlins supporting a straight decking roof diaphragm.

In general, the observed areas of existing framing appeared to be in good condition with no obvious signs of distress or unsatisfactory performance.

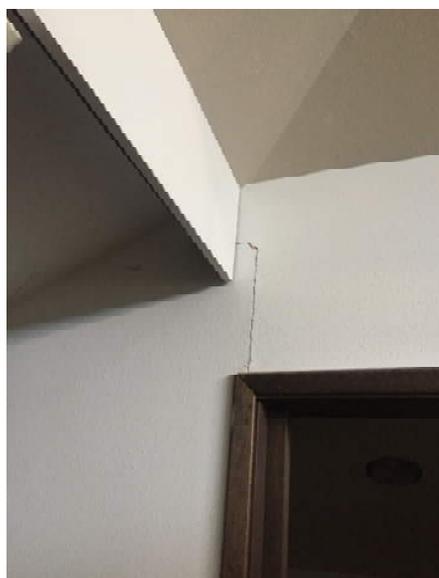
Distress over attic door (south side)

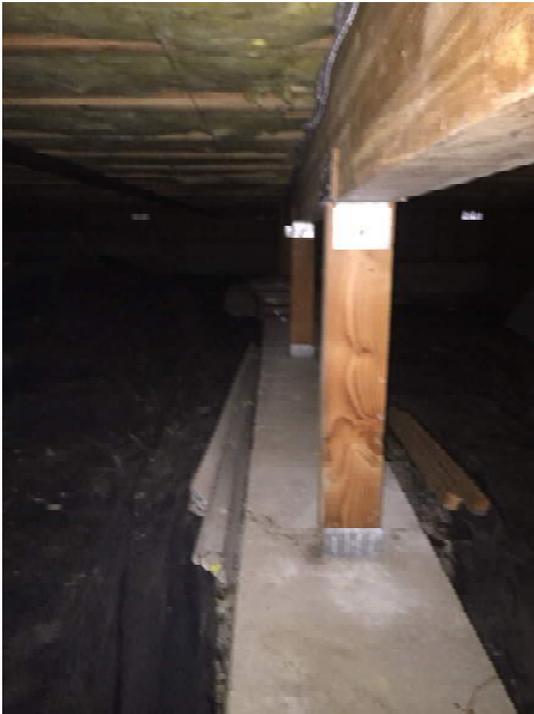
We accessed the crawlspace below the 1994 addition and reviewed the existing framing systems. The floor structure installed is consistent with what is shown in the 1994 structural drawings except for some areas of the foundation. In lieu of strip footings and concrete stem walls to support the posts, continuous grade beams were used instead. A photograph of the existing condition is attached. Some locations do have isolated spread footings that the original structural drawings indicate however.

Continuous grade beam in lieu of stem wall & strip footing.

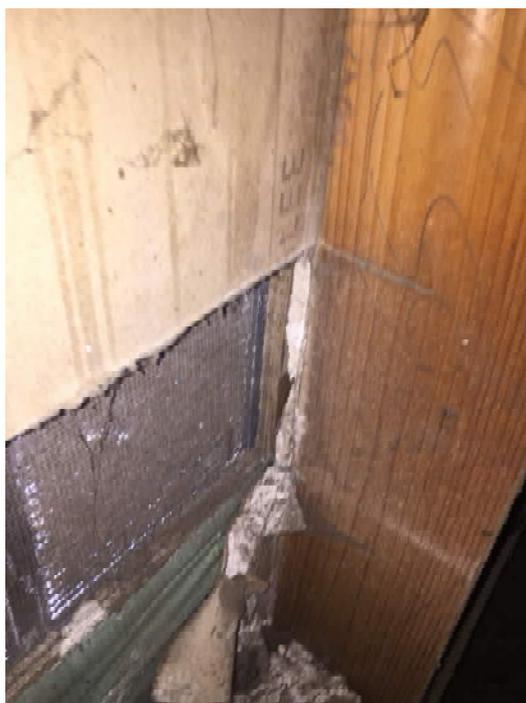
At several locations, we identified that the exterior plywood sheathing for the exterior shear walls was installed over top of the gypsum wall board. In other cases, the gypsum wall board was installed over top of the plywood. We are not certain why the difference in sheathing installation had taken place.

The preference is to install the sheathing over top of the studs and the gypsum wallboard installed over top of the sheathing.

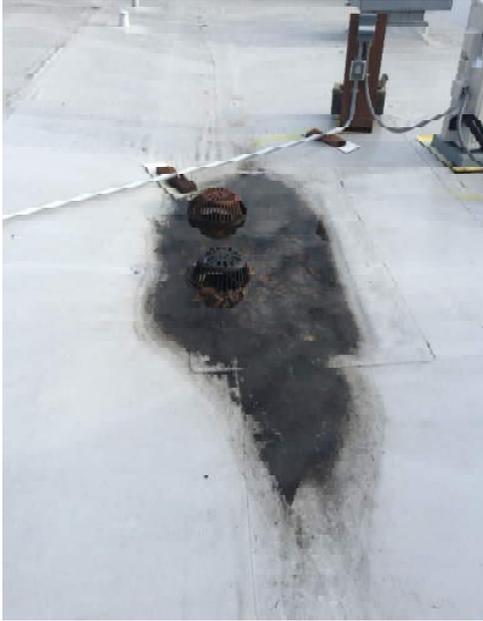
The exterior of the buildings showed little sign of deterioration or distress. The existing perimeter wall systems appear to be performing adequately. There was little evidence of deferred maintenance, rot or other structurally related distress. The existing roof carries numerous slopes, with some relatively flat slopes in portions of the composition roofing system. A minimum slope is advised for composition roof systems of this type and we are not certain whether the current roof profile meets the required slope.

Our review of the existing roof systems suggests that the roof structure is performing adequately. However, we did note some areas of loose roof membrane and some evidence of ponding water near the roof drain. This apparent ponding could simply be staining from soil particles that settled onto the roof as the roof water flowed to the drain.

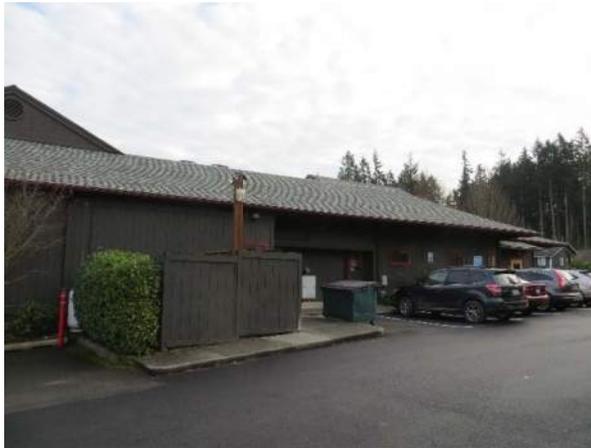
Picture 3 – Electrical Utility Power transformer located in fenced area.

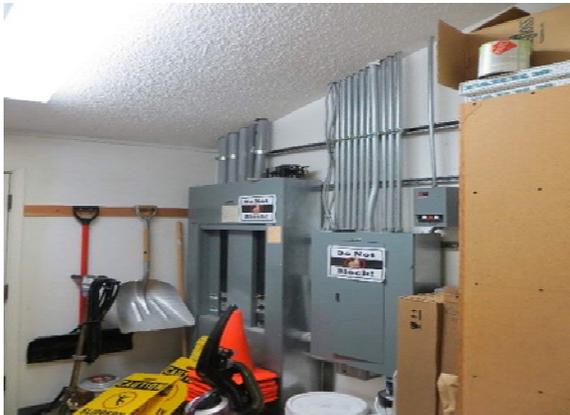
The main panel is a Square D, I-Line style panelboard. It is a modern type panelboard that contains circuit breakers (not fuses). It appears that it was new in 1994 when an addition was built onto the Library. It appears to be in good condition and is a similar type that would still be installed in a new building today. It has five main circuit breakers. 3 of the five circuit breakers are rated 200 amp, 3 phase and supply sub-panels in the building. The fourth circuit breaker supplies a 3 phase mechanical unit HC-1. The fifth breaker supplies a 1 phase mechanical unit AHU-1. Six main breakers is the maximum limit allowed by code, however, there is physical space to add another breaker, leaving capacity for future growth.

Picture 4 – Main Switchboard Located in Elec. Rm.

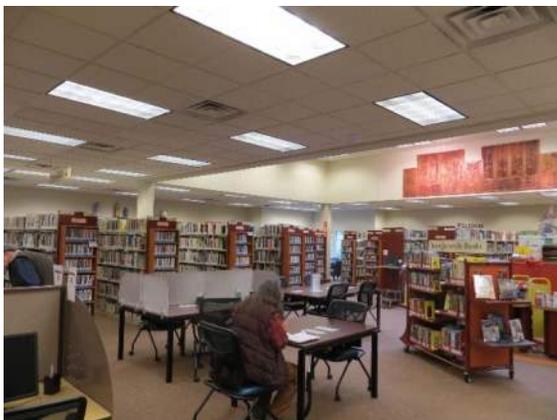
The interior lighting in the 1994 building addition is primarily made up of commercial recessed 2x4 fluorescent fixtures with T8 lamps. There are some incandescent track lighting and incandescent can lights. T8 fluorescent lighting is still a fairly efficient means of lighting. The existing fluorescent lighting appears to be in good condition.

Picture 6 – Existing T8 Fluorescent Lighting

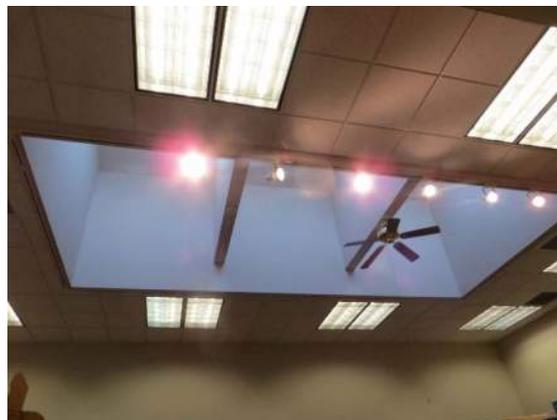
Picture 7 – Existing Incandescent Track Lighting

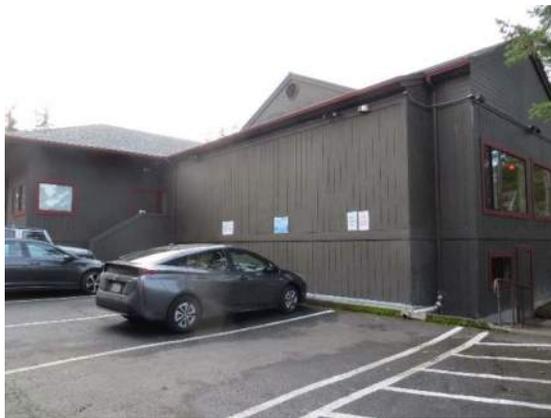
The existing exterior lighting is primarily made up of building mounted lights with no pole mounted lights for the parking lot. The site visit was performed during the day time, however, the existing lighting does not appear that it provides very much light at night. The exterior lights are primarily high pressure sodium (HPS) wall packs, building mounted. The north and east sides of the building appear to be underlit. At some point in time, incandescent flood lights have been added with surface conduit routing from light to light around the perimeter to provide more light. LED lighting is currently a more efficient lighting method. Eventually, the exterior lighting should be replaced/upgraded with LED type.

Picture 8 – East HPS and Incand. Lighting

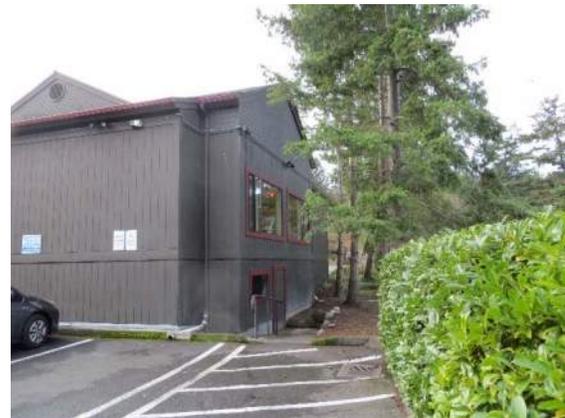
Pict. 9 – North HPS and Incand. Lighting
