SAN JUAN ISLAND LIBRARY SITE FEASIBILITY

Final Report • 6 August 2019

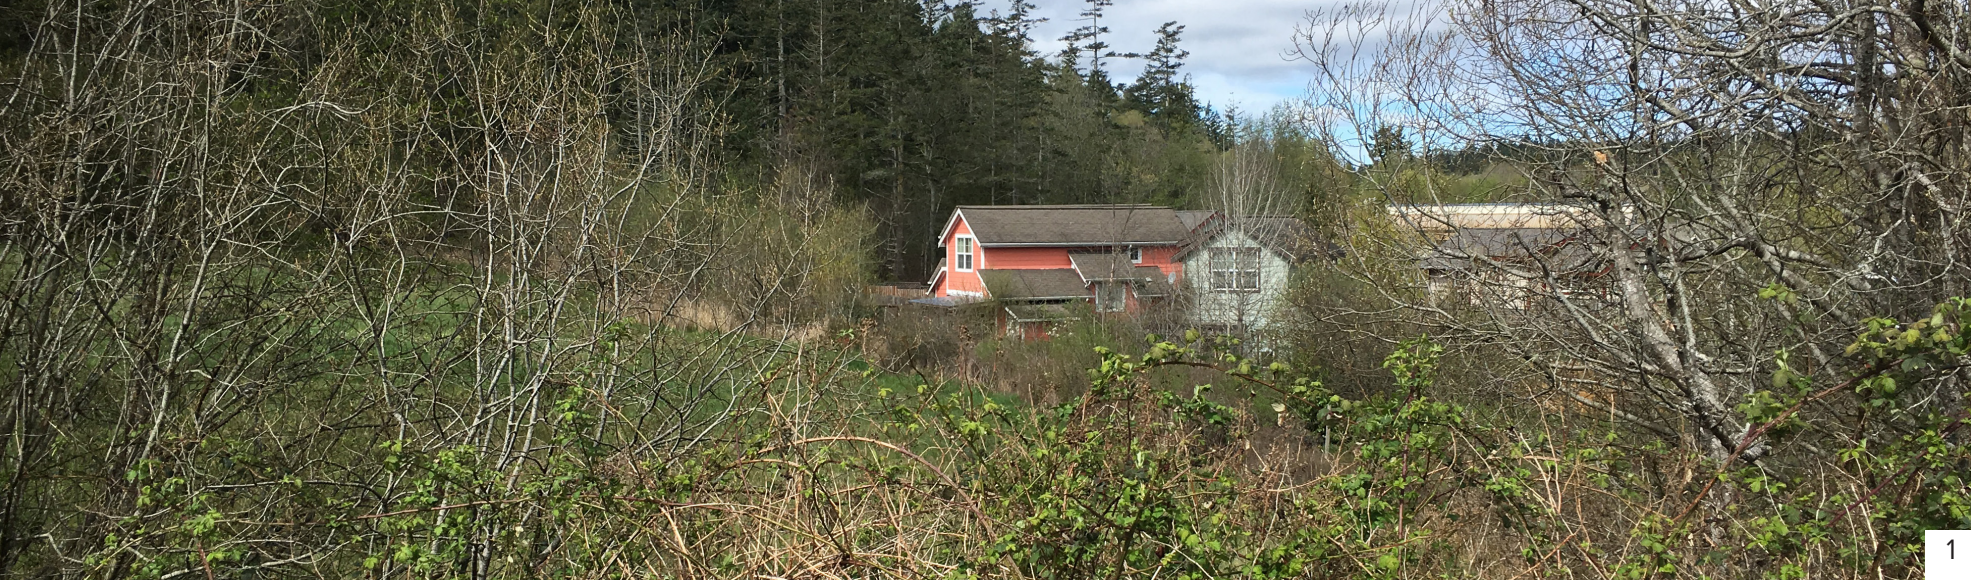
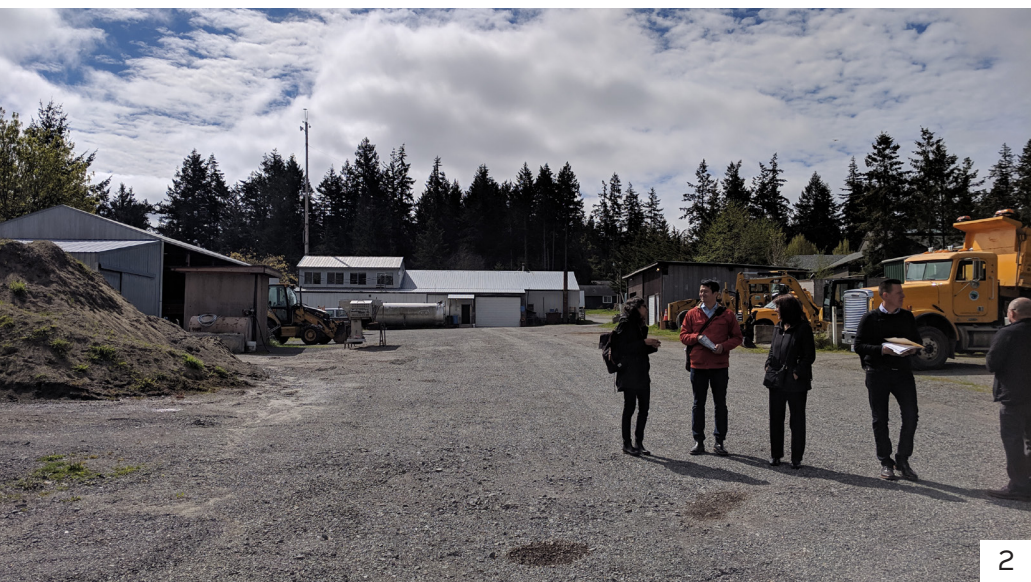
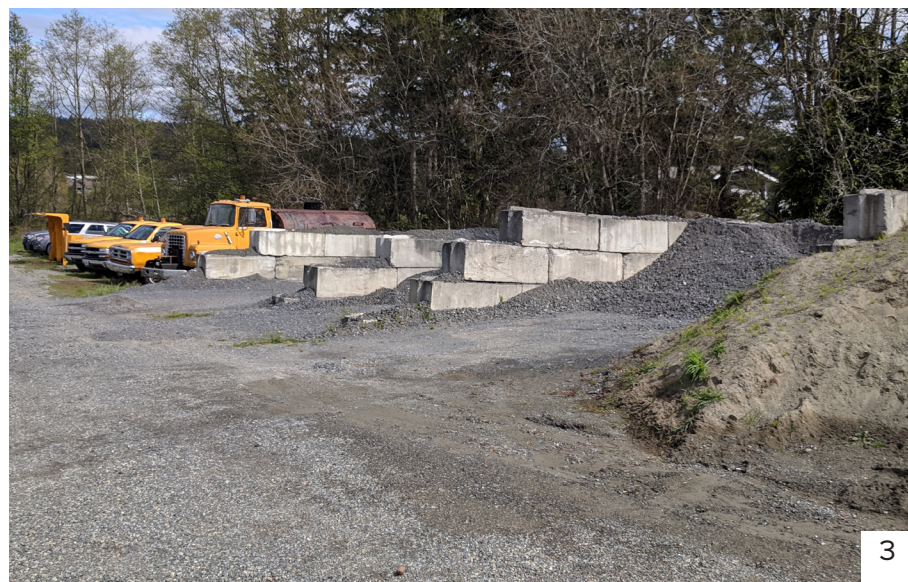
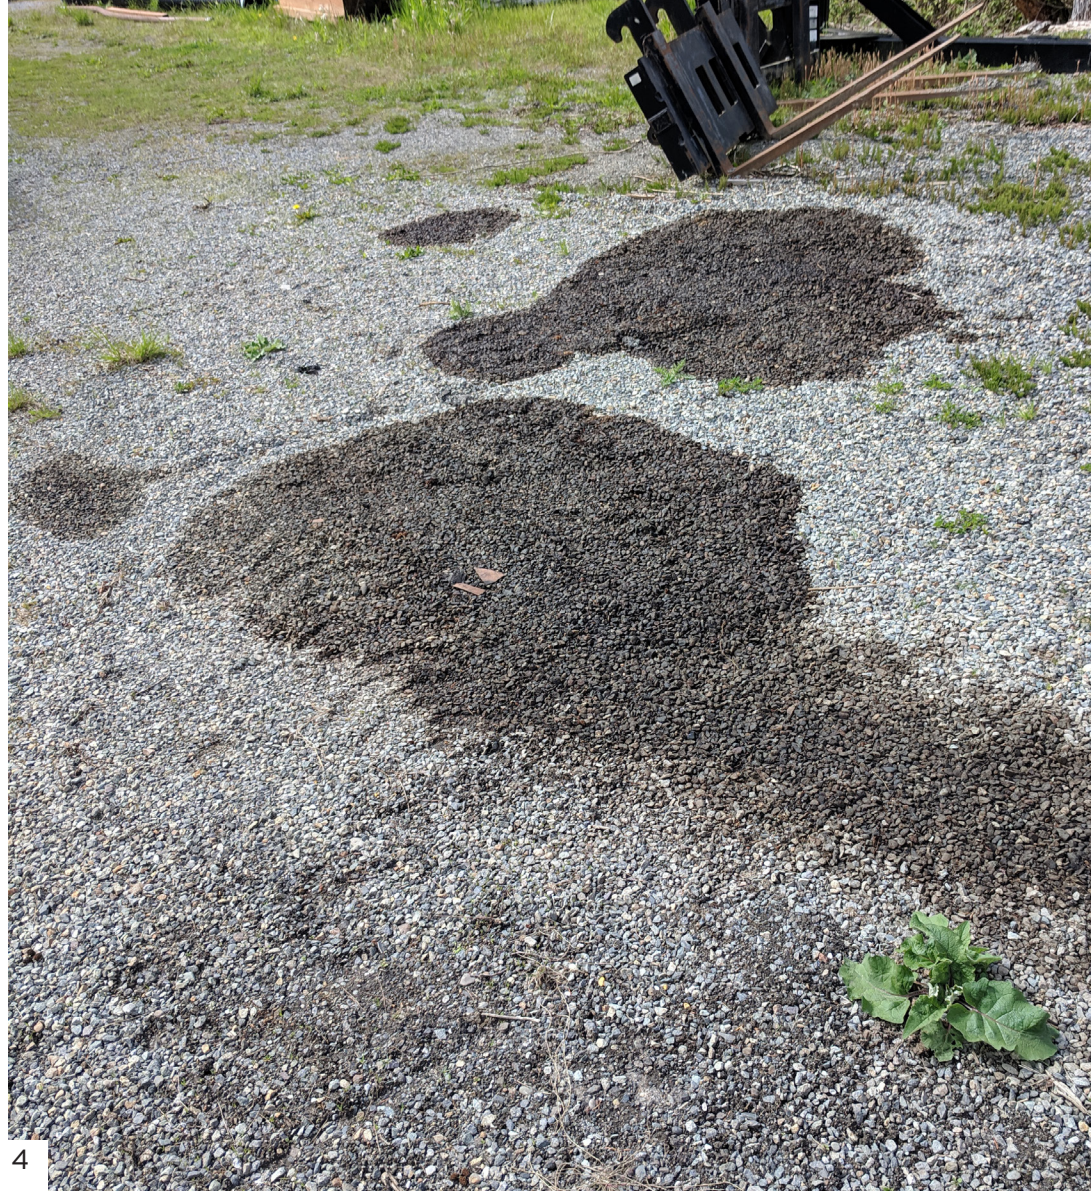
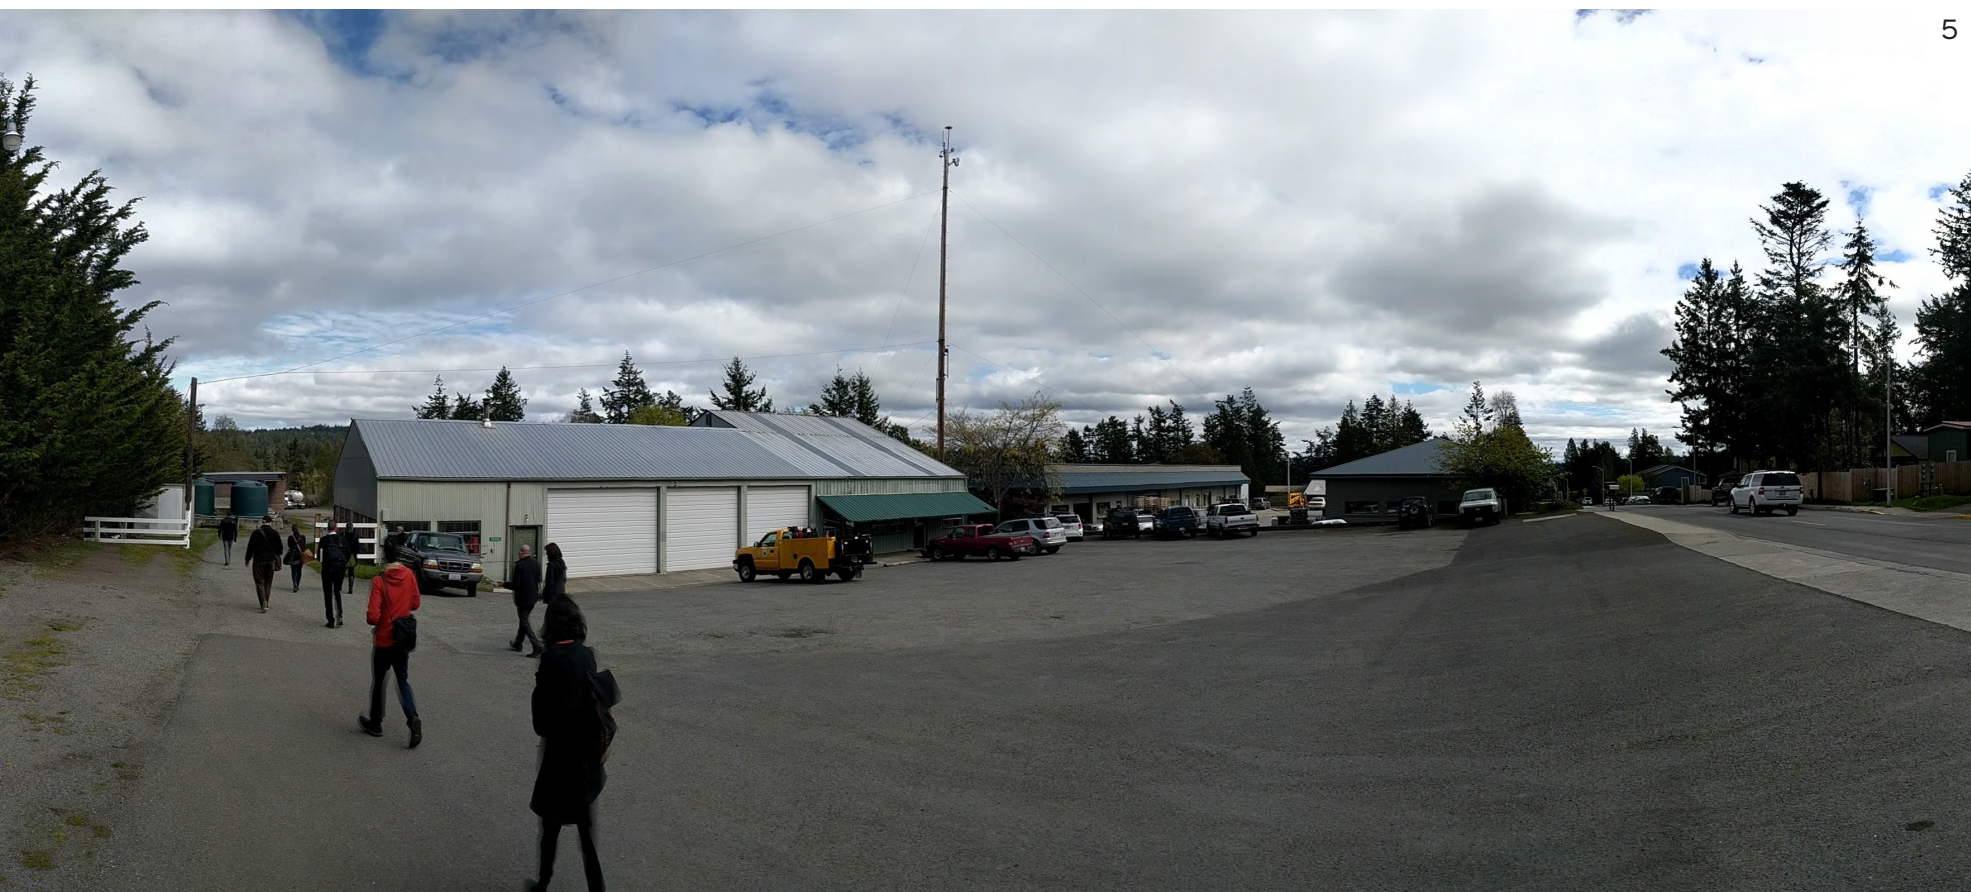
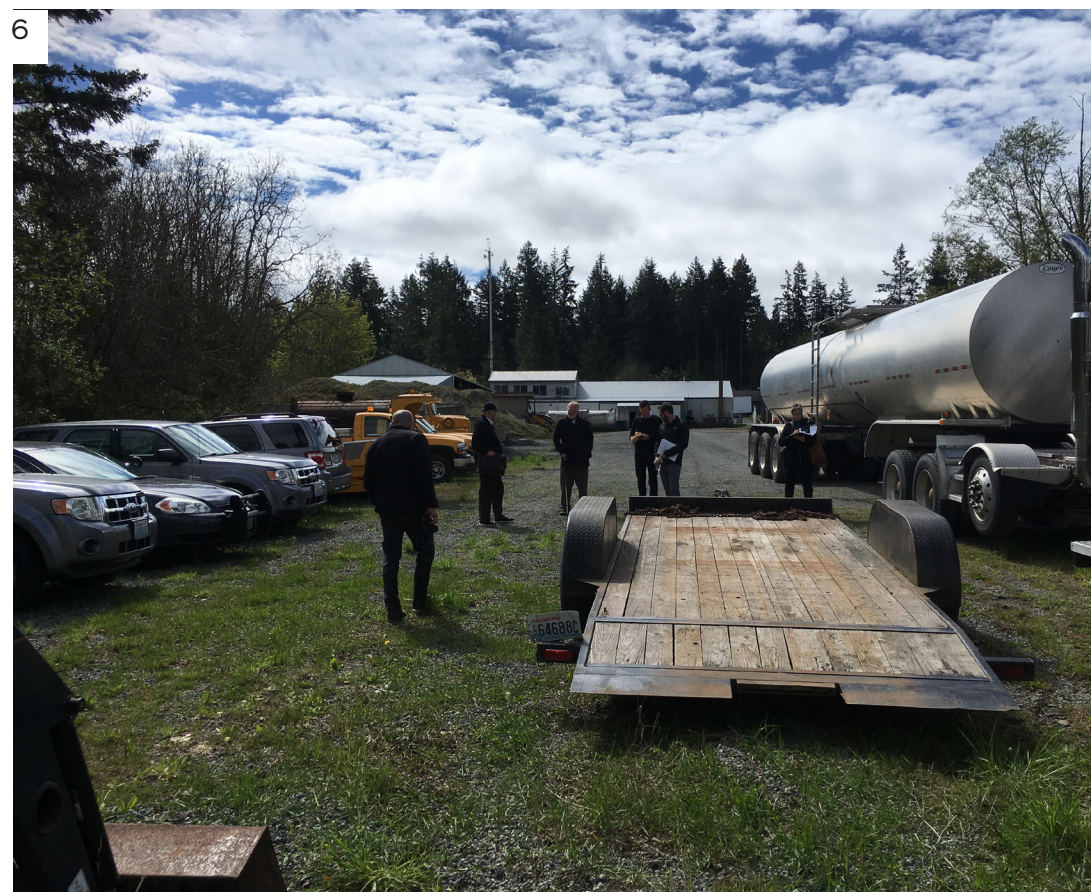
1. Neighboring site
2. Middle of site looking South
3. Middle of site looking East
4. Oil contaminated gravel
5. Existing buildings
6. Back of site looking South

Much of the site consists of fill soil which is not suitable for new construction. The fill is confirmed by the steep grade at the northern perimeter of the site. There are large oil stains seen on the gravel surface toward the north and three oil tanks have been removed from the property over the years. An environmental assessment will be required to determine the extent of non-structural fill and contaminated soil that will need to be removed from the property and in the case of contaminated soil, exported off island which is disproportionately expensive. The site slopes more than 30' toward the north. The storm main in Guard Street is at a higher elevation than the site which prevents storm runoff from connecting to the main. A storm water detention pond or underground detention tank will be required to allow slow infiltration on site. The property has very little street frontage which gives the library limited street presence and the proportion of the site is very linear making walking distances long and accessibly more difficult.

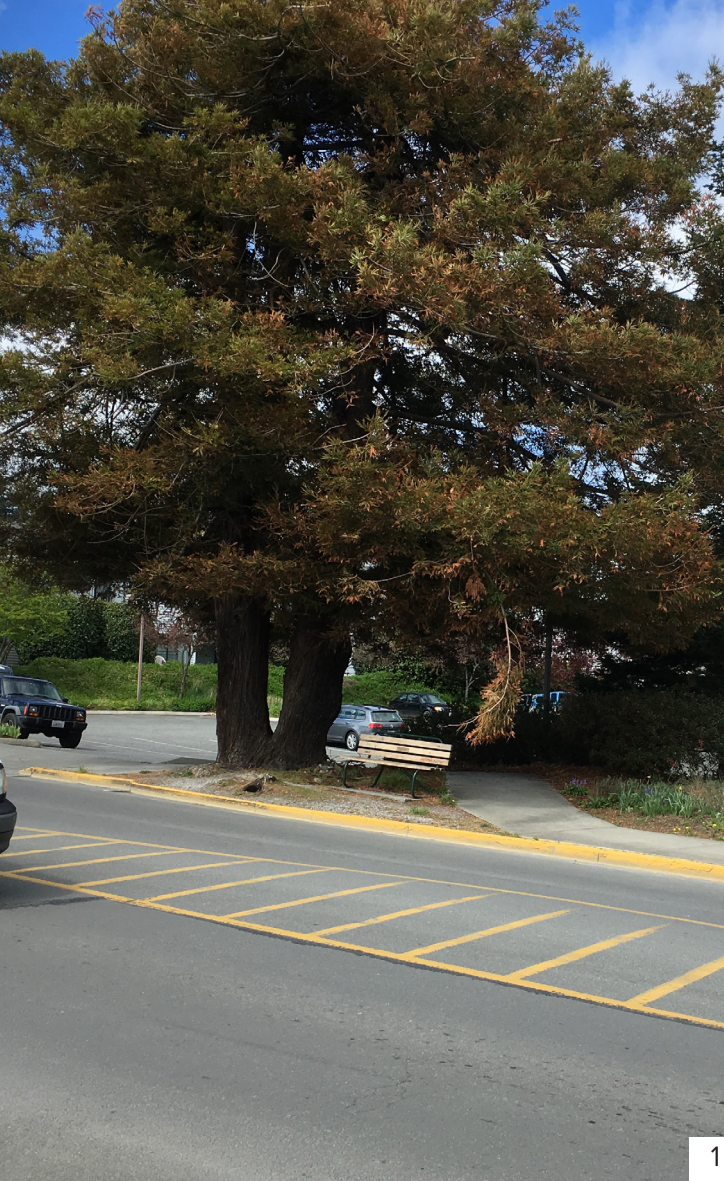
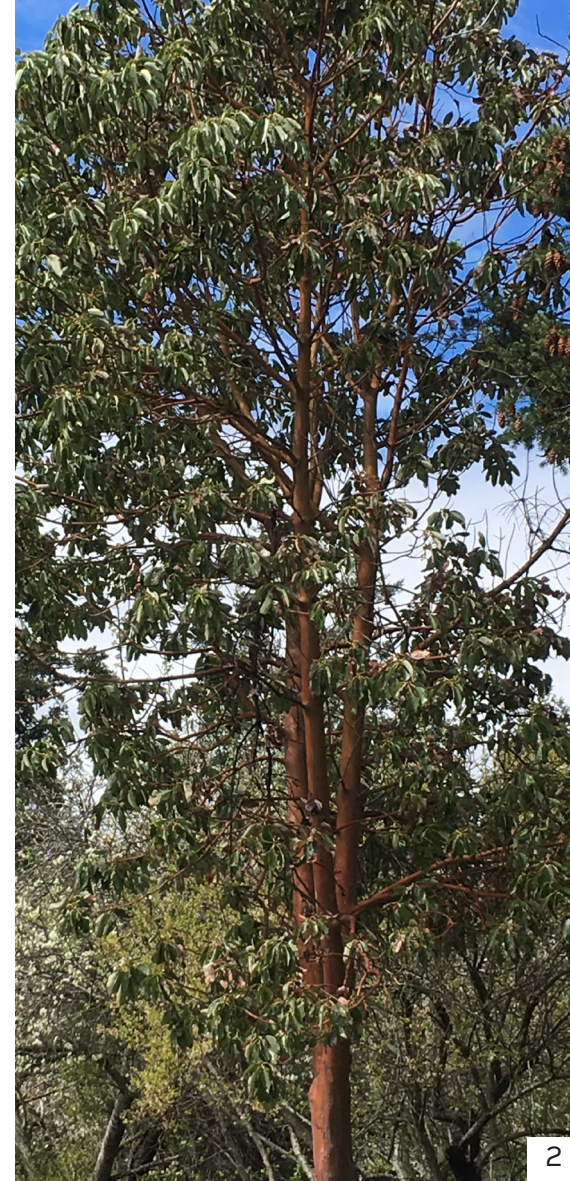
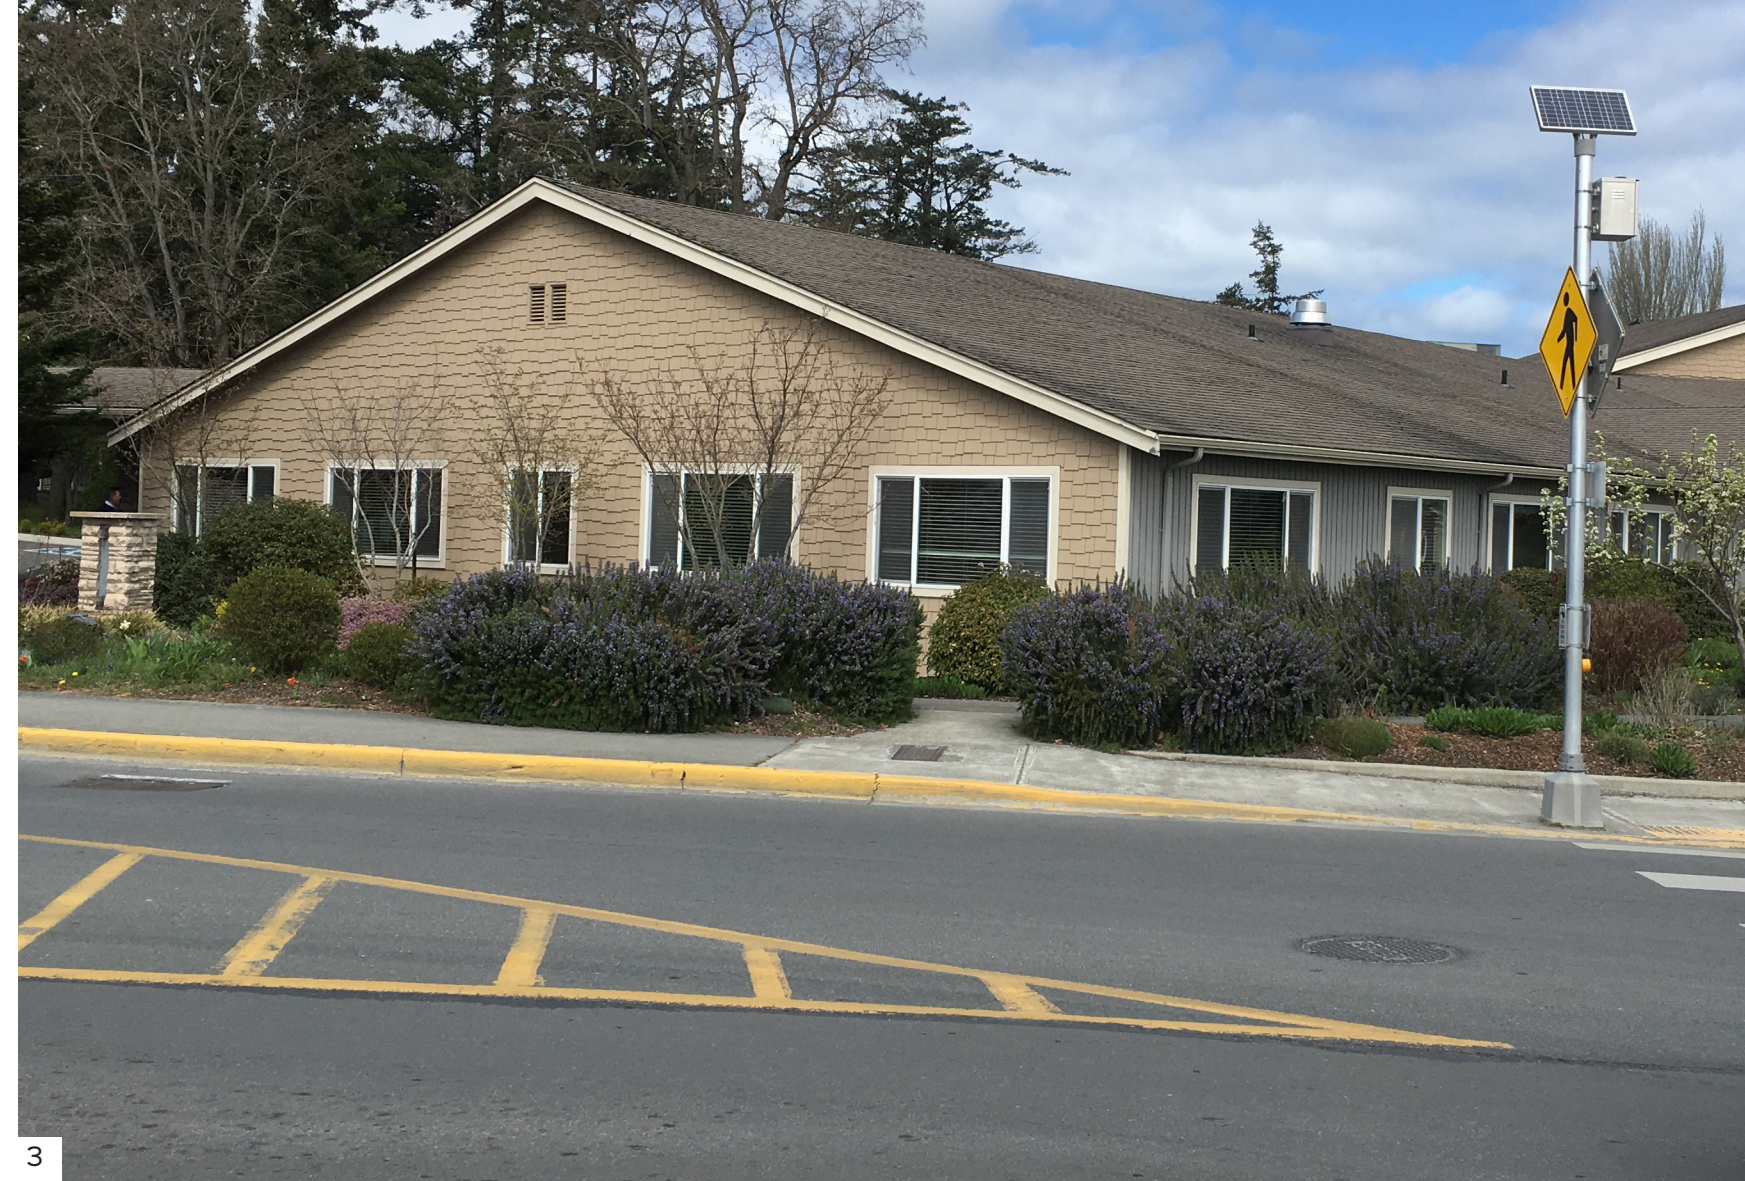
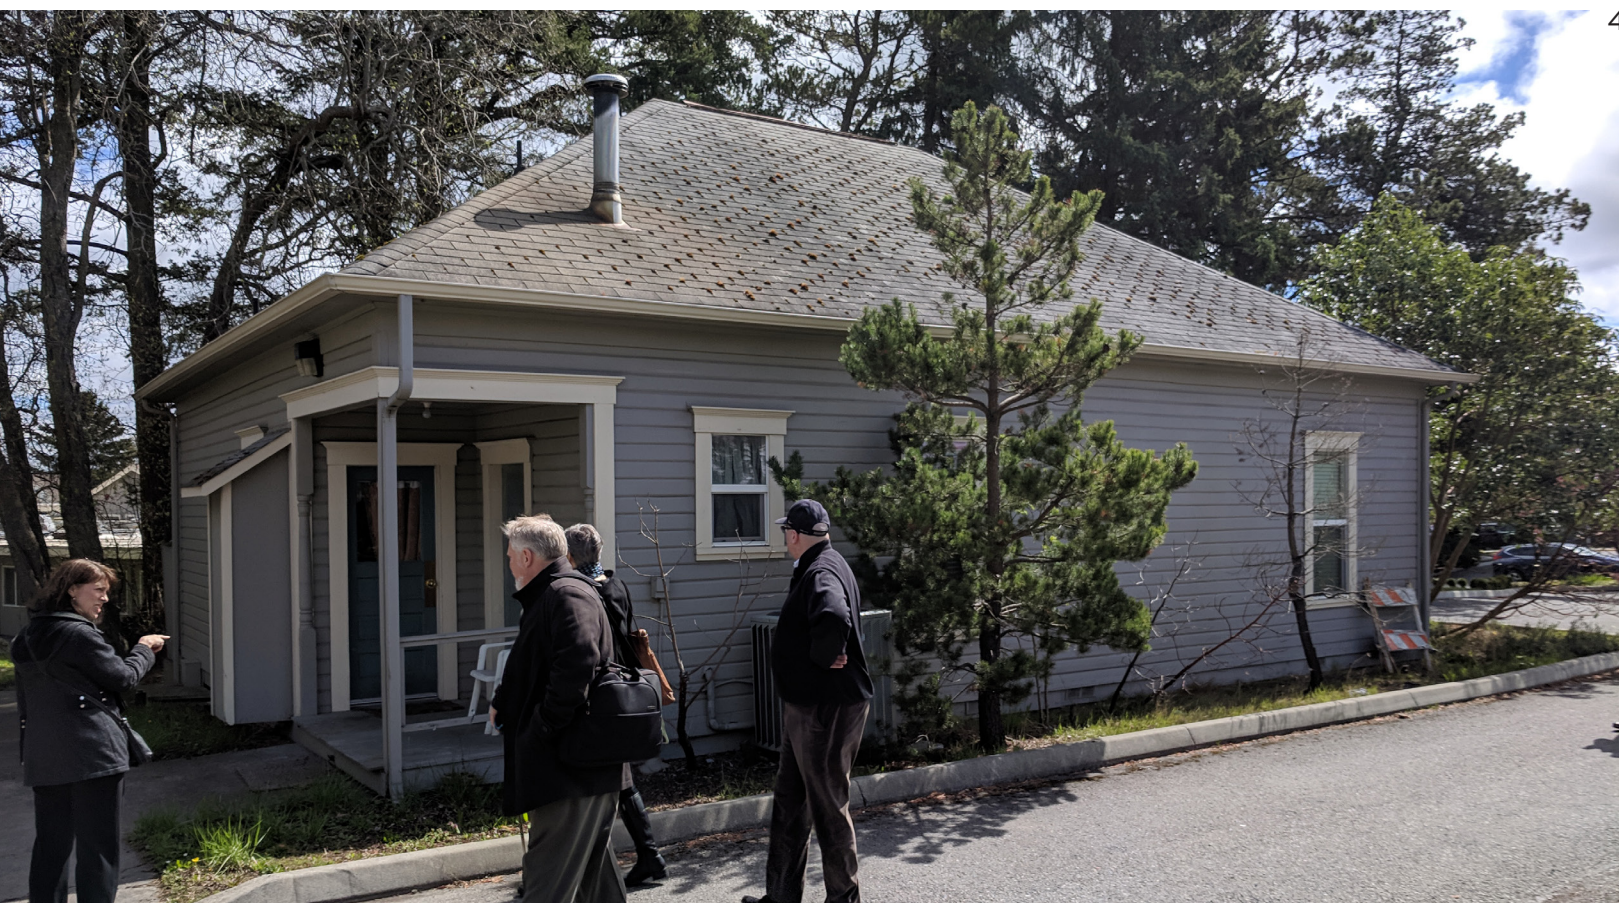
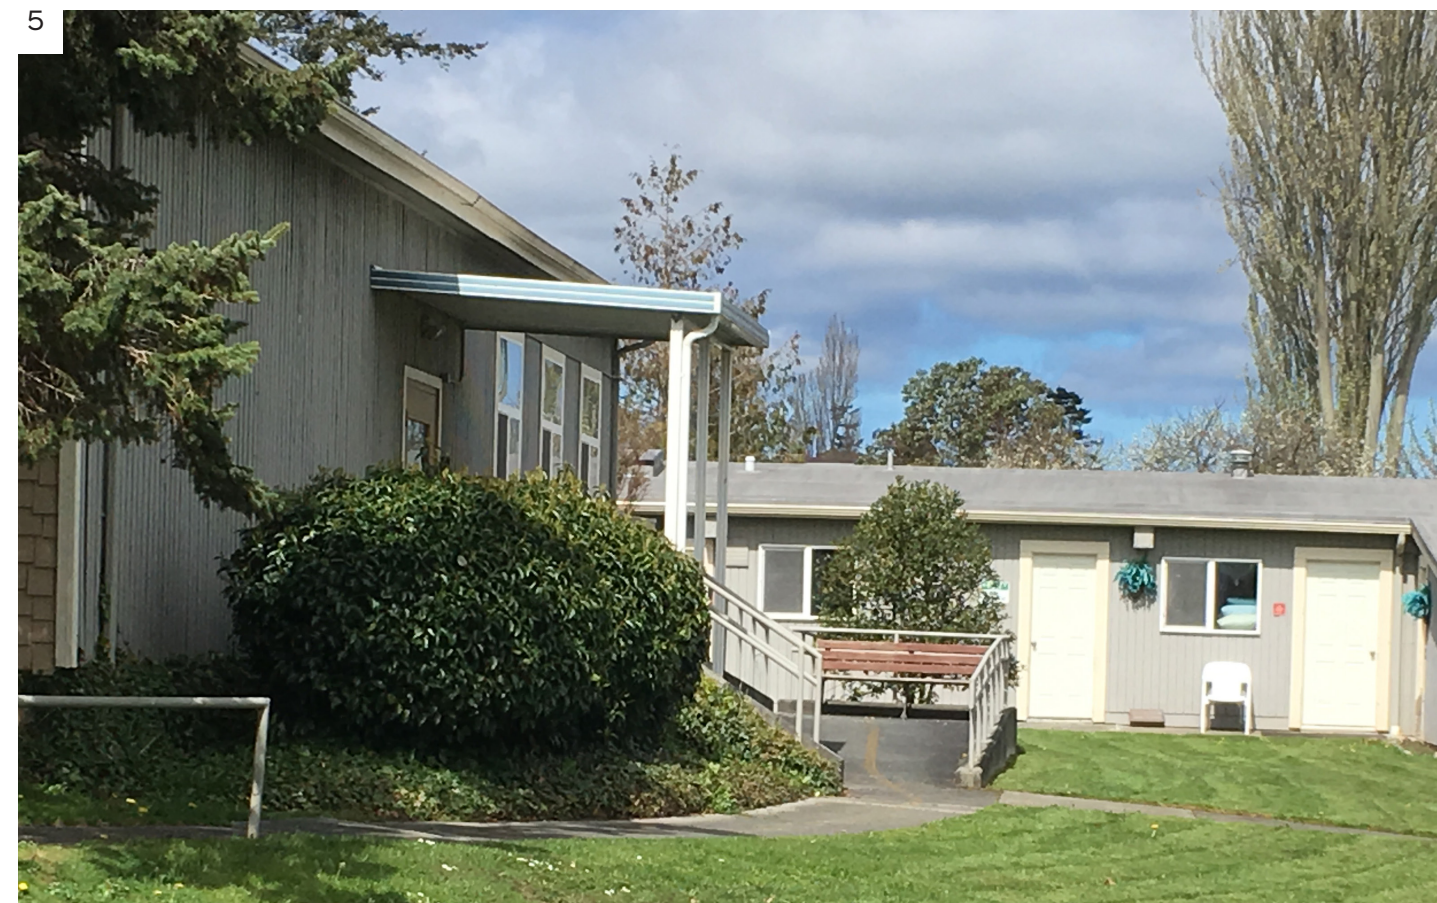
1. Exceptional tree at entry on Spring
2. Madrone trees on site
3. View of site from across Spring
4. Existing House
5. Existing buildings

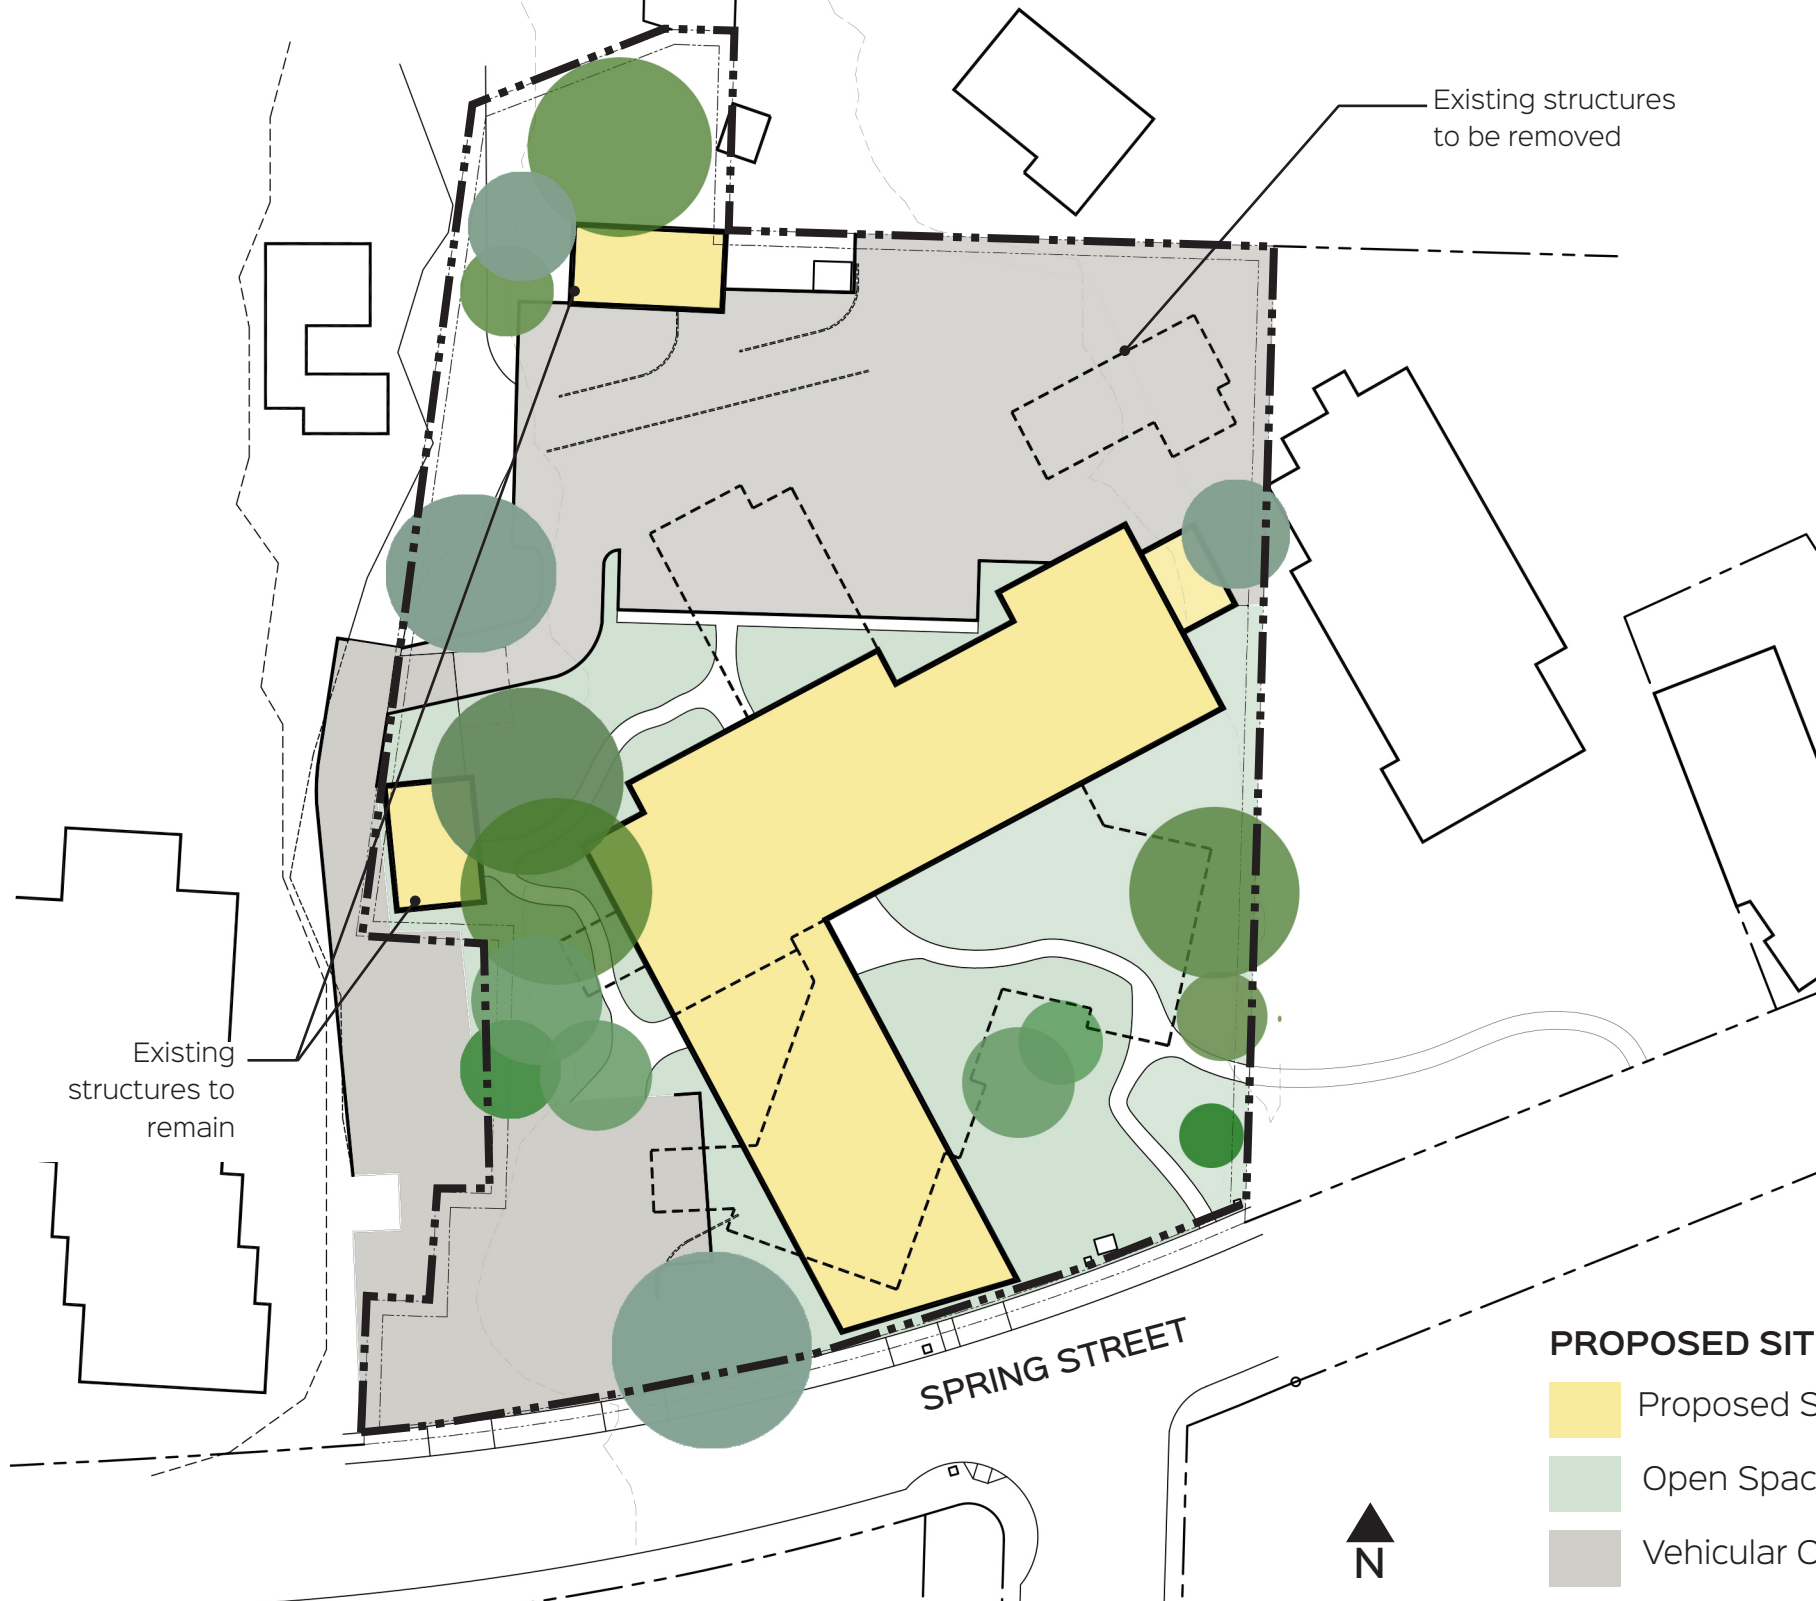
Spring Street Site Plan Notes:

1. Easements: An access easement exists at the west side of property. Recording number 90169142. Exact extents to be determined by licensed surveyor.

2. Utility Mains: Sewer, water and storm main are located in Spring Street. All utility connections to utility mains are adequately sized for proposed buildings. No known connection upgrades are required.

3. Power: The power transformer located in the above ground vault on property is adequately sized for the proposed structure.

4. Utility Sizing: The existing structure is 28,000 sf. Proposed building is 20,000 sf.

5. Utility Distribution: All utility distribution exists on the property but will require upgrades to meet current codes. Assume reuse of water and sewer lines, lining will be required for sewer line.

6. Water: The water meter is oversized for library use. It is recommended to replace the existing meter with a smaller meter to minimize on going use fees.

12. Parking: All parking, drive aisles and driveways are assumed to be asphalt. Total parking count = 104 stalls

13. Hazardous Material: There is known presence of asbestos in original 1966 building. Asbestos must be disposed of off-island.

14. Building Reuse: For estimating purposes assume full demolition of building and partial reuse of 1966 slab-on-grade. Potential for reuse of larger portions of building can be determined after the completion of a building assessment.

15. Storm: Assume storm water retention using culverts beneath parking area with overflow to existing storm main connection.

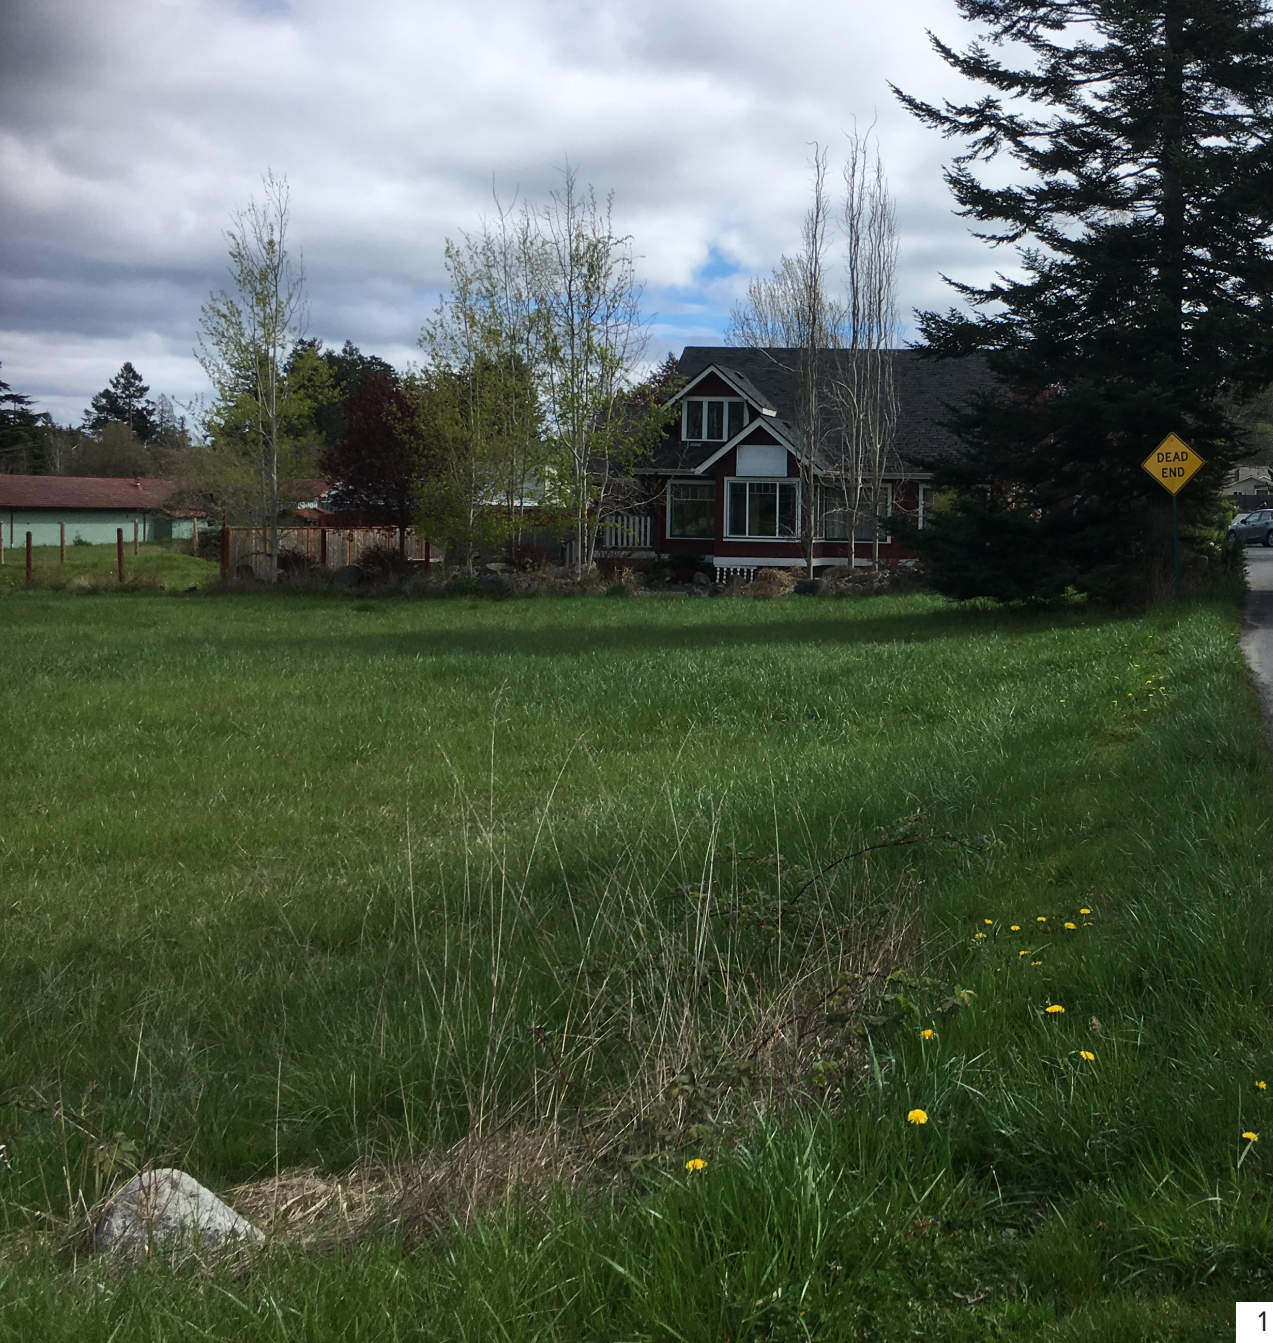
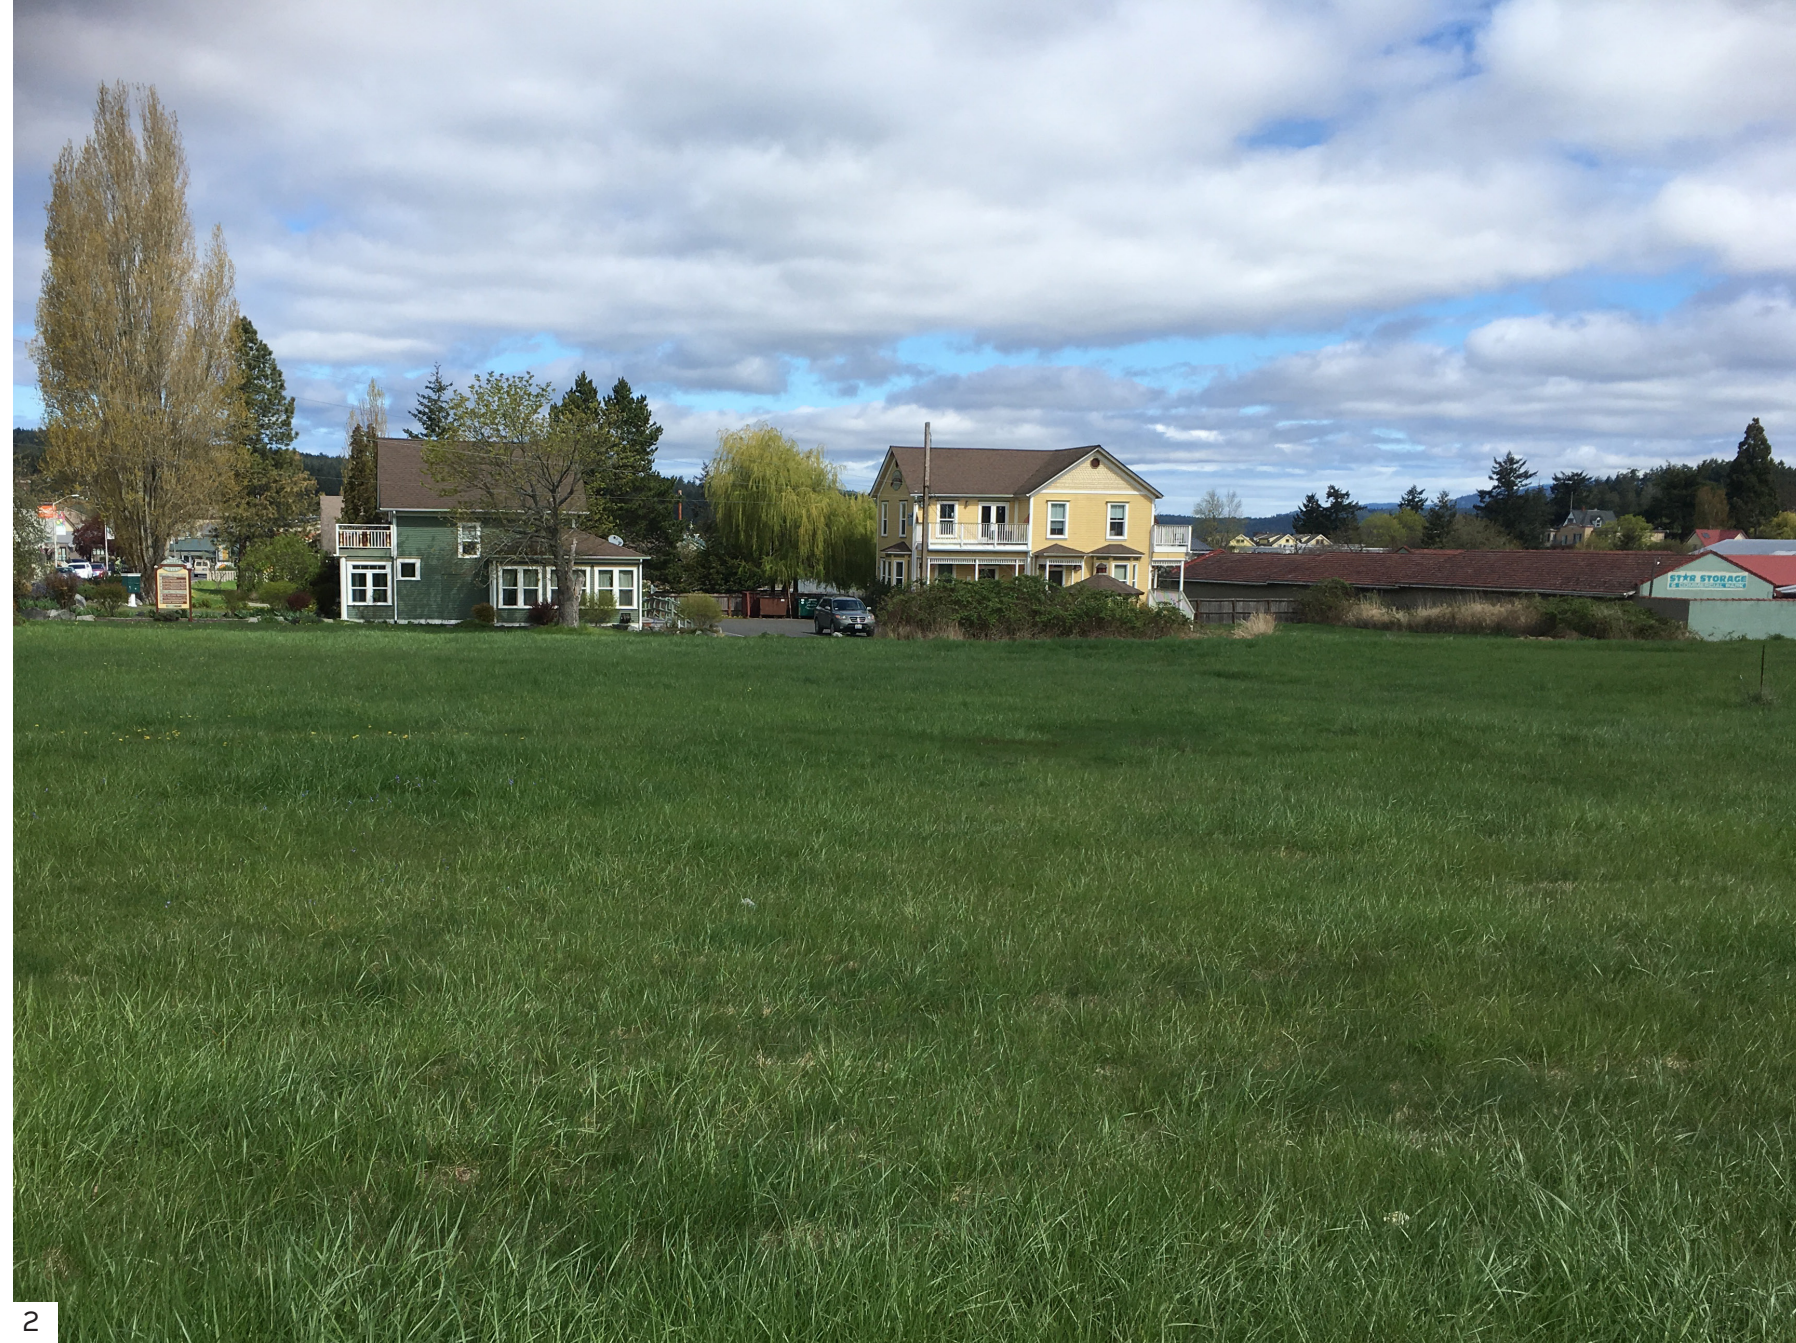
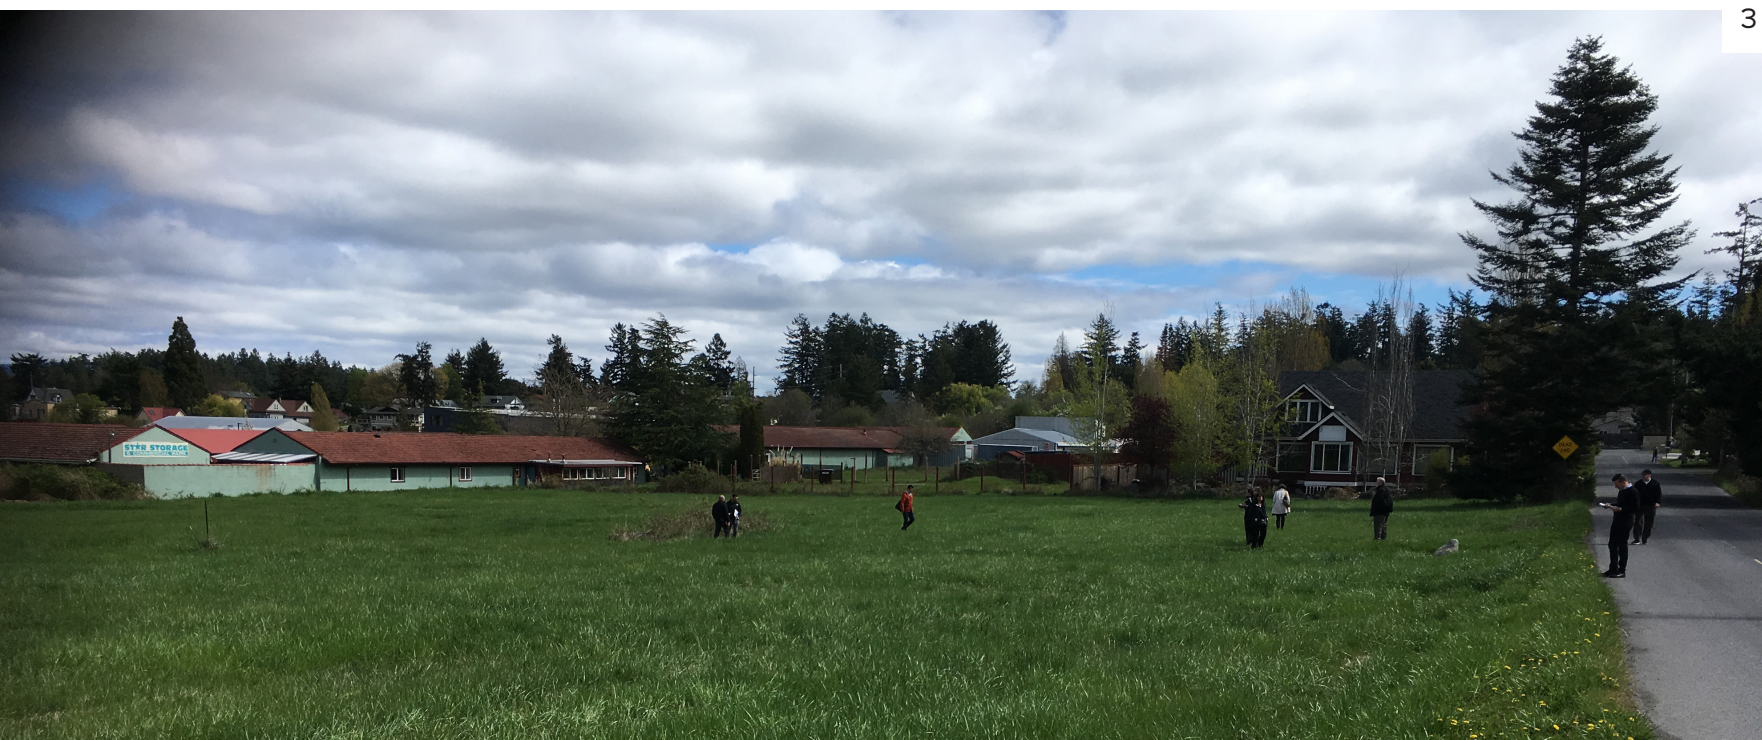
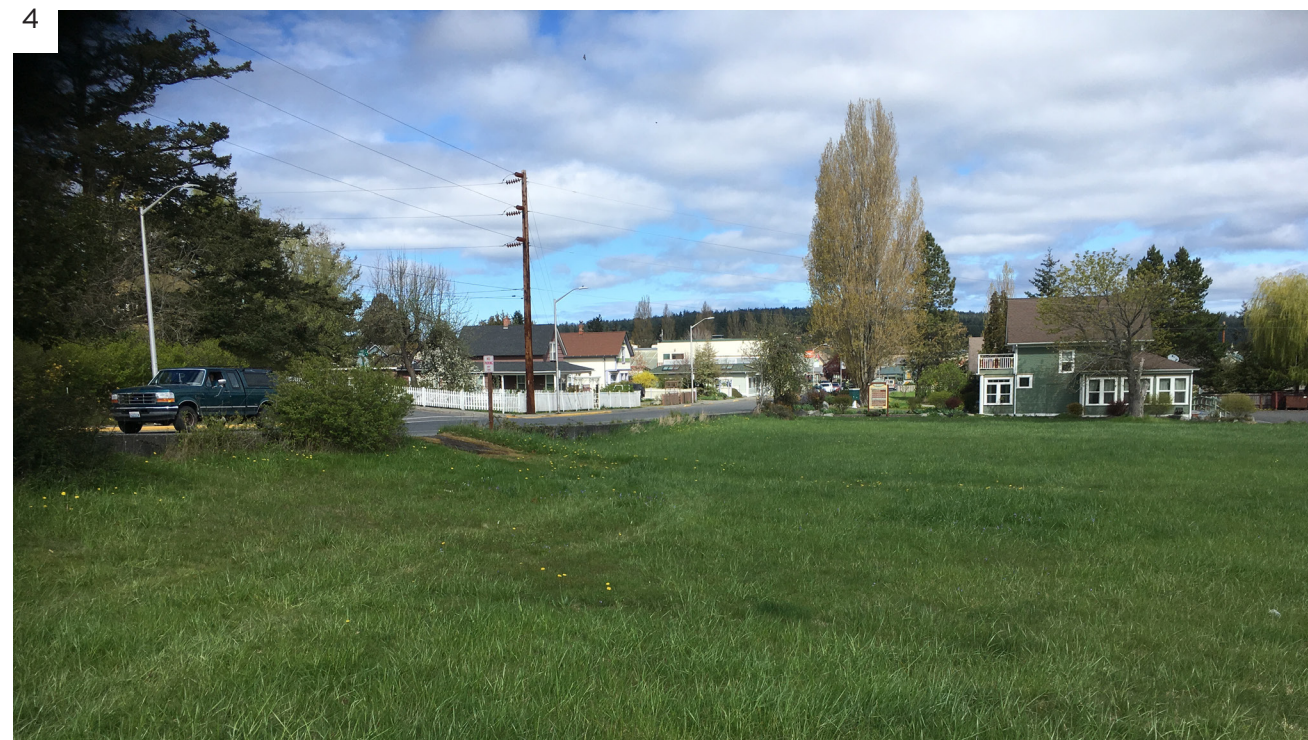
1. Neighboring site the east
2. Neighboring site to the north
3. Malcolm Street side
4. Looking North to Argyle Street
