SAN JUAN ISLAND LIBRARY SITE FEASIBILITY

Final Report • 6 August 2019

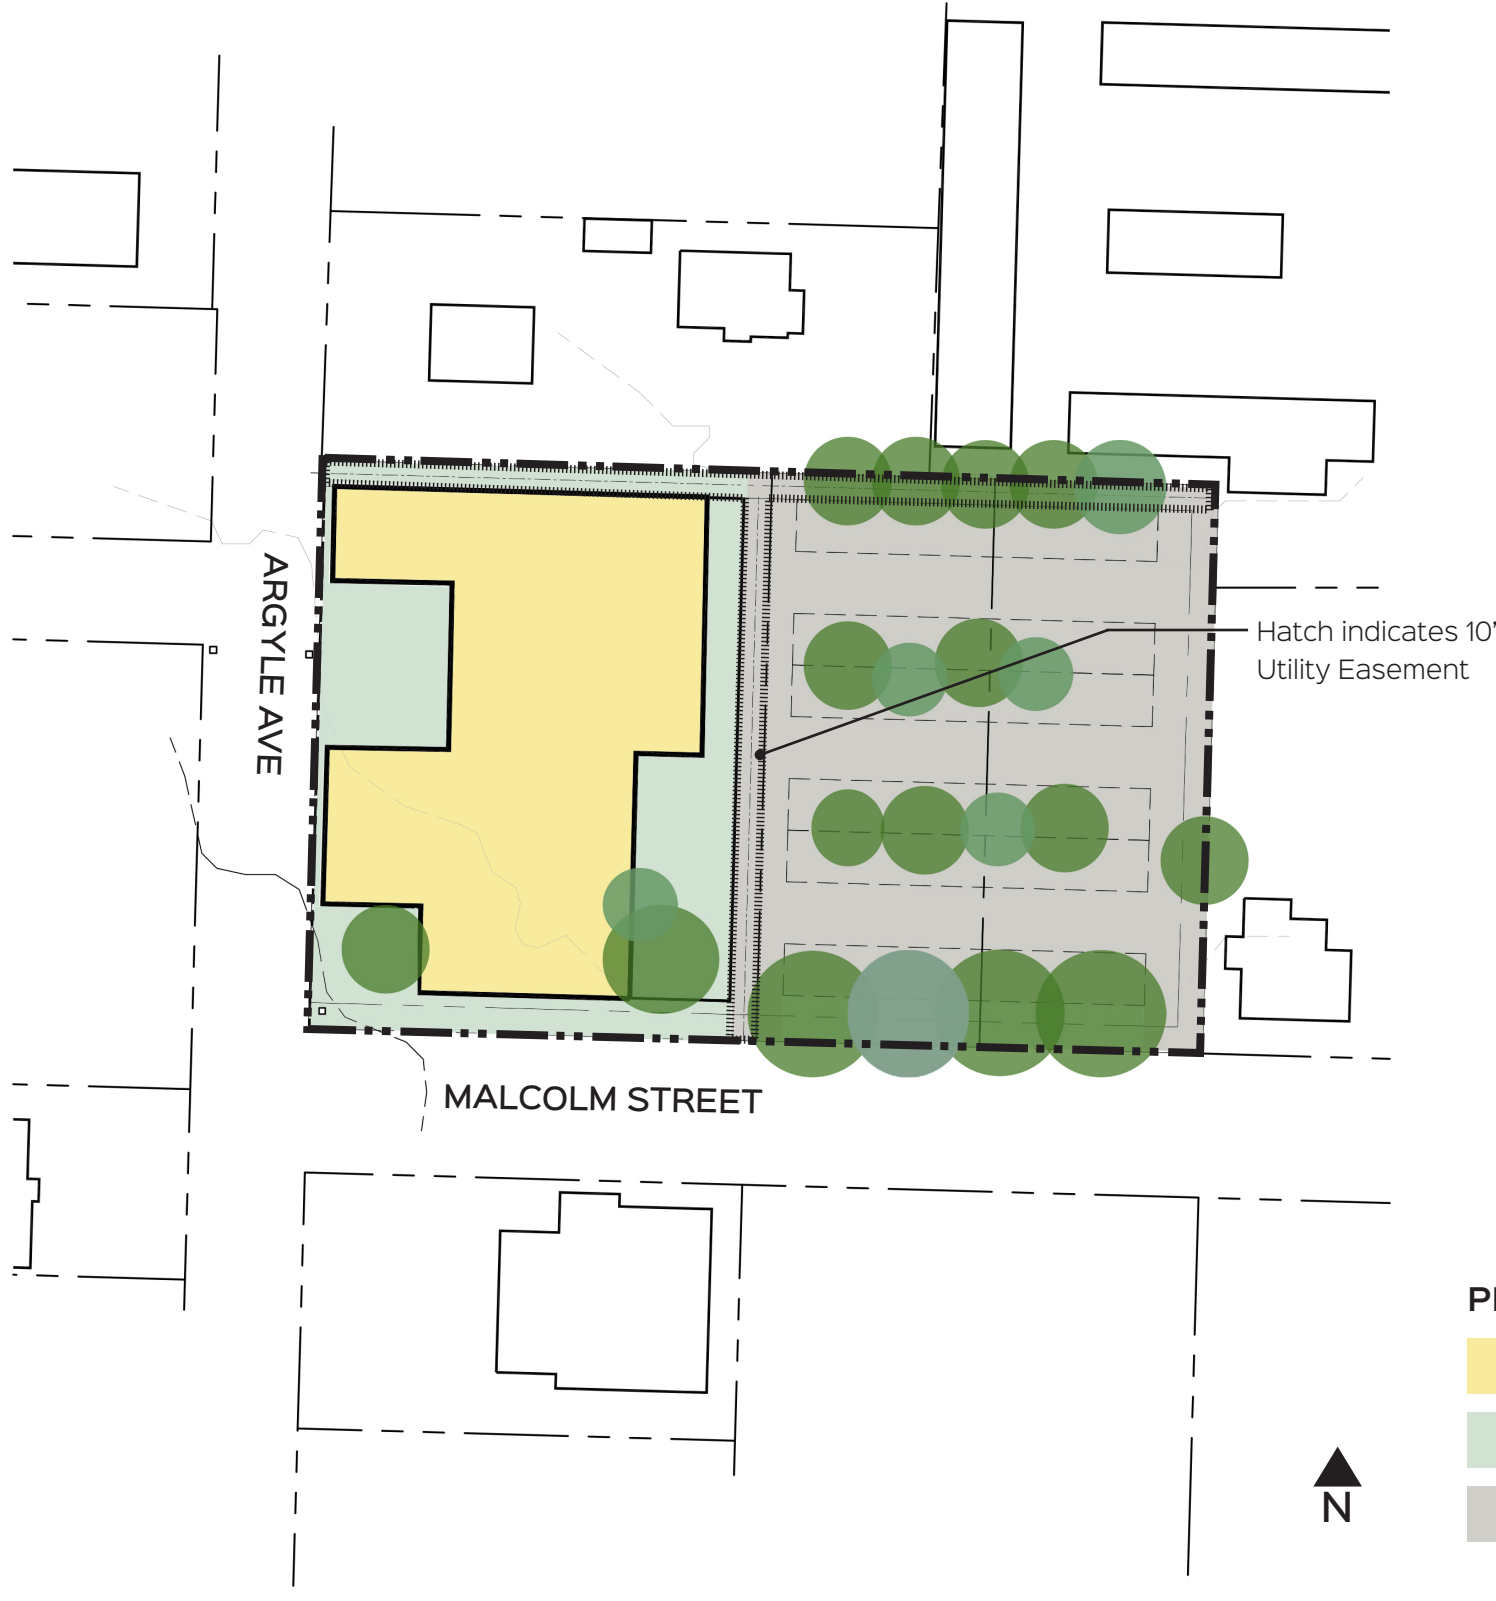
Malcolm Street Site Plan Notes:

1. Easements: A sewer easement exists at the center and north edge of the property.

2. Utility Mains: Sewer, water and storm mains are located in Malcolm Street. A storm main connection does not exist. Water and sewer main connections exist. Assume utility trenching in Argyle Ave for water. Storm connection will have to connect through a future easement on the adjacent northeast property because the storm main in Argyle Ave is too high for a gravity connection.

3. Power: There is no existing transformer that can accommodate this site. Single phase power is available and a pad mount transformer can be added. 3 phase power can be extended to this site and a flush mount transformer can be added.

4. Utility Sizing/Distribution: There are currently no structures on this site therefore no utility distribution exists on the property other than the existing 8" sewer main in the easement and 3 6" sewer stubs on tax parcel 200, 100 & 80. Utility distribution needs to be added for water, storm, power and some sewer.

6. Water: There is an existing undersized water meter in the SW corner of the site. It is recommended to upgrade this existing meter.

9. Critical Areas: There are no known critical areas or shoreline habitats on this site. Although the site is not mapped as a wetland it has a known presence of standing water over ~30% of the site.

10. Road Improvements: Malcolm Street is a minor arterial. There are currently no street improvements on Argyle or Malcolm. Assume new curb, gutter, sidewalks, curb cuts, and a cross walk at Caines Street, crossing Argyle Ave.

15. Storm: Assume storm water retention using culverts beneath the parking area with overflow to future storm connection via future easement with the northeast neighbor.

16. ADA Accessibility: It is recommended to fill roughly 2 feet at the building pad area to bring the slab elevation closer to the street. Ramps from Argyle to the building and from parking lot to the building will need to be installed.

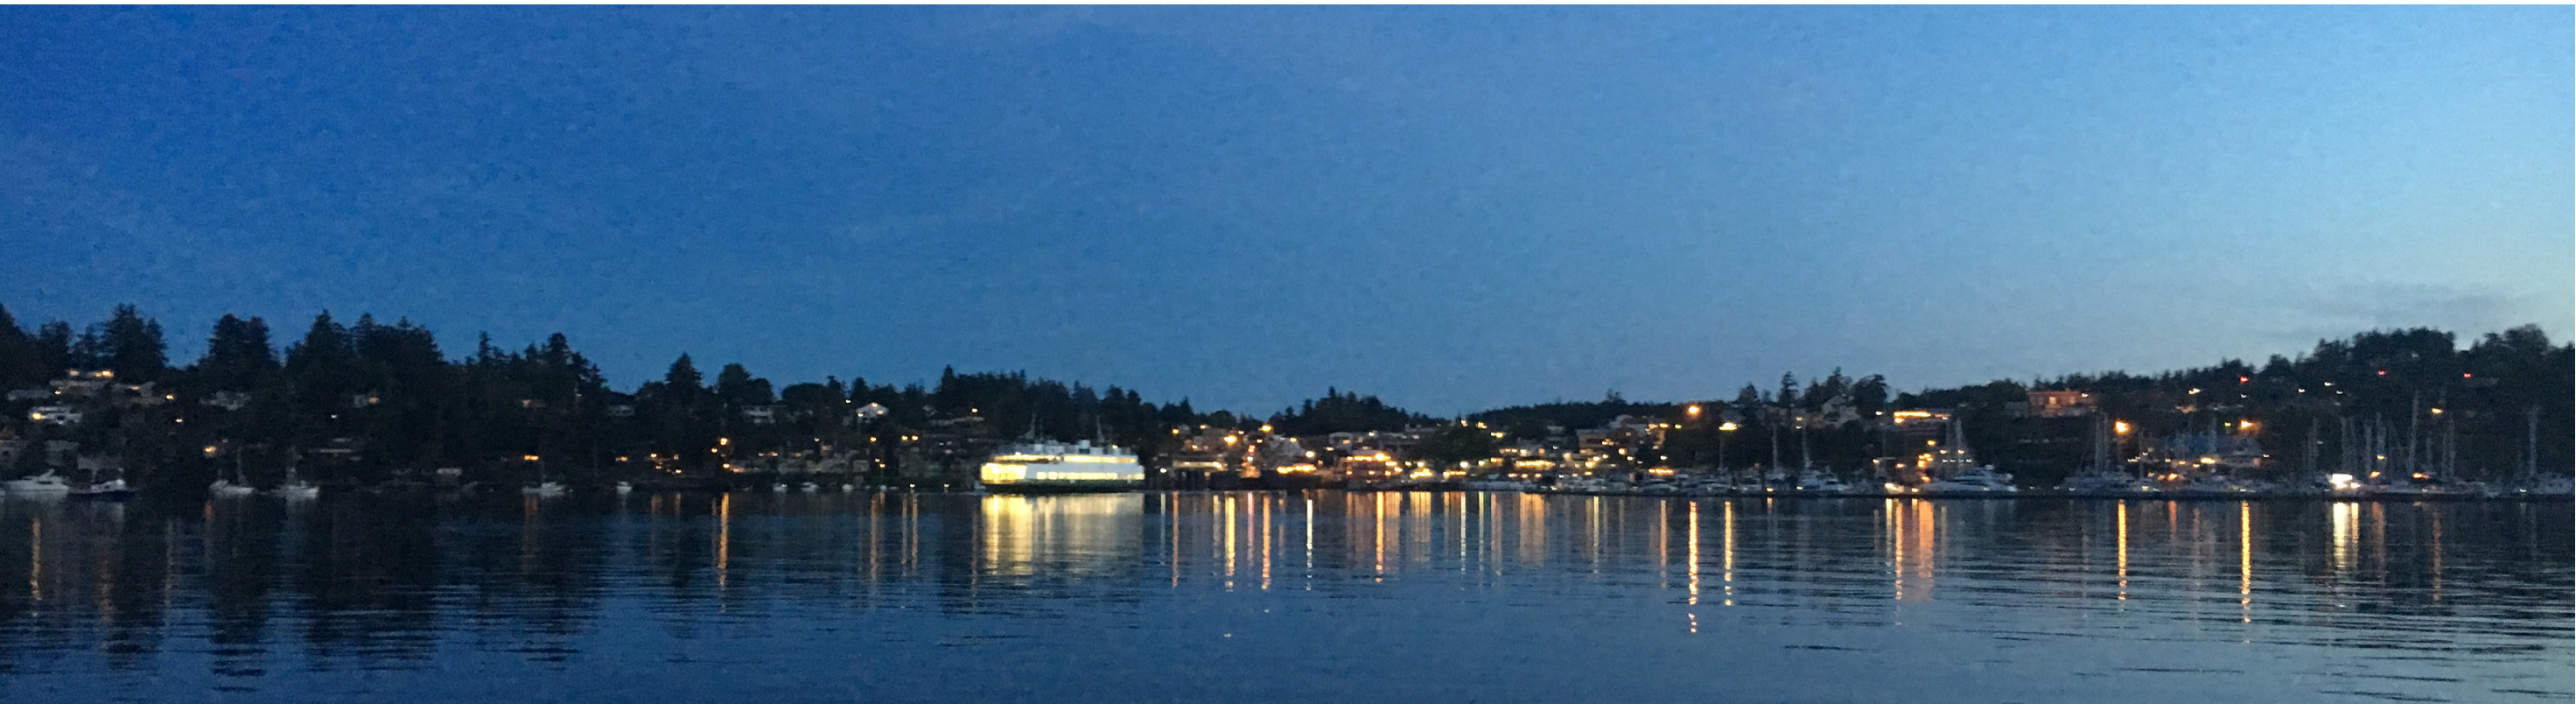
SCHEDULE MILESTONES

Milestone	Duration	Start	Finish
Feasibility Study	29 Days	6/24/19	8/2/19
Secondary Site Analysis	24 Days	8/2/19	9/4/19
Design: Research	13 Days	1/21/21	2/18/21
Design: Schematic Design	59 Days	2/9/21	4/30/21
Design: Design Development	85 Days	4/27/21	8/23/21
Design: Construction Docs	60 Days	7/13/21	10/4/21
Bidding	20 Days	10/5/21	11/1/21
Construction	12 Months	11/2/21	10/3/22
