SAN JUAN ISLAND LIBRARY

BUILDING CONDITION ASSESSMENT & FEASIBILITY STUDY

May 2018

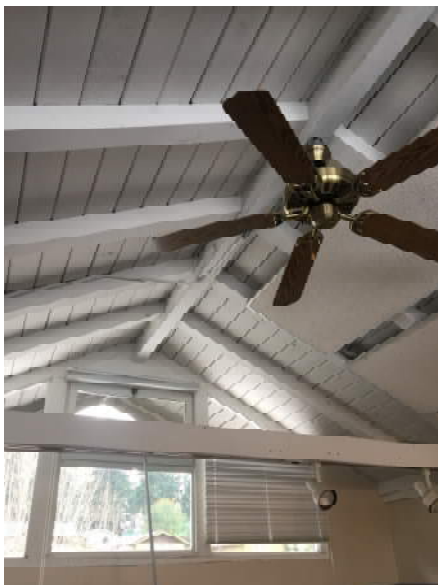
In general, the observed areas of existing framing appeared to be in good condition with no obvious signs of distress or unsatisfactory performance.

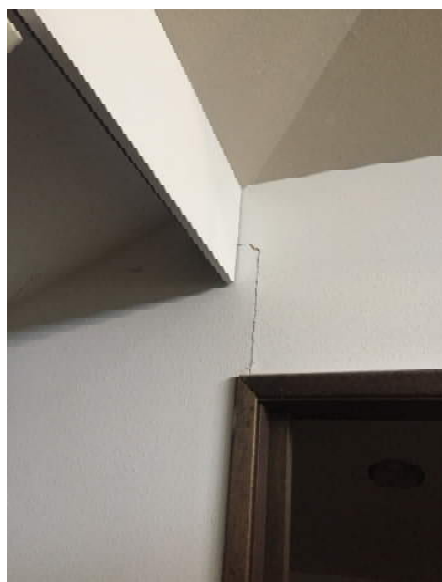
Distress over attic door (south side)

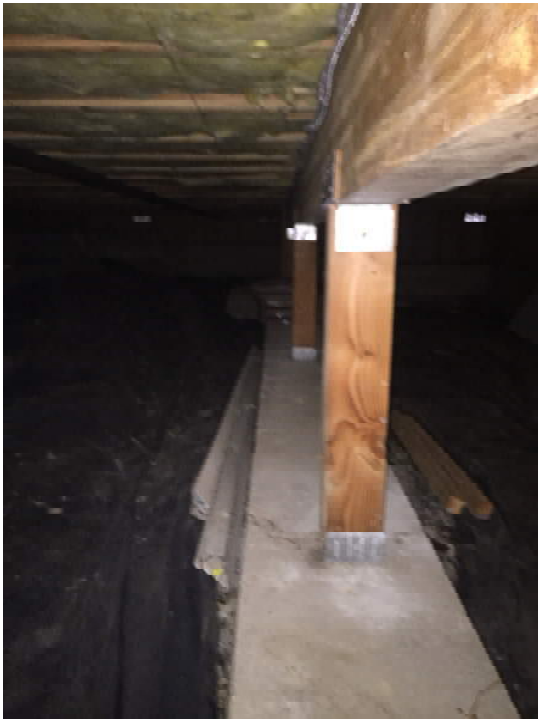
Continuous grade beam in lieu of stem wall & strip footing.

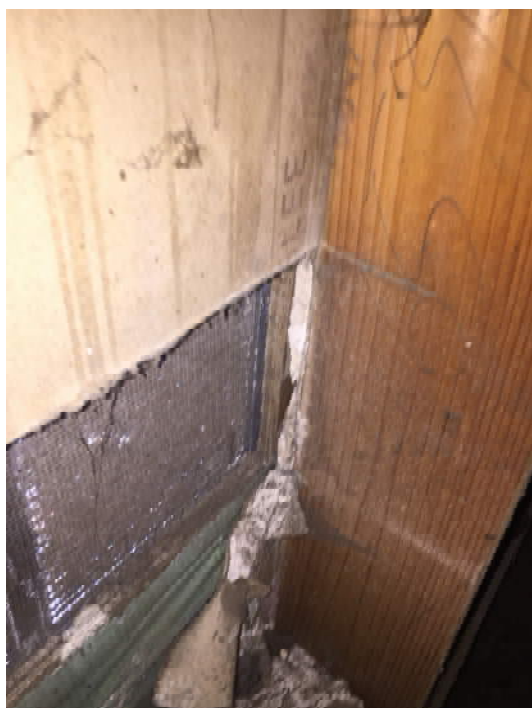
At several locations, we identified that the exterior plywood sheathing for the exterior shear walls was installed over top of the gypsum wall board. In other cases, the gypsum wall board was installed over top of the plywood. We are not certain why the difference in sheathing installation had taken place.

The preference is to install the sheathing over top of the studs and the gypsum wallboard installed over top of the sheathing.

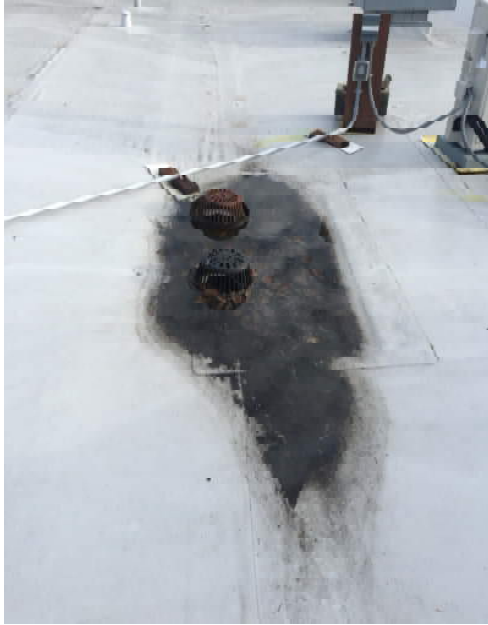
The exterior of the buildings showed little sign of deterioration or distress. The existing perimeter wall systems appear to be performing adequately. There was little evidence of deferred maintenance, rot or other structurally related distress. The existing roof carries numerous slopes, with some relatively flat slopes in portions of the composition roofing system. A minimum slope is advised for composition roof systems of this type and we are not certain whether the current roof profile meets the required slope.

Our review of the existing roof systems suggests that the roof structure is performing adequately. However, we did note some areas of loose roof membrane and some evidence of ponding water near the roof drain. This apparent ponding could simply be staining from soil particles that settled onto the roof as the roof water flowed to the drain.

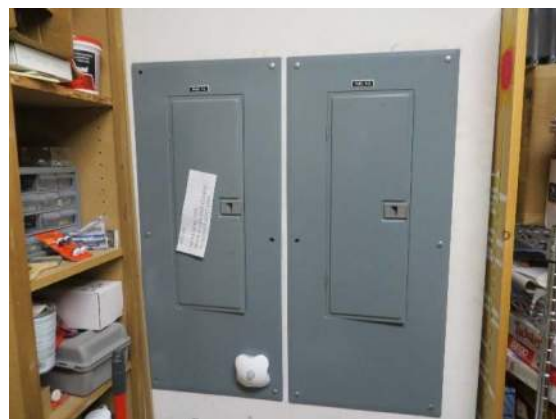
Picture 5 – Sub-panels Located in Elec. Rm.

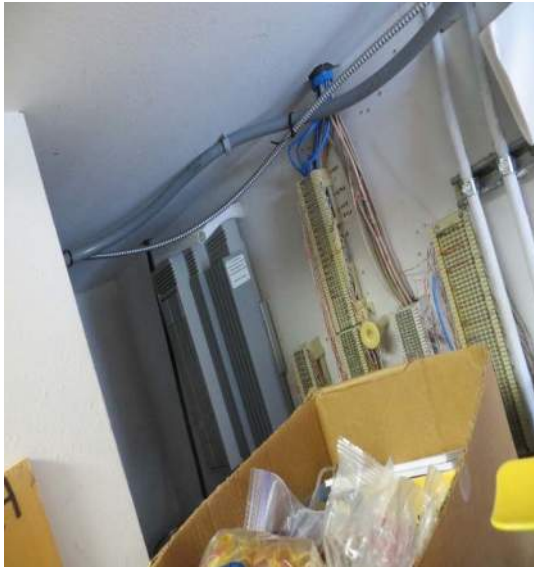
Picture 10 – Main Telephone Terminal Board

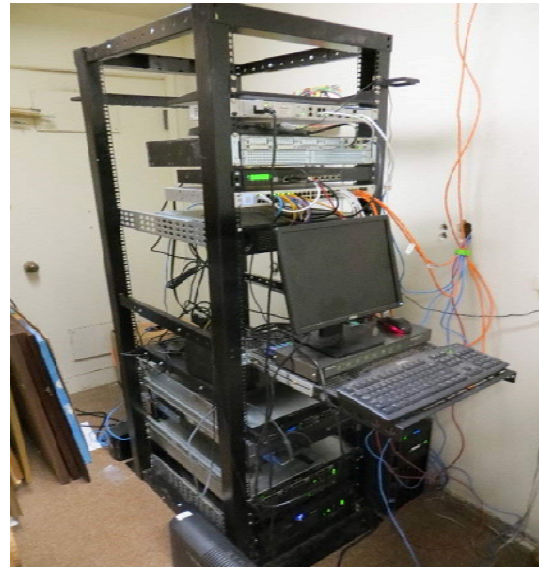
Pict. 11 – Main Telecom Equipment Rack
